CHAPTER 2

PARKS & FACILITIES ASSESSMENTS

MAGGIO RANCH PARK

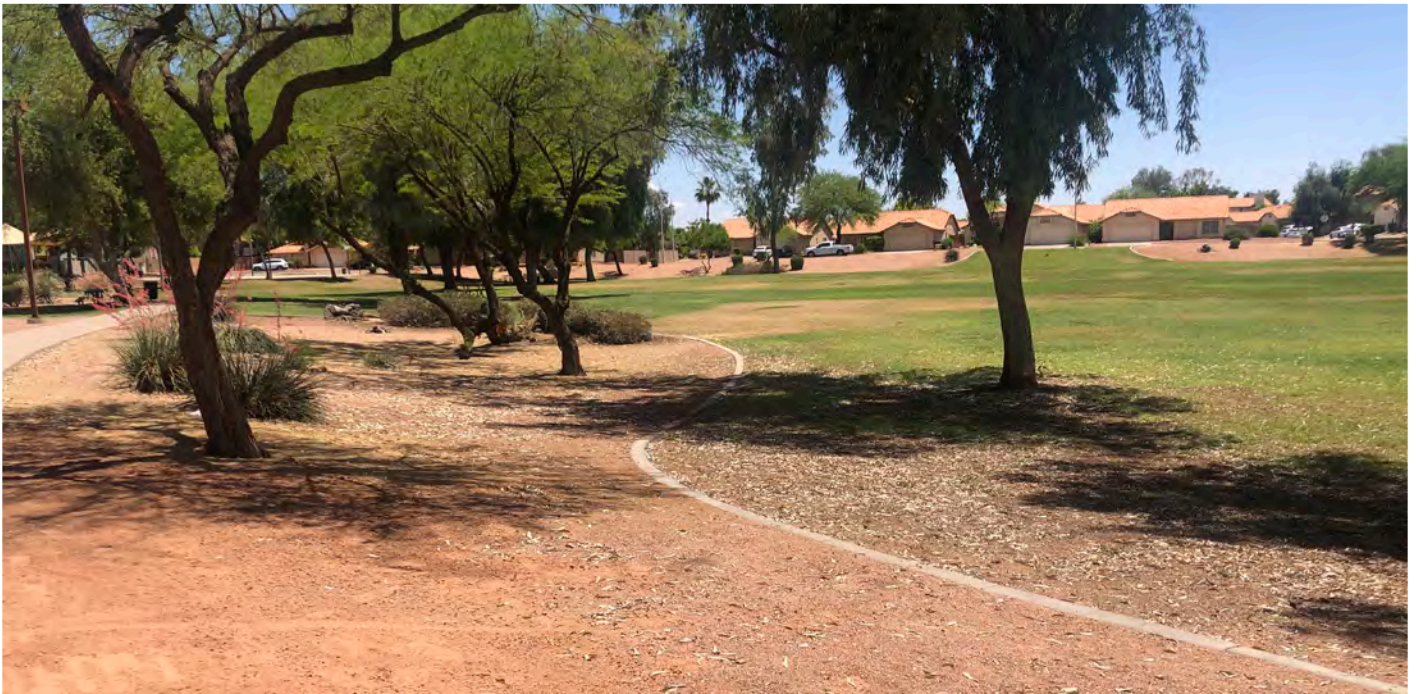
Overall Drainage

The south turf area is in fair condition with some hard compaction areas throughout. Some of the steeper bank slopes along Maggio Way are worn and new curb and decomposed granite on steeper slopes is recommended. An aeration and soil agronomy test to evaluate soil condition is also recommended.

The north turf area is in a worn condition. Several established and mature shade trees make it difficult for turf to grow in the playground area. It is recommended that staff look into reducing turf in shaded areas.

The sand volleyball court is in poor condition (net has been removed due to COVID-19). The court has high-pressure sodium lighting. LED fixture replacement for the sand volleyball court is recommended.

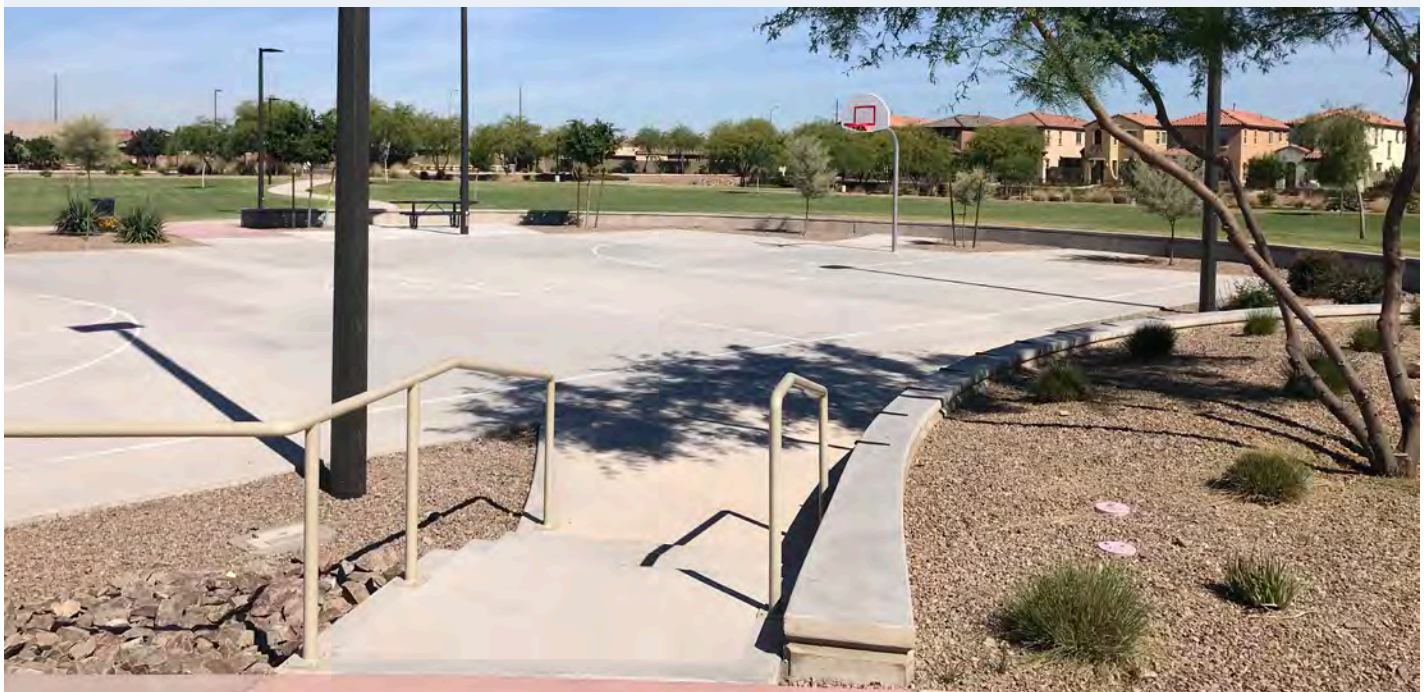
Turf Areas

The turf is in excellent condition with strong growth. An aeration and soil agronomy test to evaluate soil condition and recommendations for amendments is suggested.

The synthetic turf surfacing is in average condition. The header curbs and sidewalk areas are in new condition and the equipment is also in new condition.

The sand volleyball and basketball courts are in new condition. The courts have LED light fixtures.

The concrete sidewalk is in good condition.

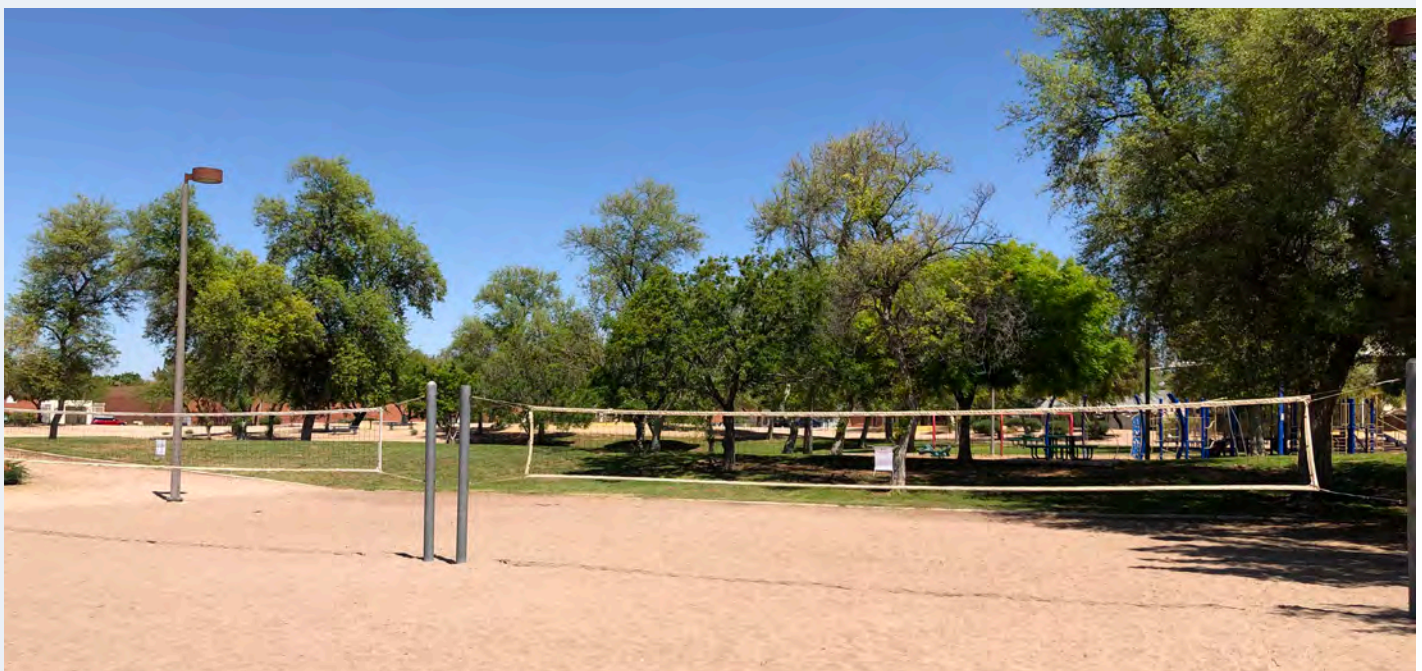
Overall Drainage

The park has four large turf areas. The southern basin has a headwall in decomposed granite, while the northern area has a headwall in the turf area. The northern turf basin does not appear to receive offsite flows and serves as overflow for the southern turf basin. It is recommended that the offsite volume, which outfalls into the southern turf basin, be evaluated as it does not appear to need to utilize the northern basin to equalize the storage volume.

There are several areas within the perimeter of the turf basins where the concrete header curb is broken or displaced. Header replacement is recommended to provide separation from turf and decomposed granite.

The overall turf is in below-average condition with several worn areas throughout all the basins, including sideslopes. The condition is due to lack of irrigation maintenance not activity. The turf has silty, crusty film from incoming offsite drainage in the southern turf area. The ground appears to be very compacted. An aeration and soil agronomy test is recommended to evaluate soil condition.

The concrete post-tension court appears to be one of the older courts in the system but is in good condition. The existing court lighting is high-pressure sodium. LED fixture replacement is recommended.

The park lighting (pathway, basketball court, and volleyball courts) have high-pressure sodium light fixtures. LED fixture replacement is recommended.

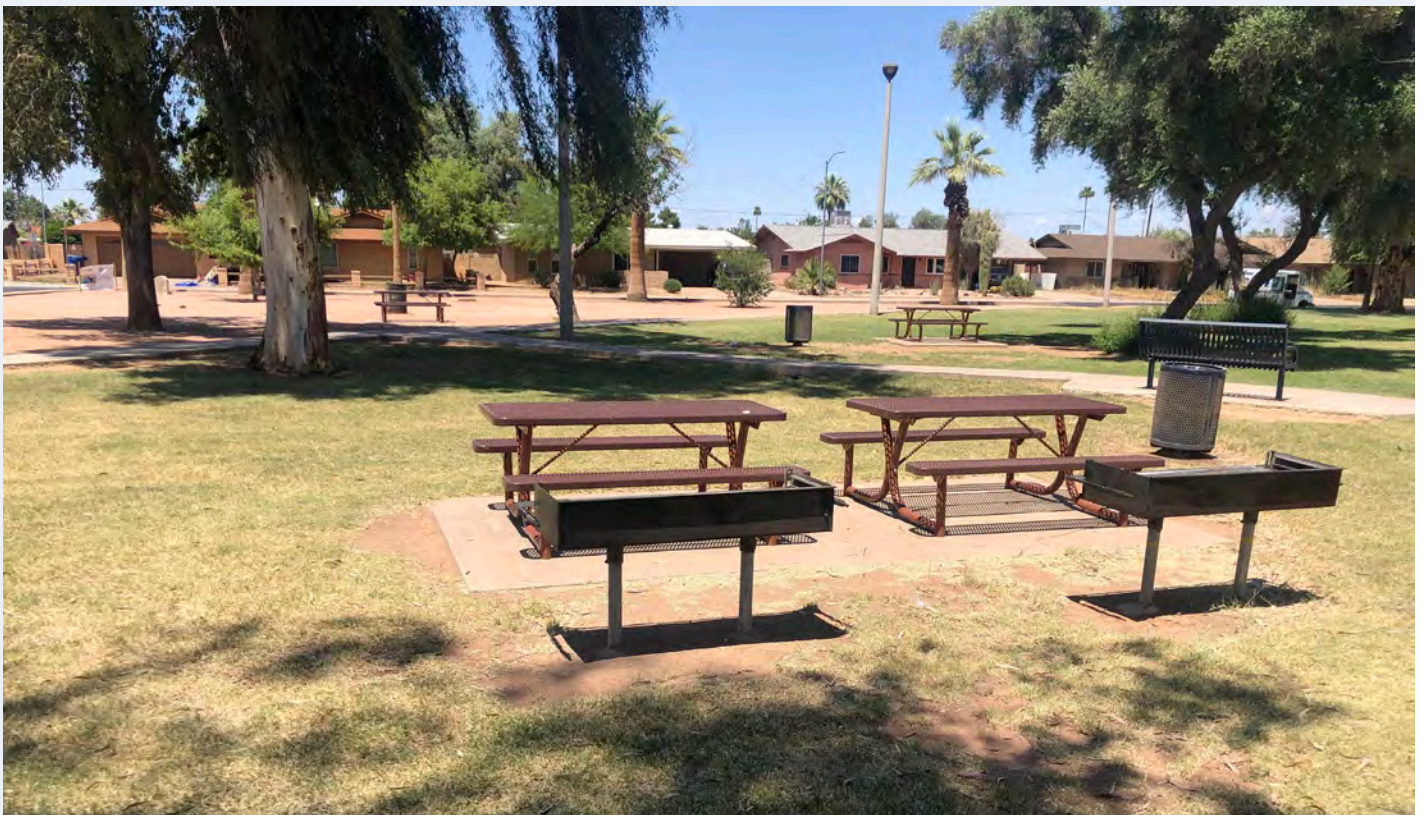
Parking Area

The existing parking lot was crack sealed and seal coated recently. The parking area needs to be replaced as the asphalt-concrete pavement has reached its life expectancy.

The turf area is in fair condition but the berm separating the two irrigation flood valves is worn.

The park lighting has a mixture of pedestrian lighting and actual street light poles. The site park lighting is high-pressure sodium. LED fixture replacement for the pathway lighting is recommended.

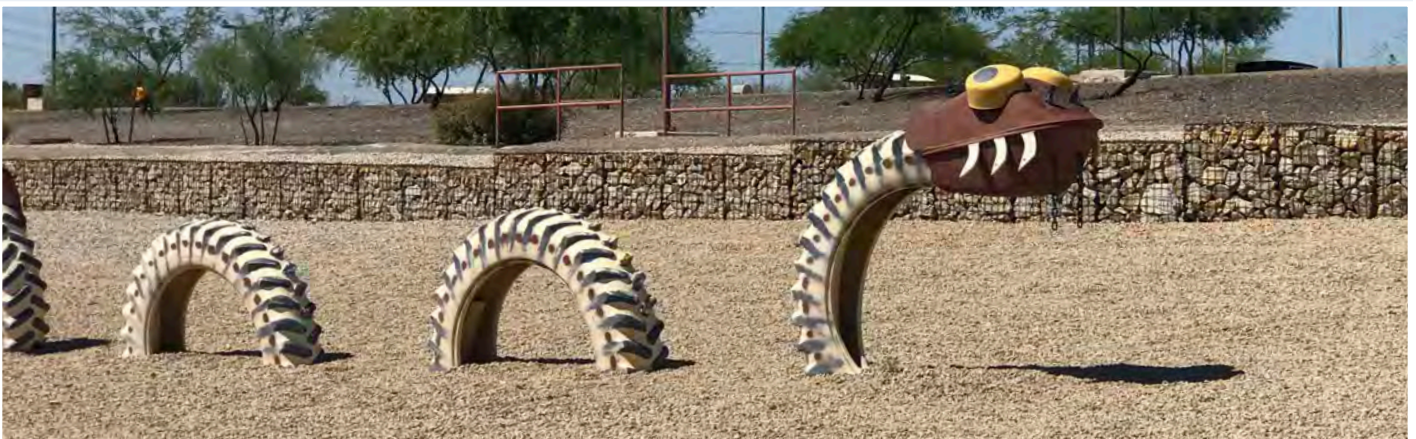
Overall Drainage

The pedestrian and parking area lights are high-pressure sodium fixtures. LED fixture replacement along pathways is recommended.

The turf in the dog park is in good condition with some worn areas, fencing, and header curb. The site furniture/amenities are in good condition.

The playground area is in good shape. The header curbs, sidewalk areas and play equipment are in good condition.

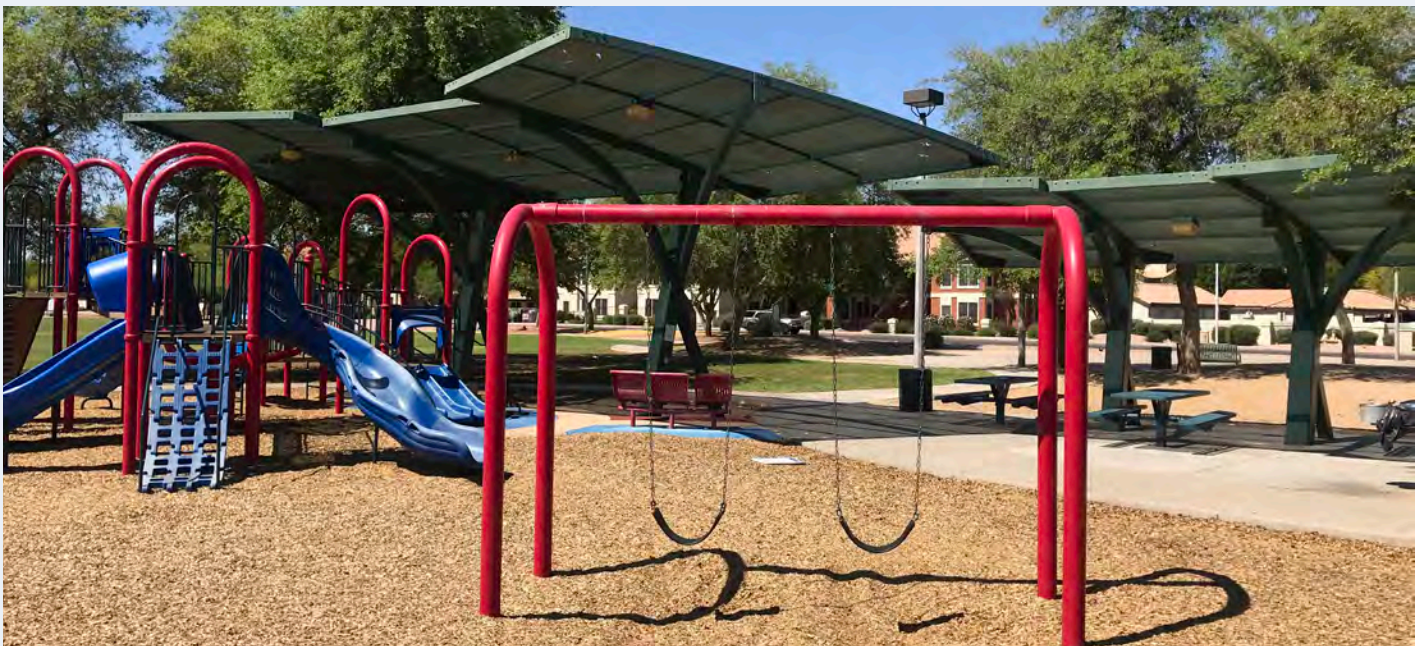
Overall Drainage

The park provides offsite drainage storage for Coronado Street, which has two surface flow scuppers at the south and north park frontage areas. These two collection points both convey runoff to decomposed granite areas. The south conveys storm water along the decomposed granite perimeter of the park. The north scupper outlets to a basin around the basketball courts, which has caused some erosion on the sideslopes due to the steep bank slopes from the depth of basin to the finish floor of the basketball court.

The turf is in overall good condition, but does have heavy compaction throughout the middle of the turf area. There are areas of standing water from the spray irrigation. The areas around the playground have nice established trees providing good shade; however, the tree areas within the turf turn into muddy spots as the grass does not grow from the shade. Recommend aeration and soil agronomy to evaluate soil conditioning. Recommend turf reduction in mature shade tree areas and more decomposed granite with less irrigation.

There are several areas with established trees being located near the sidewalk. This has caused some cracking/heaving. The City has replaced some of these, but they are being replaced in the same location as the existing tree and will cause further uprooting in the future. A concrete sidewalk relocation to provide better separation from the tree root zones is recommended.

The park pathway lighting utilizes high-pressure sodium light fixtures. LED fixture replacement for court lighting is recommended.

The concrete sidewalk is in good condition. There are some overspray areas from the irrigation heads.

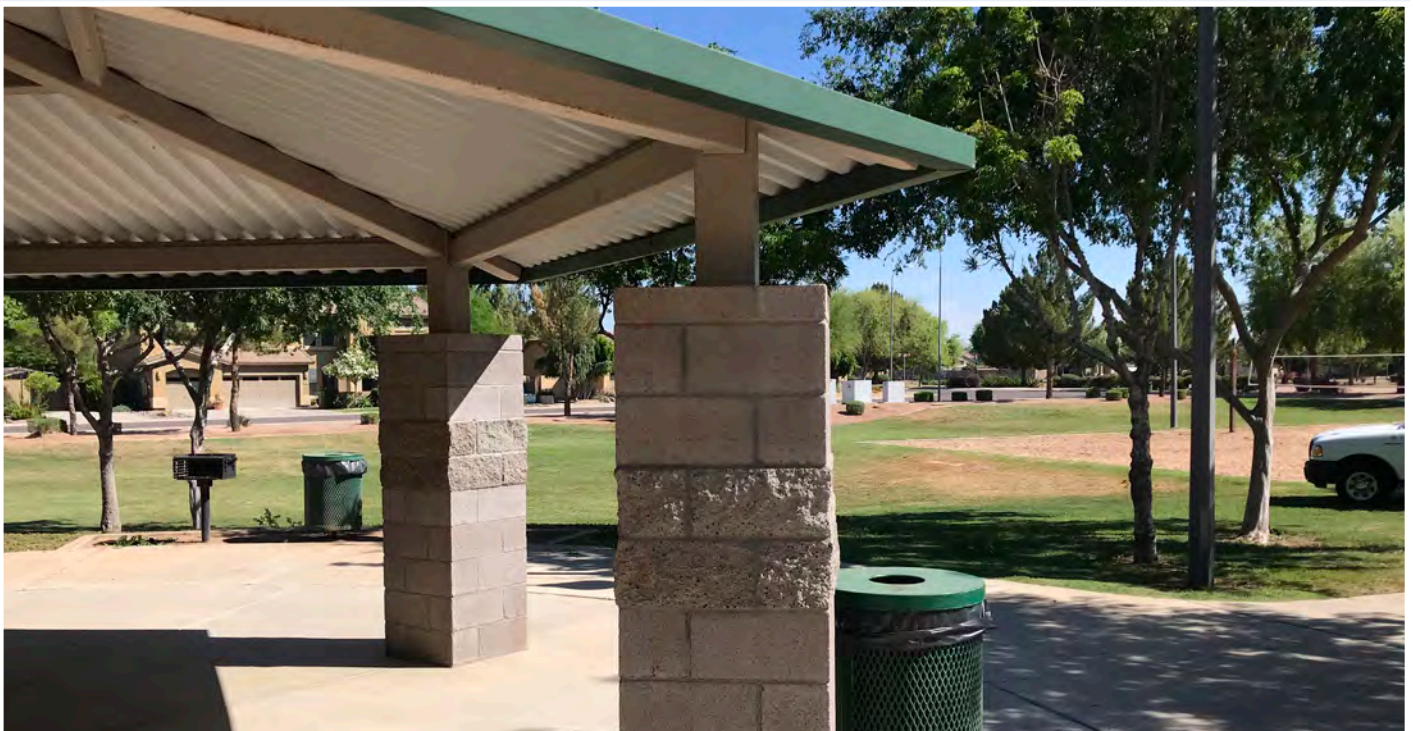
West Turf Open Area

The west turf area has several worn/non-growing areas on the berm slopes and in the areas with the established trees. The condition of slopes is due to lack of irrigation maintenance not activity. The area is very compacted throughout. An aeration and soil agronomy test to evaluate soil conditioning is recommended. In addition, it is suggested that staff reduce turf to decomposed granite in areas with established shade trees.

The concrete sidewalk has some cracking throughout.

The pedestrian pathway lighting is high-pressure sodium. LED fixture replacement is recommended.
