# CHAPTER 2

# PARKS & FACILITIES ASSESSMENTS

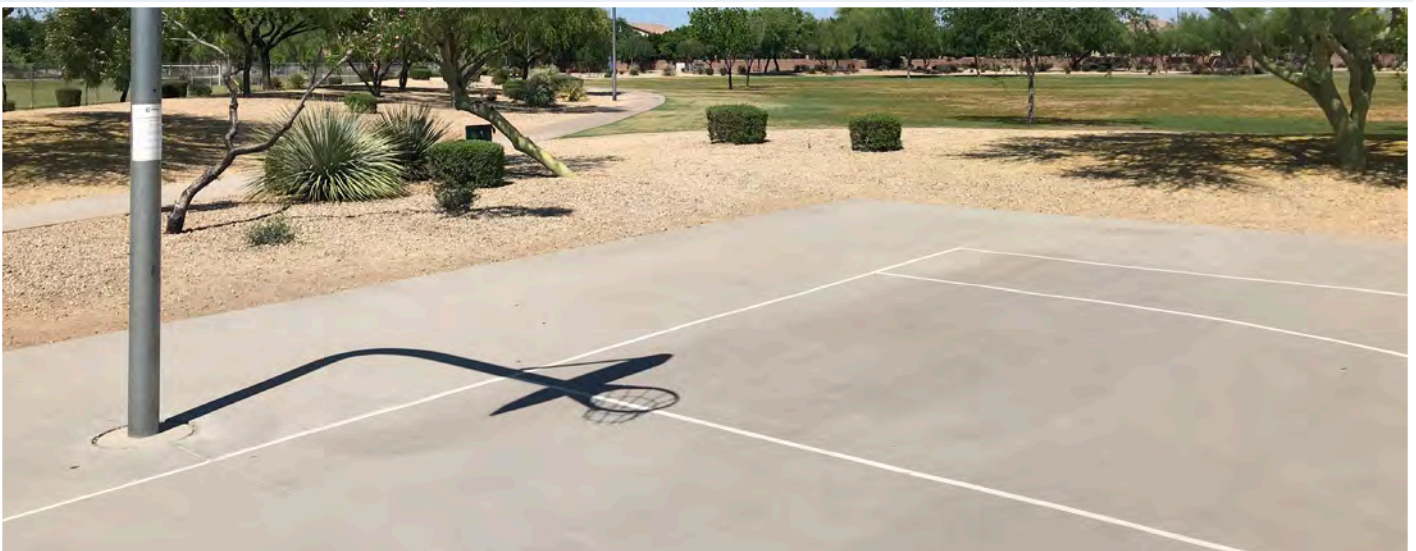
*The east turf basin turf is in below-average condition with some worn areas. The condition is due to lack of irrigation maintenance not activity. The area is very compacted throughout. An aeration and soil agronomy test to evaluate soil condition and recommendations for amendments is suggested.*

*The sand volleyball court is in good condition. The court has high-pressure sodium light fixtures. LED fixture replacement for court lighting is recommended.*

*The concrete sidewalk is in good condition but there are some cracked panels throughout the pathways and plaza areas.*

*The concrete post-tension court is in good condition and the lighting is high-pressure sodium. LED fixture replacement for court lighting is recommended.*

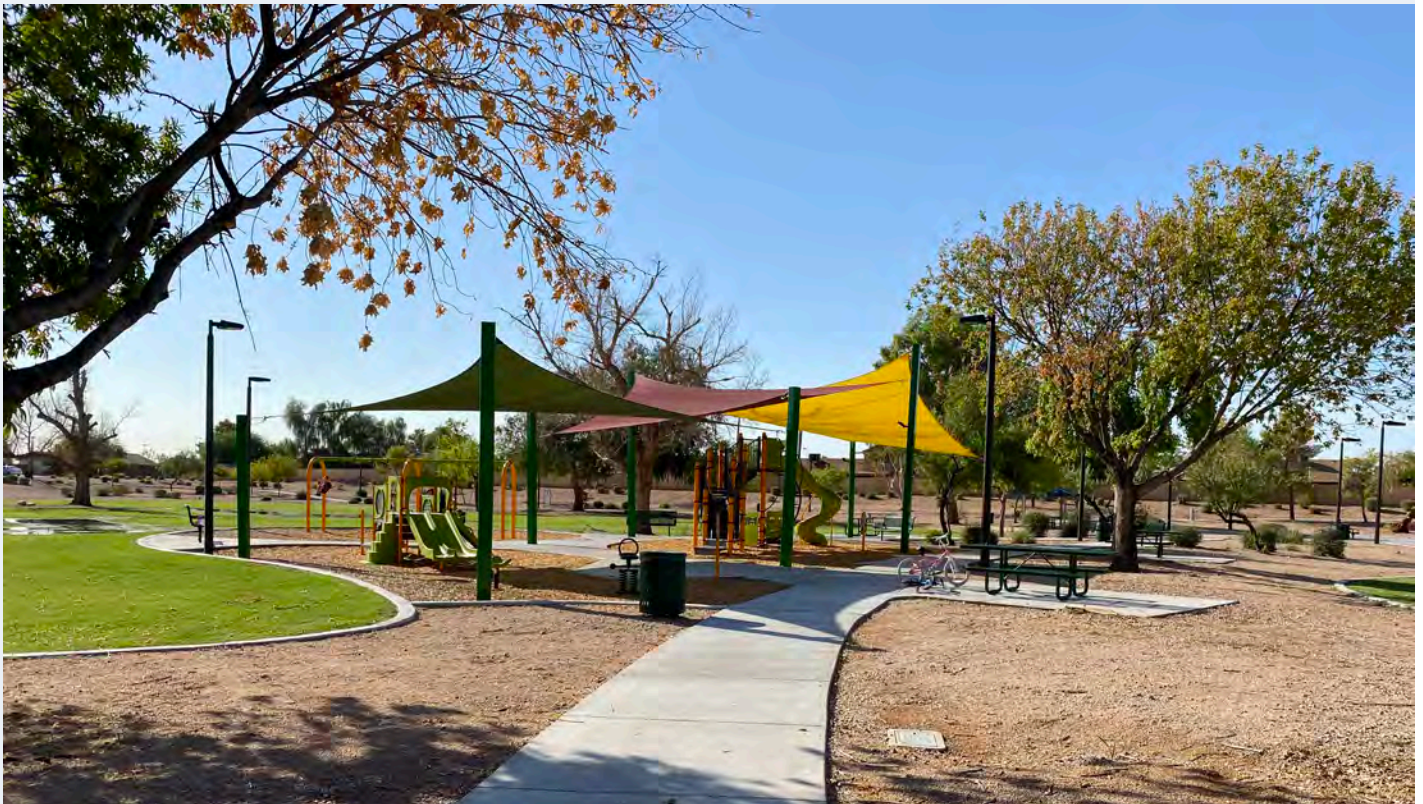
The turf is in good condition. There are some worn areas that the City recently has been addressing with new sod. An aeration and soil agronomy test to evaluate soil condition is recommended. The worn condition of slopes is due to lack of irrigation maintenance, not activity.

The concrete sidewalk is in good condition.

The concrete post-tension court is in great condition and has LED lighting. The park pathway lighting is also LED.

The playground area is in good shape, the header curbs and sidewalk areas are also in good condition and the play equipment is in good condition.

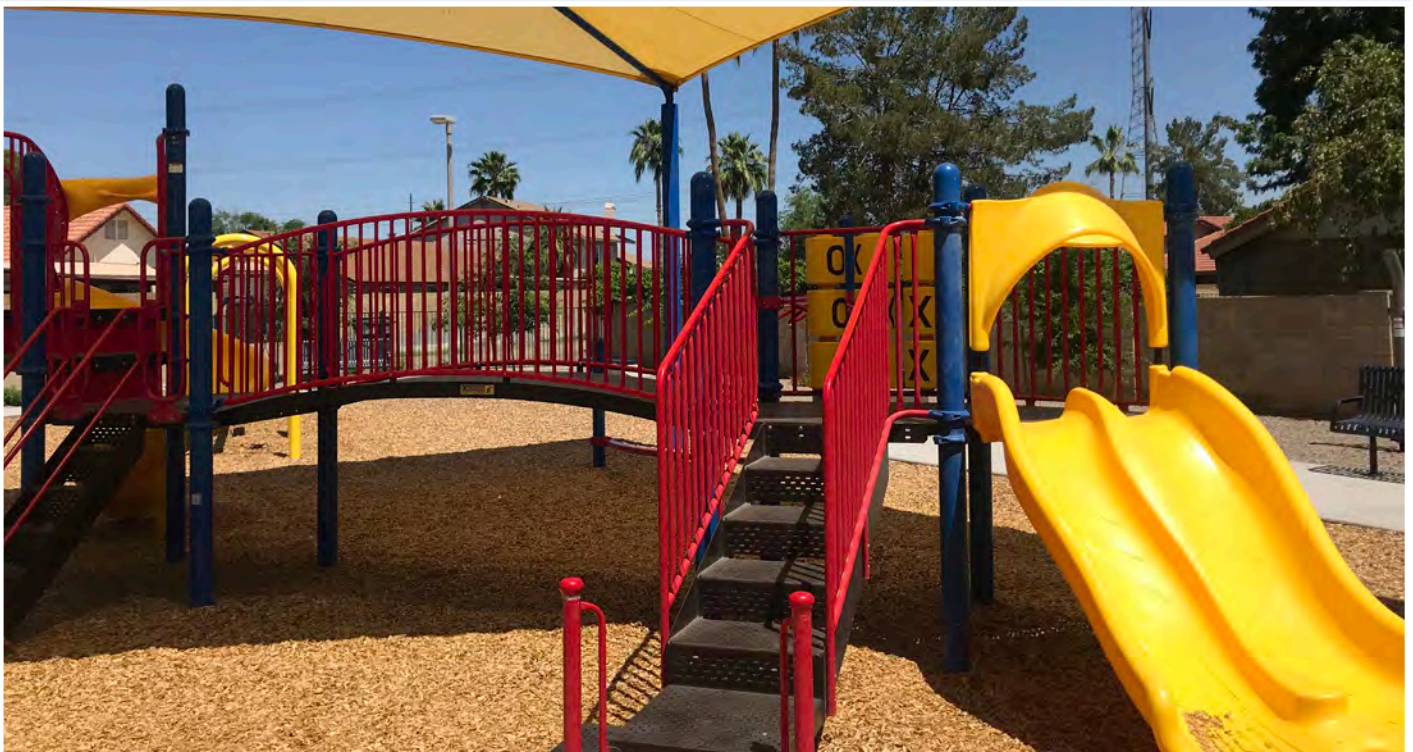
### Sidewalk and Playground

*The concrete sidewalks and playground are brand new and in good condition.*

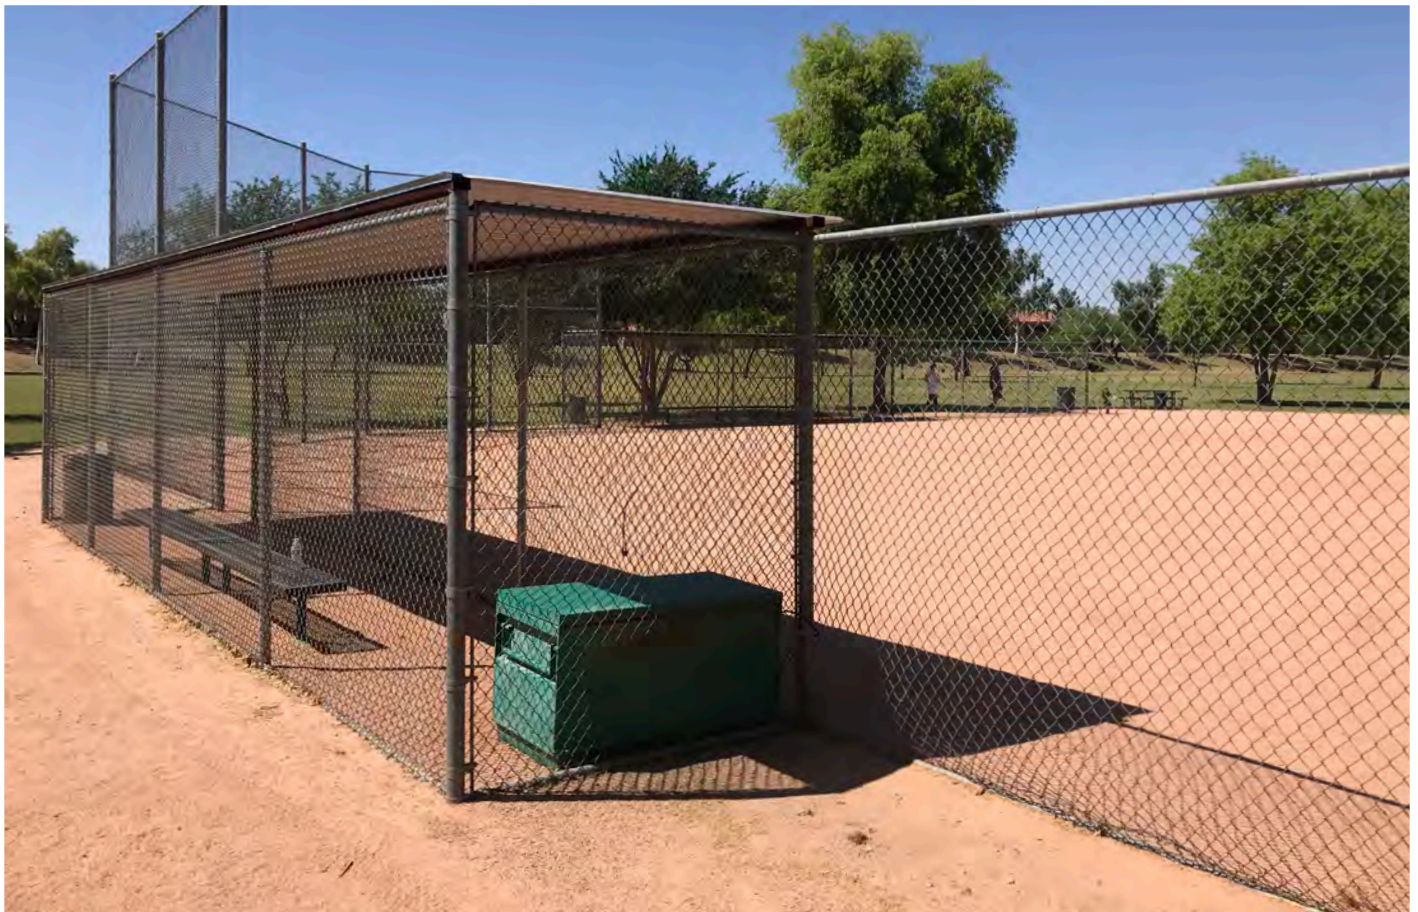
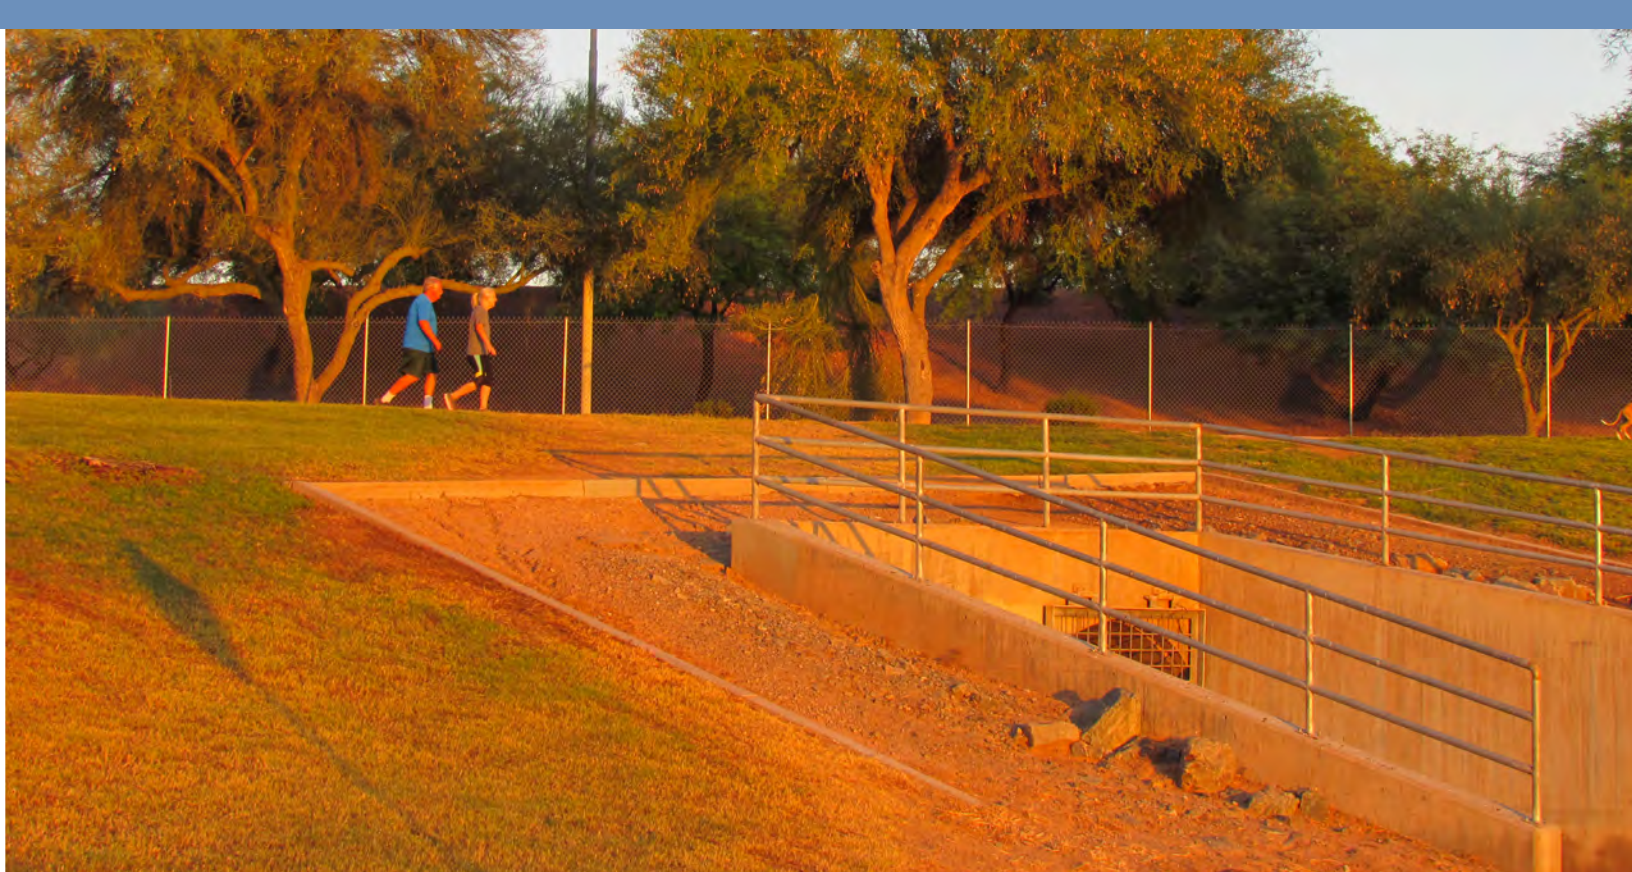
### Overall Drainage

*Thude Park is a regional retention basin facility with storm drain outlets at and along the perimeter of the park.*

*The park perimeter has some worn areas, but overall the slopes look good. Some of the decomposed granite slopes are showing minor rilling, but overall in good condition.*

*The turf floor of the basin is in average condition. There are some worn areas and the basin is compacted throughout. An aeration and soil agronomy to evaluate soil condition is recommended.*
