CHAPTER 2

PARKS & FACILITIES ASSESSMENTS

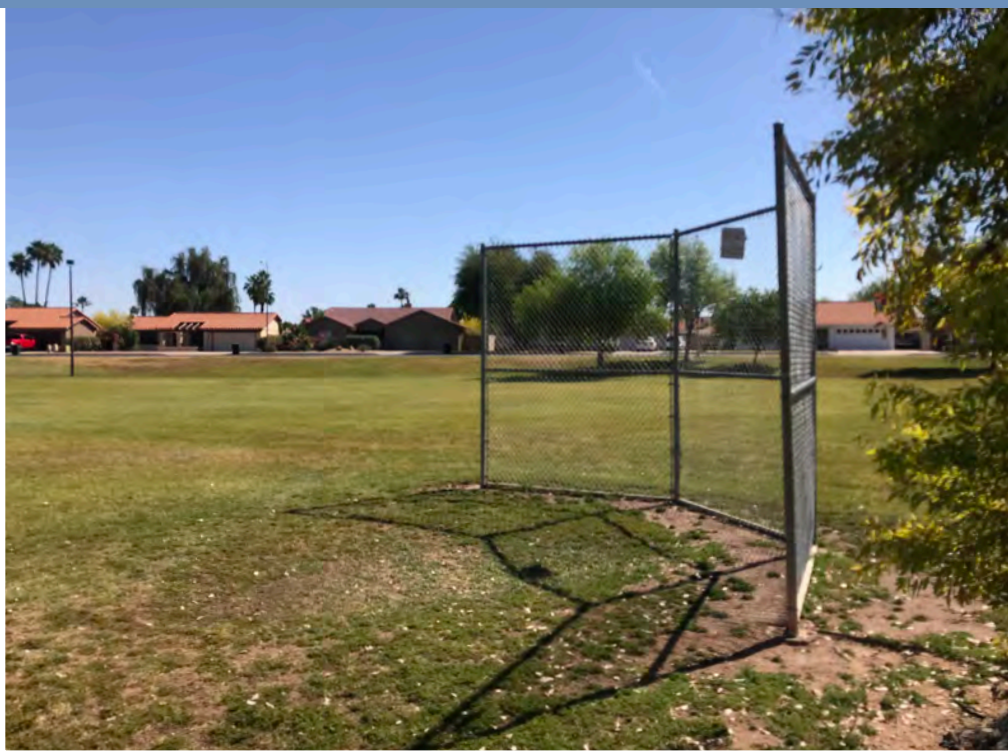
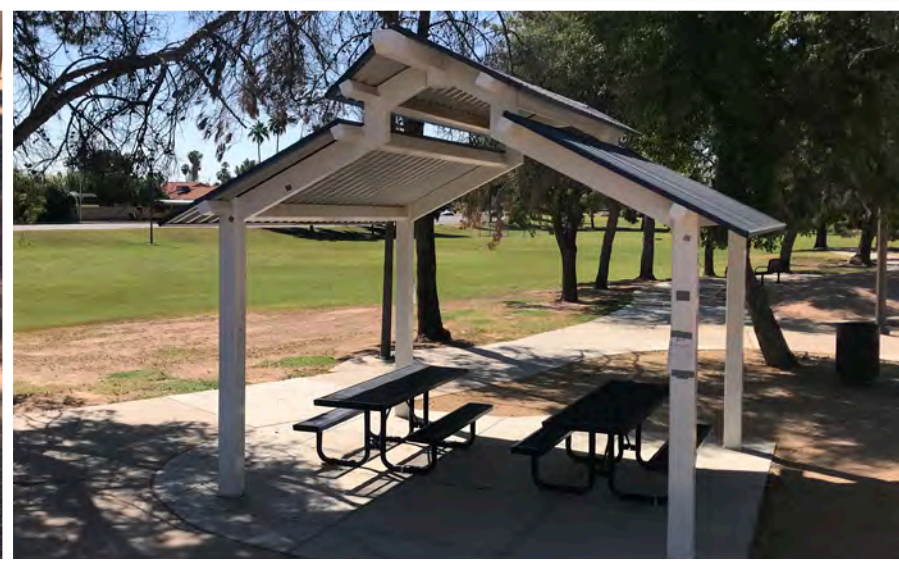
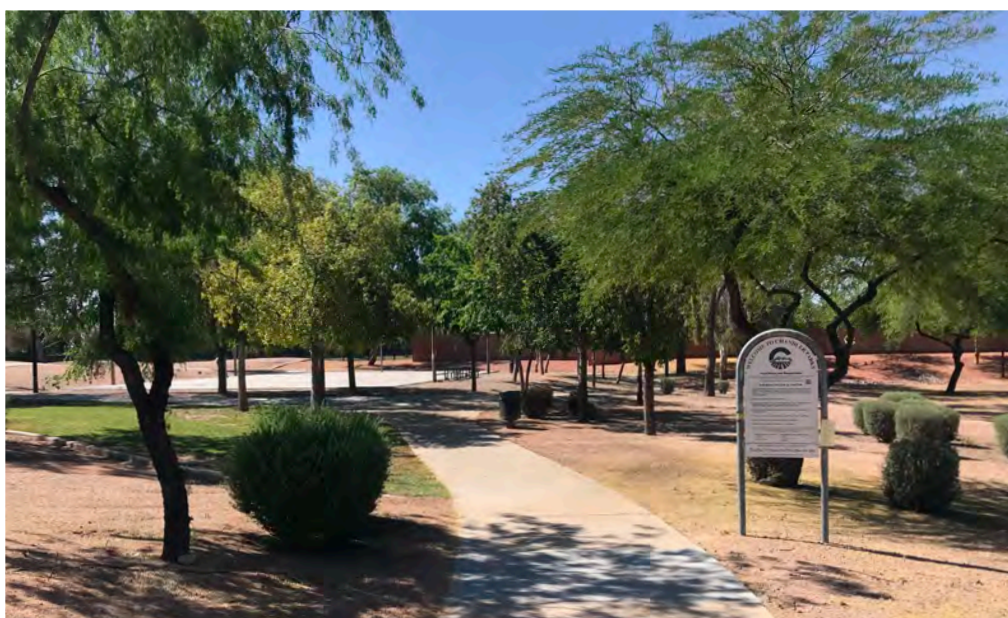
Amenity	Qty	Grade	Notes
BASKETBALL COURT (LIGHTED)	1	3	Surfacing in good condition; signs of wear and minor cracking
BENCH	6	3	Seating and paint in good condition; minor signs of rust at mounting plates
DOG BAG STATION	4	3	Showing signs of fading and use
DRINKING FOUNTAIN	1	3	Good condition; minor signs of rust and water damage
IRRIGATION SYSTEM (AC)	16.47	3	Visual assessment only
LIGHTING (SITE, SPORTS, PED, ETC)	65	2	Light fixtures appear dated and showing signs of weathering
OPEN TURF AREA (AC)	9.6	2	Turf in average condition; low spots; regrading needed; some slopes and shaded areas lack quality turf growth
PLAYGROUND (SHADED)	1	3	Newer structures; shade small and not sufficient; minor low spots in surfacing
RAMADA	1	4	Good condition; little to no signs of fading or rust
SIGNAGE (PARK ENTRY)	2	3	Aging, faded, and paint refresh needed
SIGNAGE (REGULATORY)	5	3	Average condition; fading due to exposure

TRAIL - PAVED (MI)	0.54	3	Minor cracks and wear; damaged panels replaced
TRASH RECEPTACLE	18	3	Minor, non-structural damage through use
VOLLEYBALL COURT (SAND)	1	2	Poles and net aging; showing signs of rust/damage

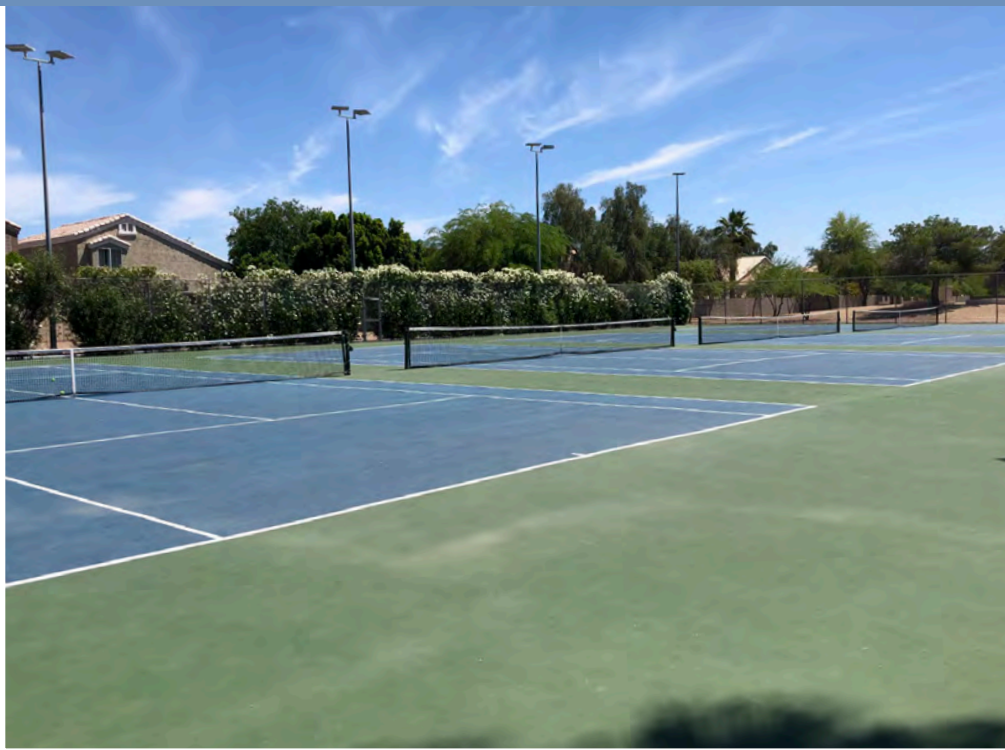
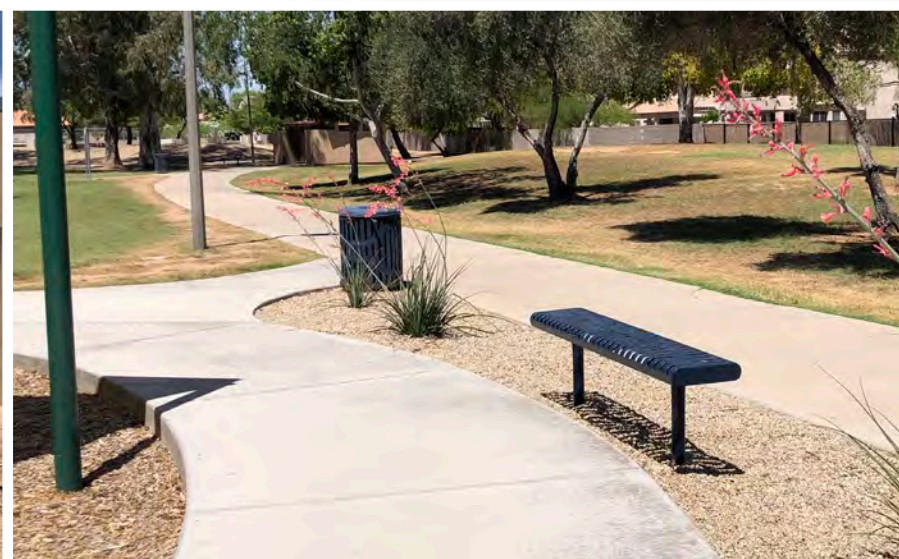
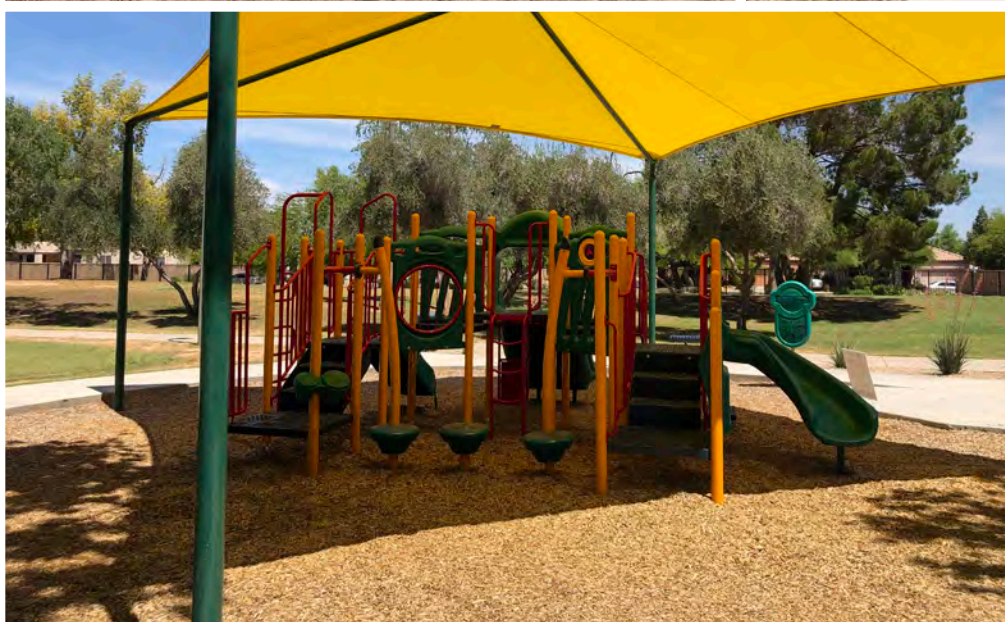
Amenity	Qty	Grade	Notes
BASKETBALL COURT (LIGHTED)	1	3	Average condition; dated light fixtures
BBQ PIT/ GRILL	2	3	Typical signs of use; consider deep clean
BENCH	9	3	Average condition
BIKE RACK/ LOOP	2	3	Average condition; showing signs of use
DOG BAG STATION	2	3	Average condition; some fading
DRINKING FOUNTAIN	1	3	Average condition; showing signs of use/sun damage
IRRIGATION SYSTEM (AC)	9.97	3	Visual assessment only
LIGHTING (SITE, SPORTS, PED, ETC)	39	4	Mostly updated lighting; basketball lighting is dated
OPEN TURF AREA (AC)	4.4	3	Potential for turf reduction opportunities; larger open spaces are well maintained; some turf erosion near playground area
PARKING LOT (SPACES)	45	2	Moderate condition; heavy cracking; resurfacing needed; consider alternate drainage strategies
PICNIC TABLE	18	3	Average condition; showing signs of use
PLAYGROUND (SHADED)	1	4	ADA ramps; newer shade structure; additional wood chips would be beneficial

RACQUETBALL COURT (OUTDOOR)	2	3	Average exterior condition
RAMADA	2	3	Average condition; showing signs of use
RESTROOM BUILDING	1	2	Dated building; some cracking
SIGNAGE (PARK ENTRY)	3	3	Average condition
SIGNAGE (REGULATORY)	3	3	Average condition
TENNIS COURT (LIGHTED)	4	5	Good condition, Replace with post tension in future
TRAIL - PAVED (MI)	0.62	3	.32 mi loop; moderate amount of cracking; instances where mature trees are impacting concrete integrity
TRASH RECEPTACLE	23	3	Average condition; showing signs of use
VOLLEYBALL COURT (SAND)	2	4	Good condition

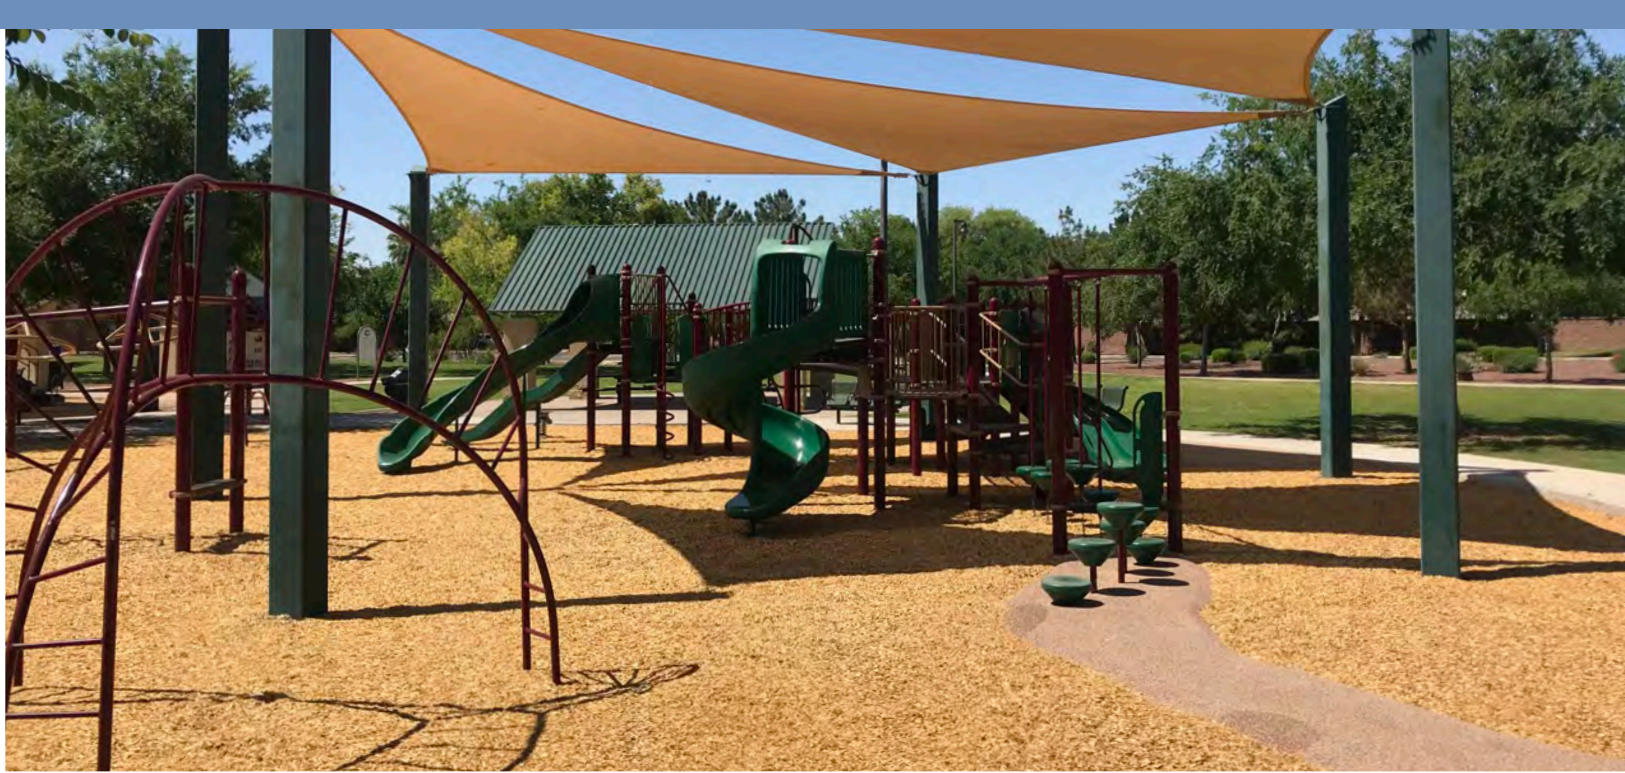
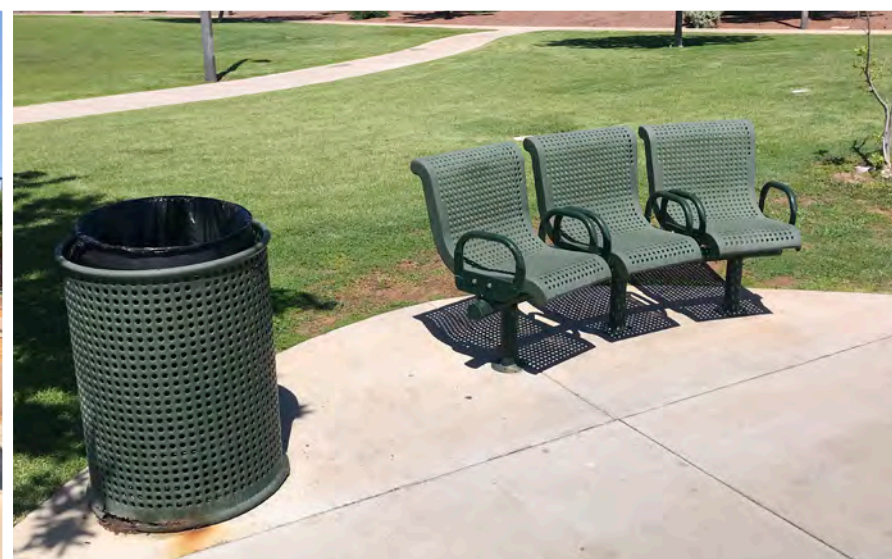
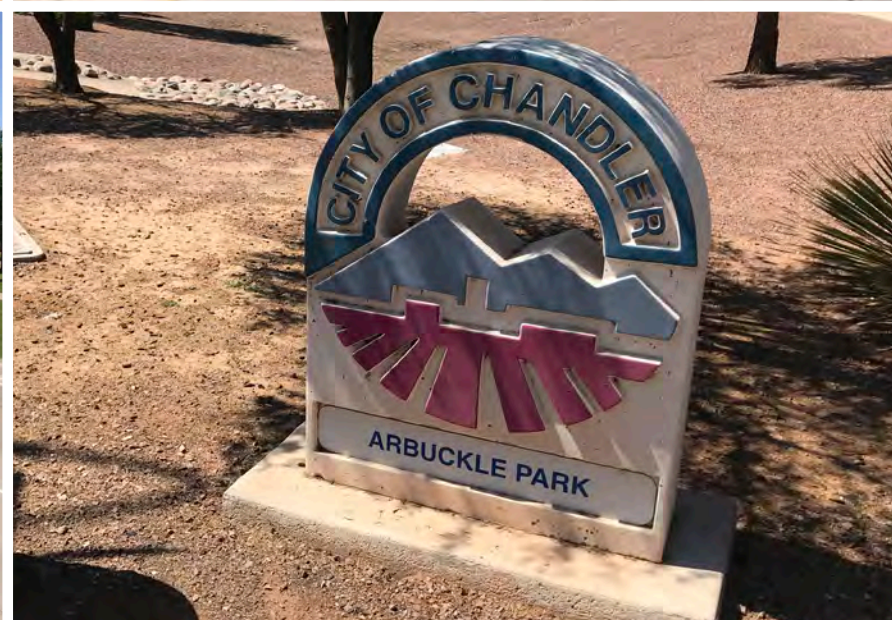
Amenity	Qty	Grade	Notes
BASKETBALL COURT (LIGHTED)	1	3	Court surface appears to have many standing water stains, low spots, and minor cracking
BBQ PIT/ GRILL	2	3	Typical signs of use, consider deep clean
BENCH	14	3	Average to good condition; some benches showing signs of significant wear, fading, and minor rust
BIKE RACK/ LOOP	1	3	Average condition, minor rust/chipping from use
DOG BAG STATION	4	4	Good condition; minor signs of use
DRINKING FOUNTAIN	1	3	Typical signs of use; minor rust and water damage
IRRIGATION SYSTEM (AC)	7.89	3	Visual assessment only
KIOSK (INTERPRETIVE)	1	4	Good condition; minor signs of fading
LIGHTING (SITE, SPORTS, PED, ETC)	33	3	Concrete poles and high pressure sodium fixtures are outdated, but in good condition
OPEN TURF AREA (AC)	4.1	3	Turf mostly in good condition; lack of growth on some slopes and low spots; erosion
PICKLEBALL COURT	1	3	Average condition; minor signs of cracking; heavy use, LED fixtures

PICNIC TABLE	1	3	Average to good condition; showing signs of significant wear and minor rust/chipping
PLAYGROUND (SHADED)	2	4	Newer surfacing and shade fabric; minor low spots and raking needed
RAMADA	2	4	Good condition; minimal color fade; no signs of rust
SIGNAGE (PARK ENTRY)	2	3	Faded due to exposure; clean and repaint needed
SIGNAGE (REGULATORY)	2	3	Faded due to exposure
TRAIL - PAVED (MI)	0.59	3	Minor signs of cracking
TRASH RECEPTACLE	12	3	Showing significant signs of rust, wear, and age

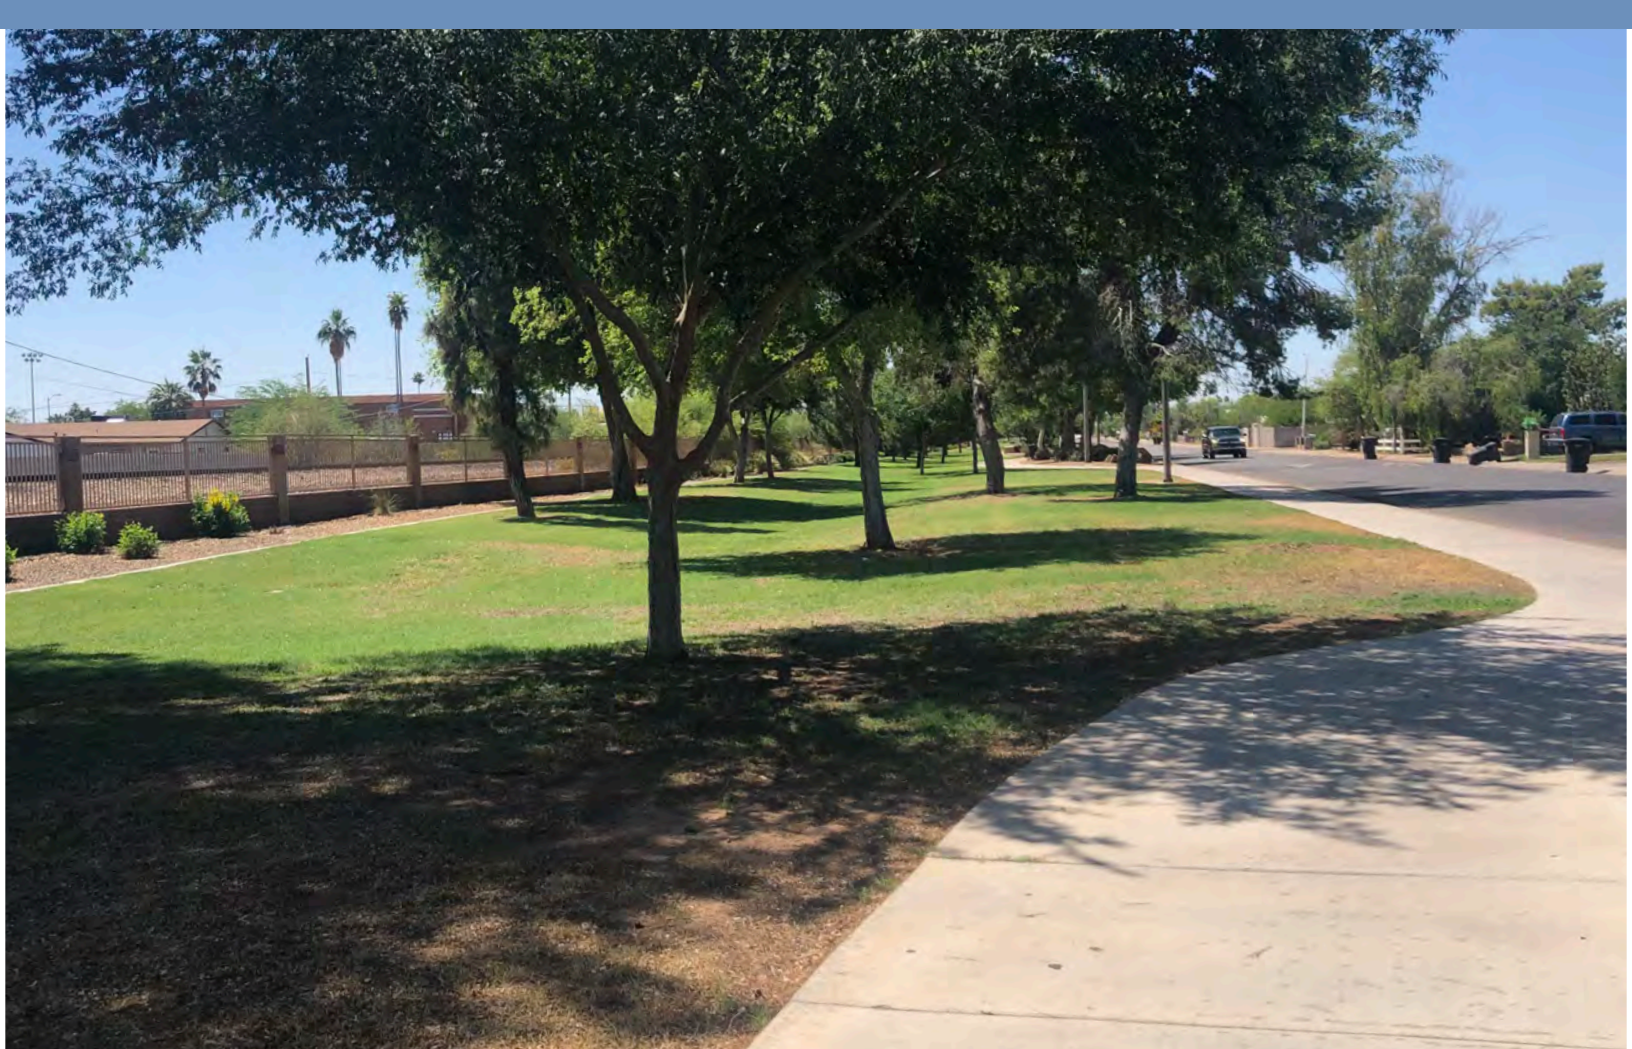
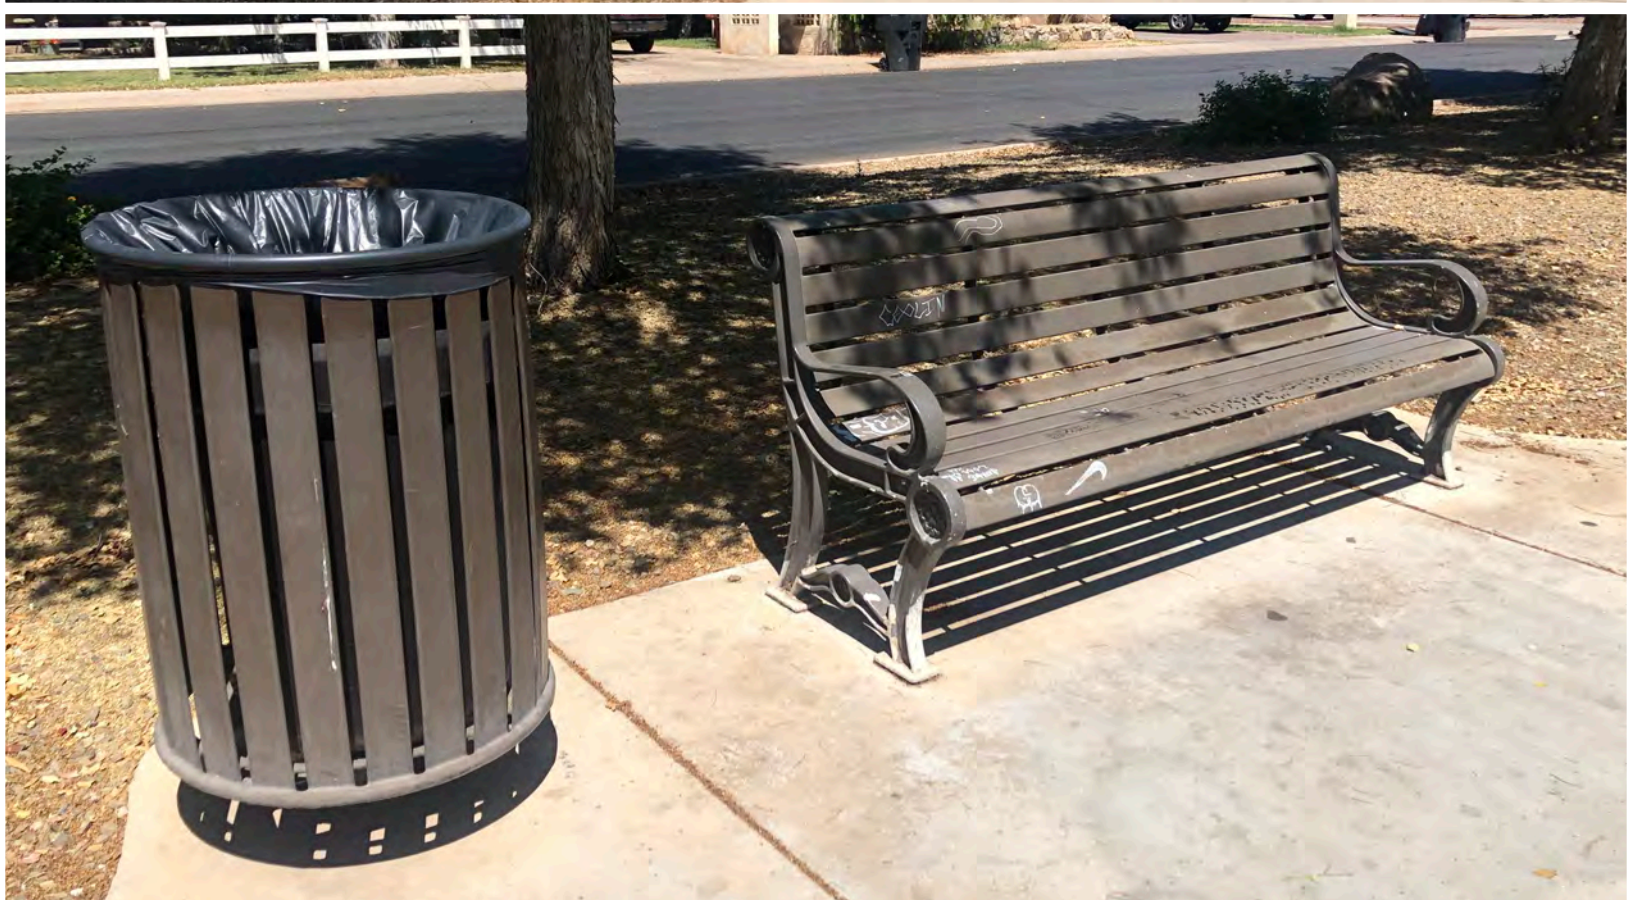
Amenity	Qty	Grade	Notes
BBQ PIT/ GRILL	1	3	Average condition; typical signs of use
BENCH	4	3	Moderate condition; all bench styles match; some tagging/graffiti
DOG BAG STATION	1	3	Some fading and typical signs of use
DRINKING FOUNTAIN	1	3	Some fading and typical signs of use
HORSESHOE PIT	1	3	Average condition
IRRIGATION SYSTEM (AC)	1.57	3	Visual assessment only
LIGHTING (SITE, SPORTS, PED, ETC)	9	4	Updated; ornamental fixture
OPEN TURF AREA (AC)	1.5	2	Turf in moderate to poor condition; turf areas are largely being used for drainage retention and are not usable
PICNIC TABLE	2	2	Picnic tables in relatively poor condition
SIGNAGE (PARK ENTRY)	1	3	Signage is located in the center of the park at the Detroit Street intersection, but no signage exists at the ingress/egress points of this area
SIGNAGE (REGULATORY)	1	3	Some fading
TRAIL - PAVED (MI)	0.16	4	Sidewalk in good condition
TRASH RECEPTACLE	4	3	Average condition; typical signs of use and sun

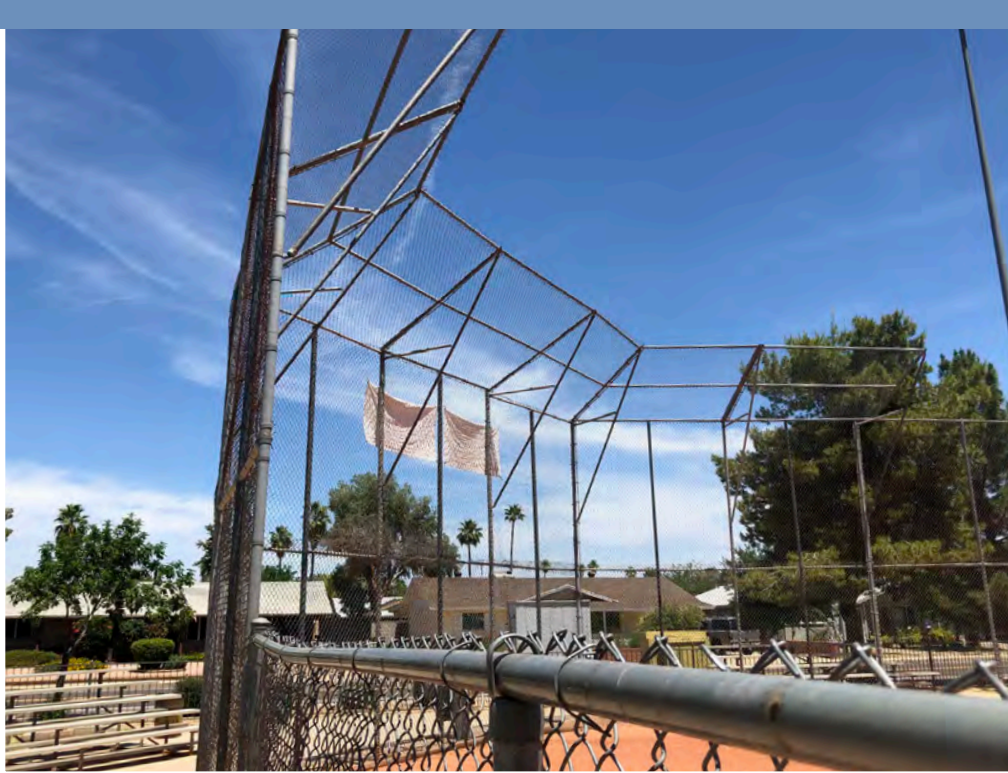
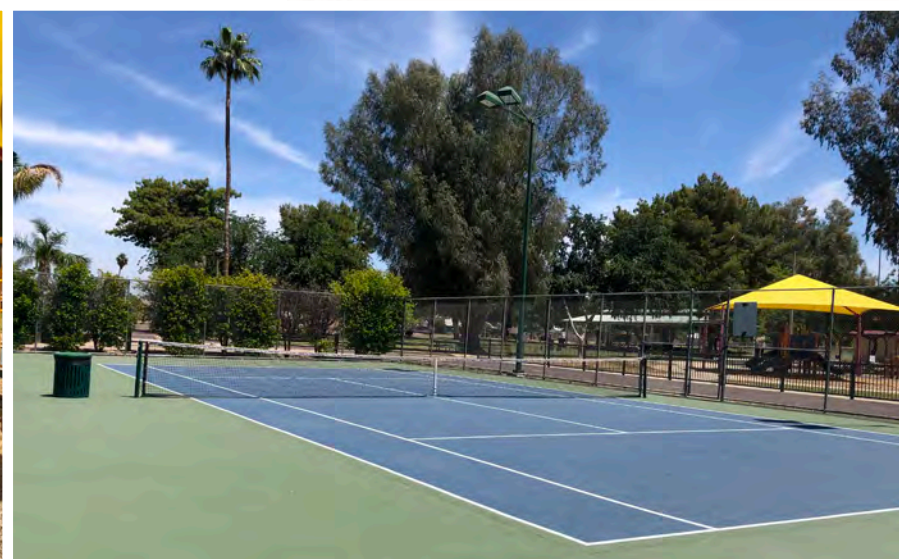
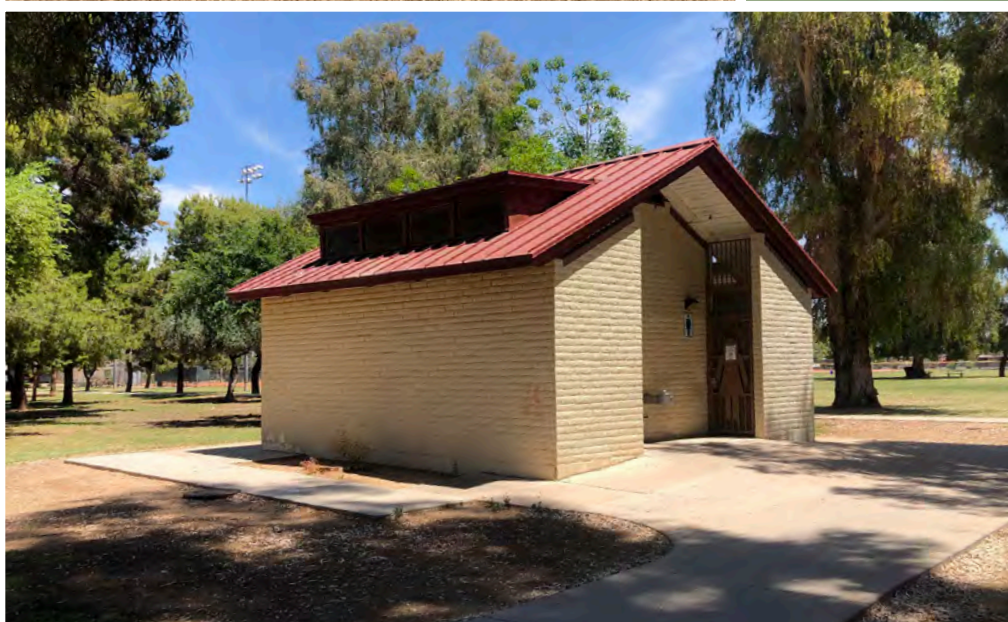
Amenity	Qty	Grade	Notes
BASEBALL FIELD (LIGHTED)	4	3	North fields are well-maintained; fencing at south fields is beginning to bow
BBQ PIT/ GRILL	10	3	Average condition; showing typical signs of use
BENCH	18	2	Vary in styles; concrete benches can pose a safety issue due to jagged edges/broken corners
BIKE RACK/ LOOP	2	3	Average condition; showing typical signs of use
BLEACHERS	8	3	Average condition
DOG BAG STATION	4	3	Some fading
DRINKING FOUNTAIN	6	3	Average condition; showing typical signs of use
FLAG POLE	1	3	Average condition
IRRIGATION SYSTEM (AC)	30.84	3	Visual assessment only
LIGHTING (SITE, SPORTS, PED, ETC)	69	3	Dated site and sport court light fixtures
MAINTENANCE YARD/ BUILDING	1	3	Average; appears dated
OPEN TURF AREA (AC)	12.2	2	Turf is very patchy; erosion issues on slopes; likely irrigation issue
PARKING LOT (SPACES)	254	2	Resealing and ADA improvements needed; consider repaving south lot

PICKLEBALL COURT	6	3	Good condition; dated light fixtures
PICNIC TABLE	56	2	Picnic tables are generally in poor condition; consider replacement (2); group ramada picnic tables seem newer and are in good shape (4)
PLAYGROUND (SHADED)	2	3	Average condition
RAMADA	5	2	Ramadass with trellis roofs are generally in poor condition (2); group ramada with solid metal roof in good condition (4)
RESTROOM BUILDING	1	2	Dated; potential roof repairs; needs paint; exterior evaluated only
SIGNAGE (REGULATORY)	7	3	Average condition; some fading and rusting
TENNIS COURT (LIGHTED)	2	4	Good condition, dated light fixtures
TRAIL - PAVED (MI)	1.61	3	Relatively good condition
TRASH RECEPTACLE	78	3	Average condition; showing typical signs of use

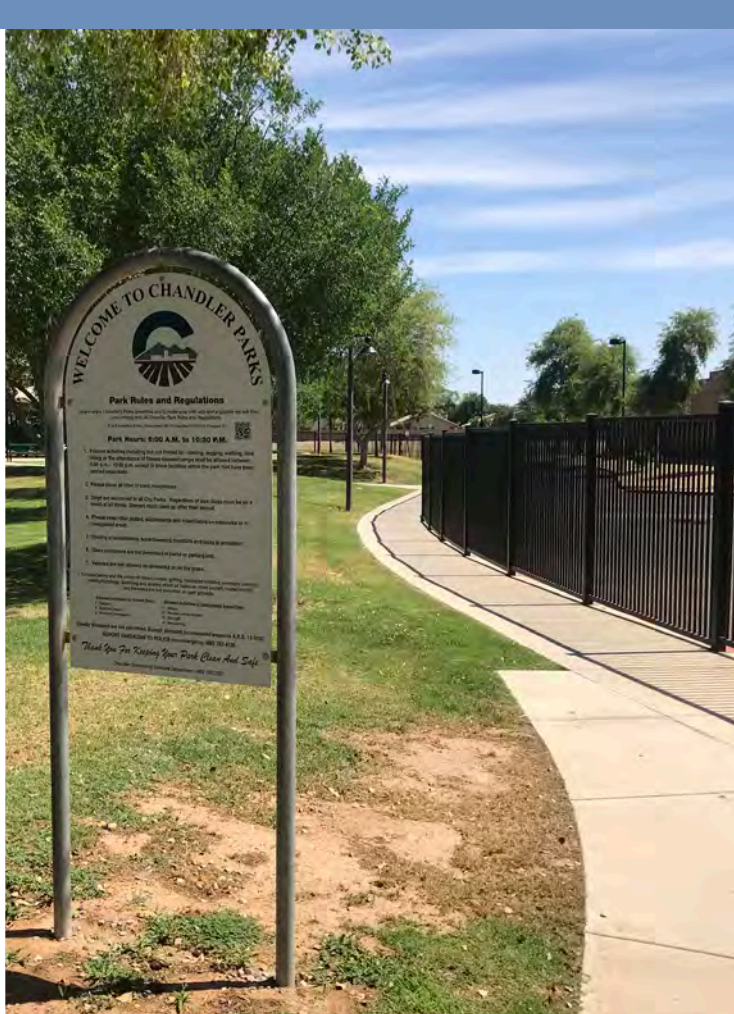
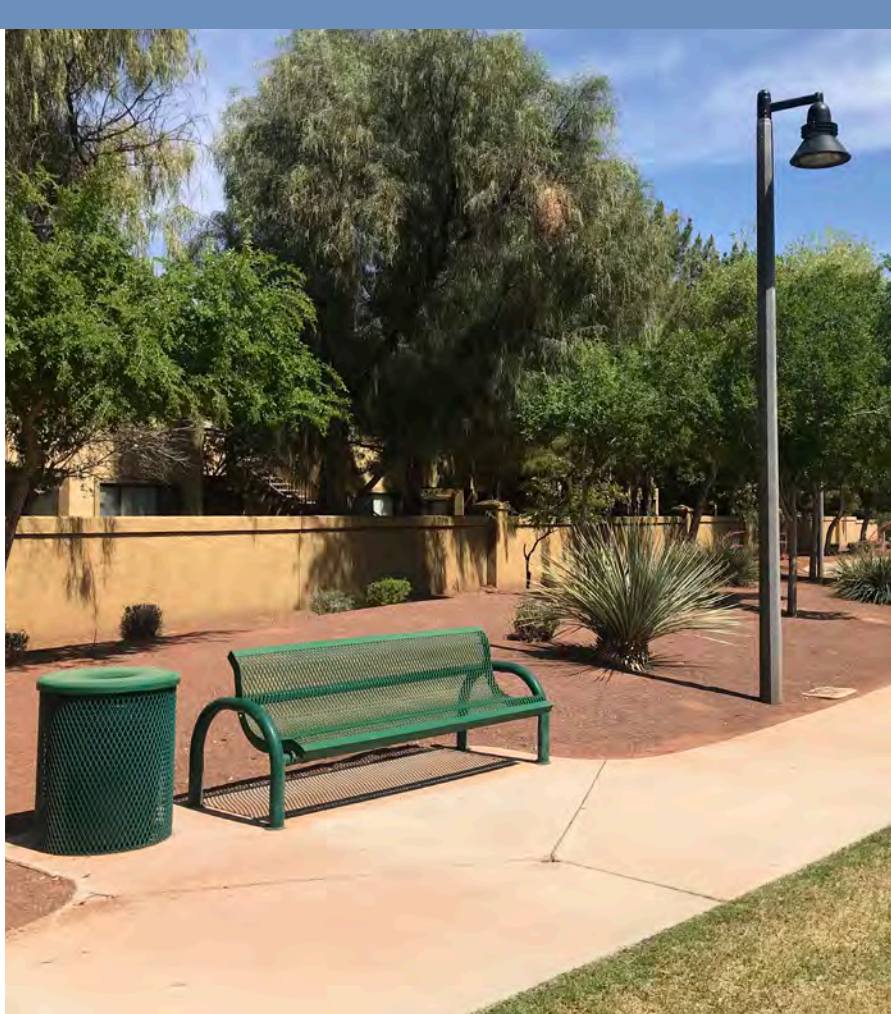
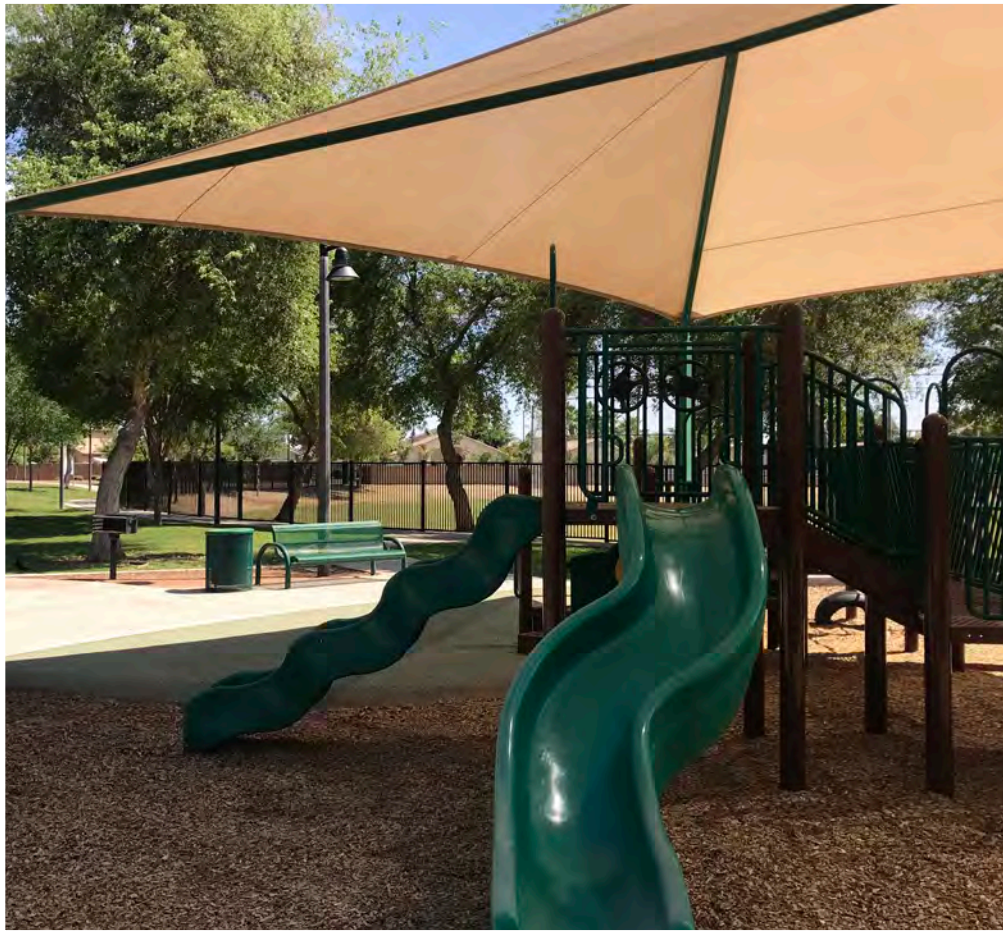
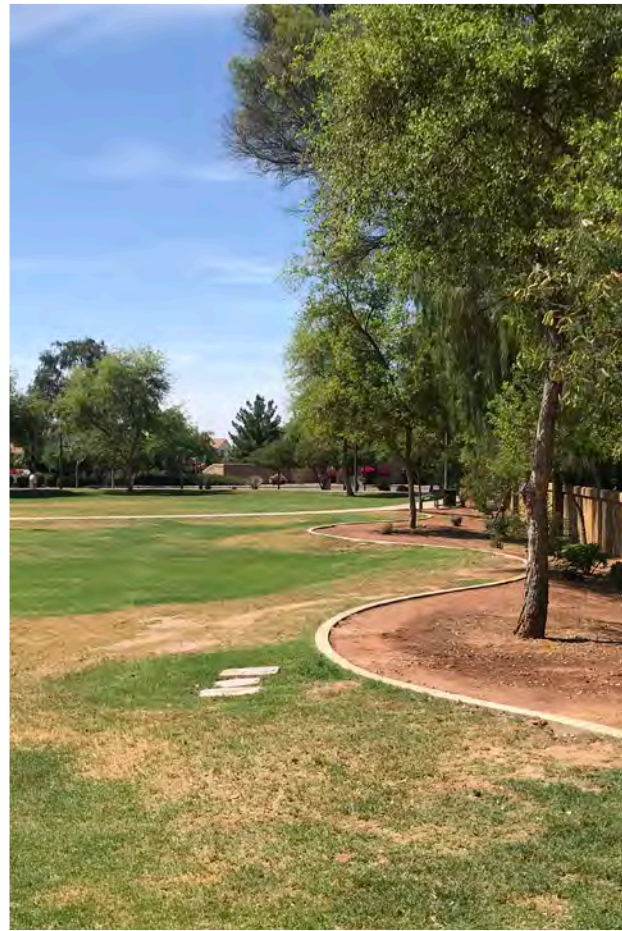
Amenity	Qty	Grade	Notes
BBQ PIT/ GRILL	2	3	General signs of wear due to use; consider deep clean
BENCH	9	3	Wear and fading due to exposure; minor rust near mounting; some chipping of paint/coating
DRINKING FOUNTAIN	1	3	Significant wear due to use, no signs of rust
IRRIGATION SYSTEM (AC)	2.85	3	Visual assessment only
LIGHTING (SITE, SPORTS, PED, ETC)	24	4	Newer high pressure sodium fixtures; poles in good condition
OPEN TURF AREA (AC)	1.8	2	Slope; drainage/ maintenance issues with turf quality
PICNIC TABLE	4	4	Good condition; no obvious signs of fading and minor wear
PLAYGROUND (SHADED)	2	4	Surfacing settling
RAMADA	2	3	No signs of rust; minor fading and wear
SIGNAGE (PARK ENTRY)	1	2	Colors fading, signs of weathering; repaint needed
SIGNAGE (REGULATORY)	2	3	Fading due to exposure and age
TRAIL - PAVED (MI)	0.38	3	Good general condition; minor wear and cracking
TRASH RECEPTACLE	11	3	Signs of fading and wear; little to no signs of rust or

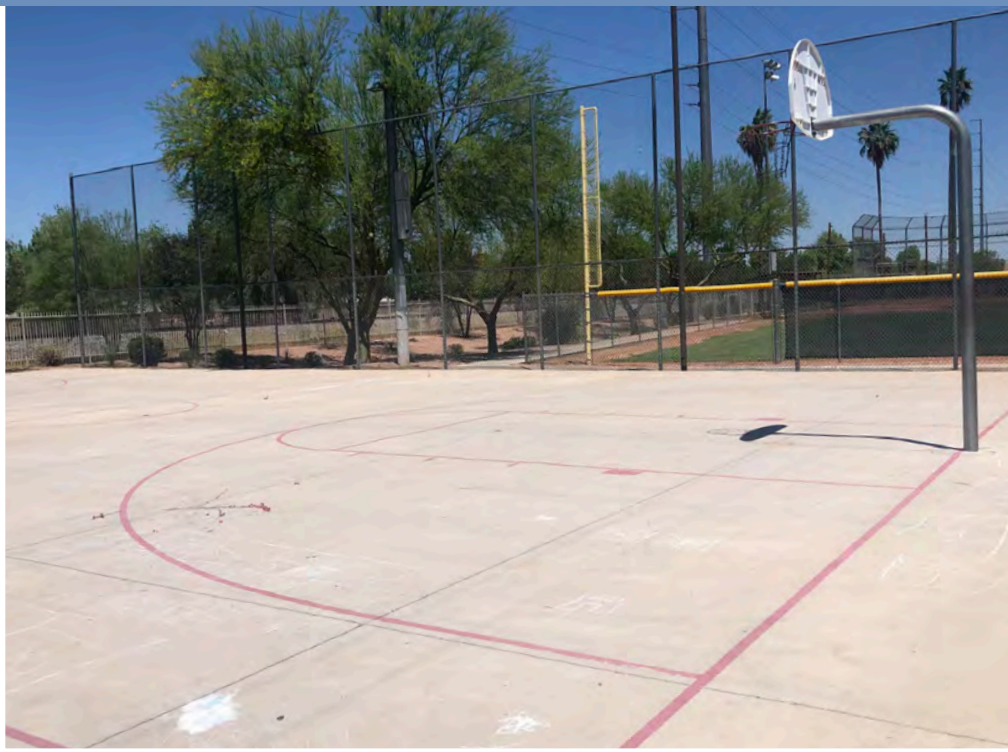
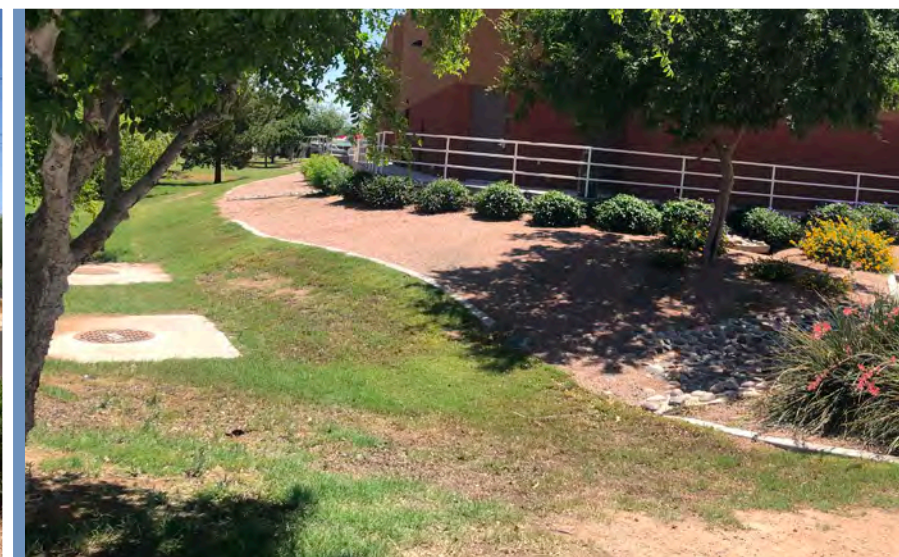
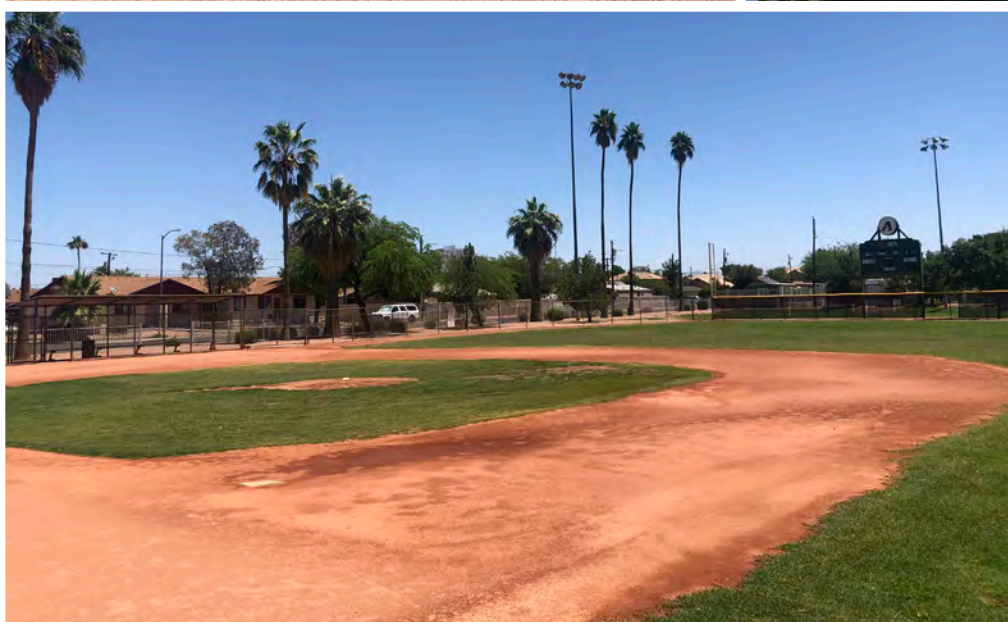
Amenity	Qty	Grade	Notes
BASEBALL FIELD (LIGHTED)	1	3	Consider replacing existing fence with a fence with bottom bar and concrete header in the future to eliminate fence bowing and maintenance issues
BASKETBALL COURT (LIGHTED)	1	4	Not post-tension; dated light fixtures
BENCH	2	3	Average condition
BLEACHERS	2	3	Average condition
DOG BAG STATION	1	3	Considerable amount of animal droppings along paths; consider adding more stations
IRRIGATION SYSTEM (AC)	5.40	3	Visual assessment only
LIGHTING (SITE, SPORTS, PED, ETC)	11	3	
MULTIUSE FIELD (LIGHTED)	1	3	Moderate condition
OPEN TURF AREA (AC)	0.3	2	Moderate condition; could use improvement and more definition to these multi-use areas; consider turf reduction in drainage areas between path and building
PARKING LOT (SPACES)	1	4	Shared with facility; good condition
PICNIC TABLE	1	3	Average condition
SIGNAGE (REGULATORY)	2	3	Average condition
TRAIL - NON PAVED (MI)	0.15	2	Consider paved access to replace existing from north side of park and on both sides of field to provide stronger connectivity

TRAIL - PAVED (MI)	1	3	Average condition
TRASH RECEPTACLE	8	3	Average condition

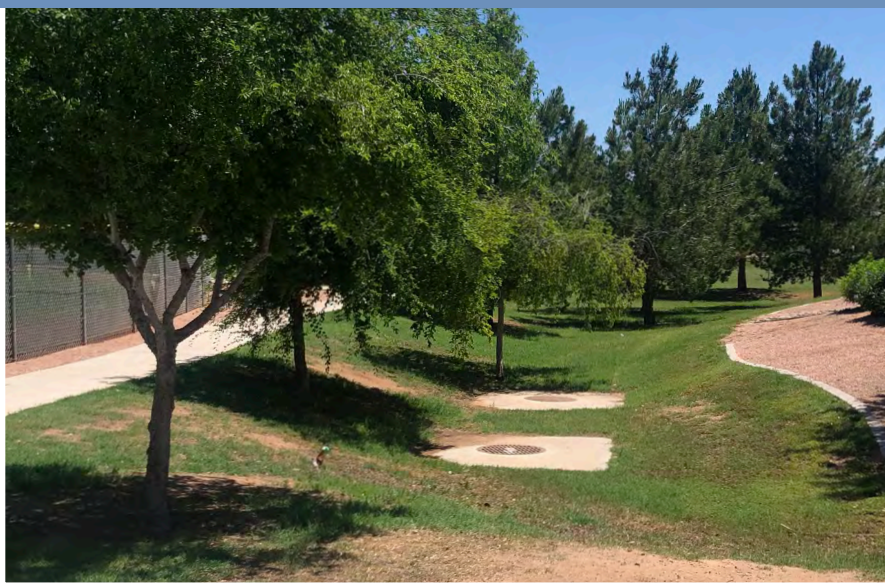
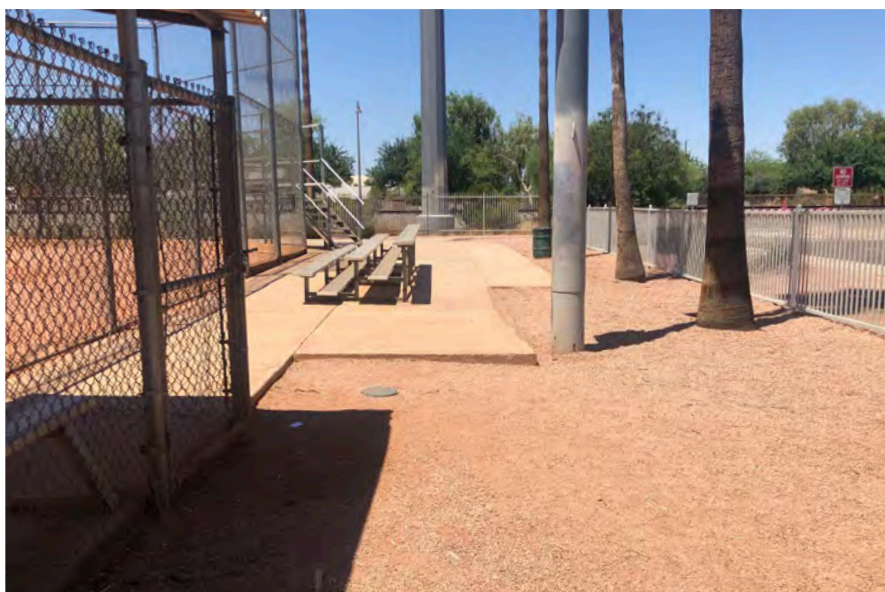
Baseball Field

The baseball field turf is in good condition in the outfield, while the infield has worn areas. The sports lighting is metal halide. The field was part of the Arizona Diamondbacks grant program and built to their specifications. It is recommended that removing the turf infield for skinned infield or converting to artificial turf would help with maintenance.

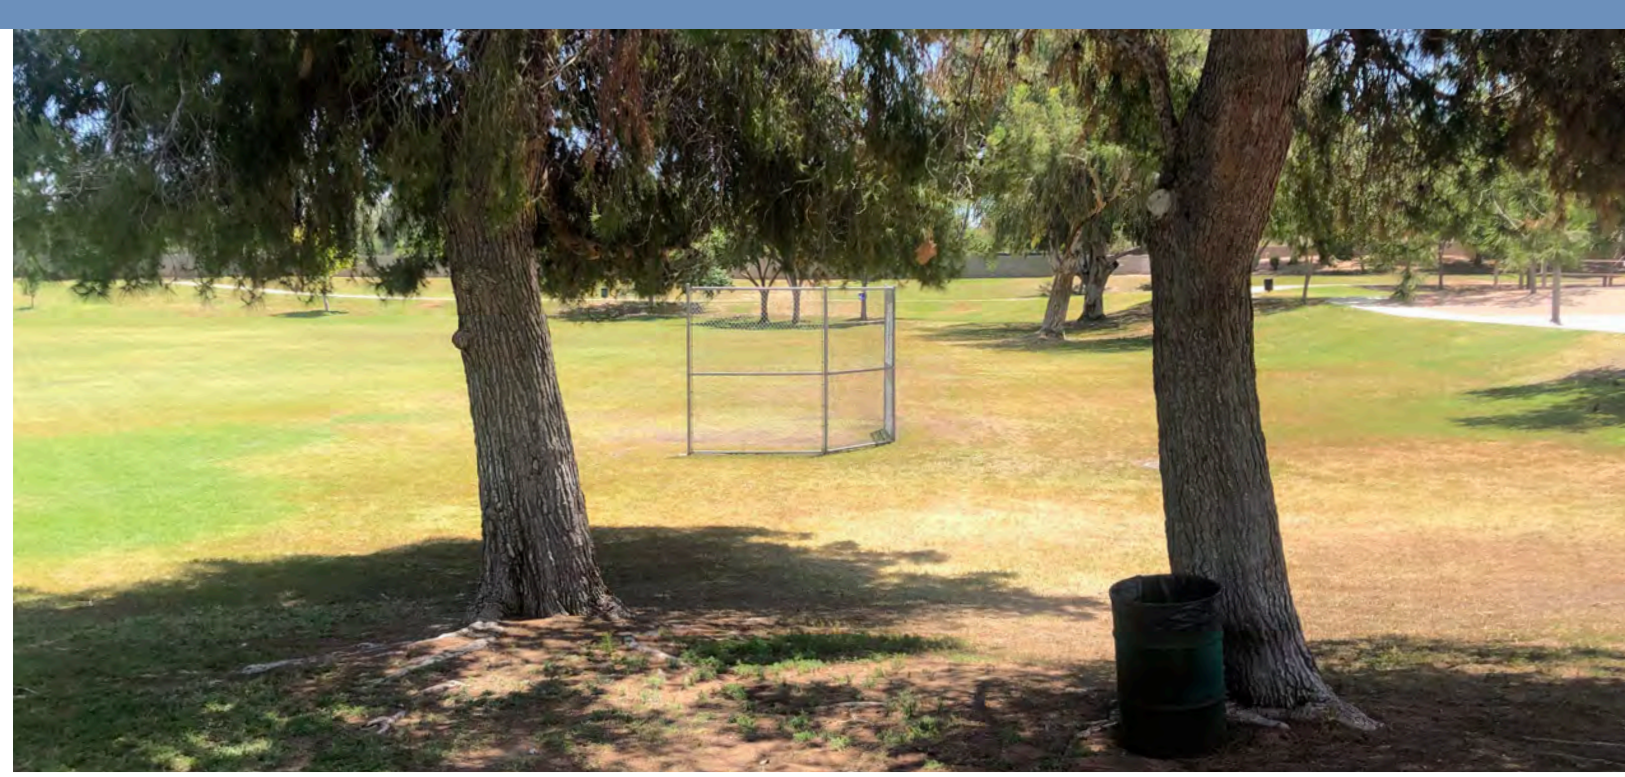
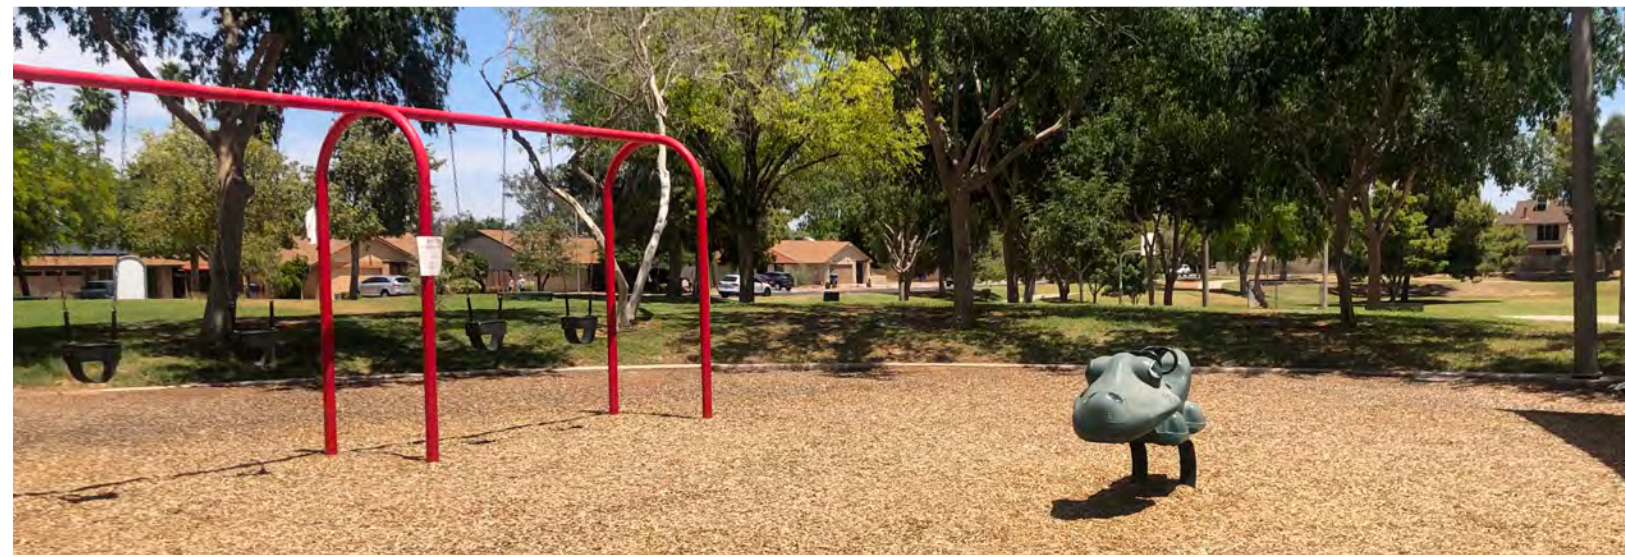
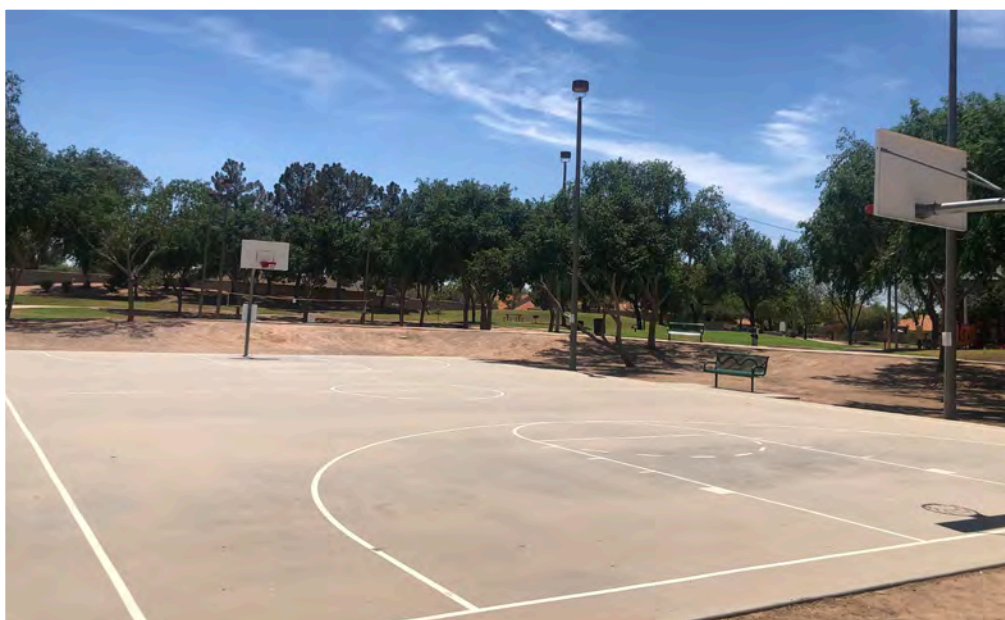
Amenity	Qty	Grade	Notes
BASKETBALL COURT (LIGHTED)	1	4	Great condition
BBQ PIT/ GRILL	3	3	Average condition; showing typical signs of use
BENCH	12	3	Average condition; showing typical signs of use
DOG BAG STATION	3	3	Average condition; some fading
DRINKING FOUNTAIN	1	3	Average condition; showing typical signs of use
IRRIGATION SYSTEM (AC)	8.16	3	Visual assessment only
LIGHTING (SITE, SPORTS, PED, ETC)	22	3	High pressure sodium lighting
OPEN TURF AREA (AC)	4.9	2	Muddy conditions under mature shade trees; patchy, erosion on slopes and near playground; likely irrigation issues
PICNIC TABLE	5	3	Average condition; showing typical signs of use
PLAYGROUND (SHADED)	2	3	Moderate condition; mushrooms growing in playground wood chips due to lack of maintenance
SIGNAGE (PARK ENTRY)	1	3	Average condition; some fading
SIGNAGE (REGULATORY)	4	3	Average condition; some fading
TRAIL - PAVED (MI)	0.65	3	Average condition

TRASH RECEPTACLE	18	3	Average condition; showing typical signs of wear
VOLLEYBALL COURT (SAND)	1	3	Additional sand needed to level court; lighting is upd
