CHAPTER 2

PARKS & FACILITIES ASSESSMENTS

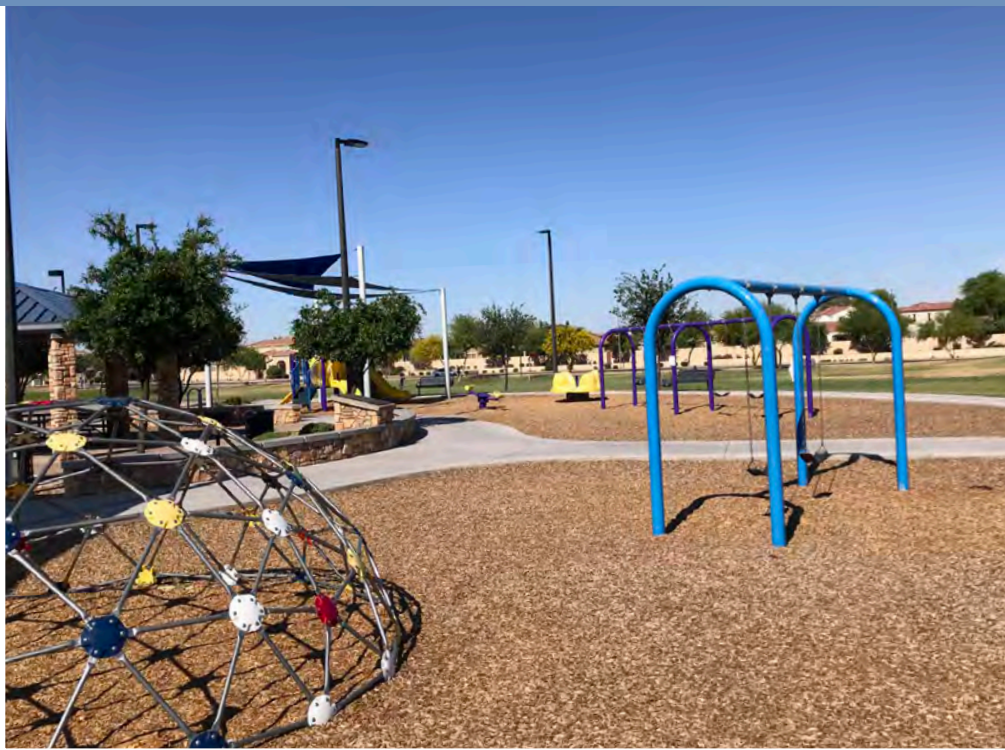
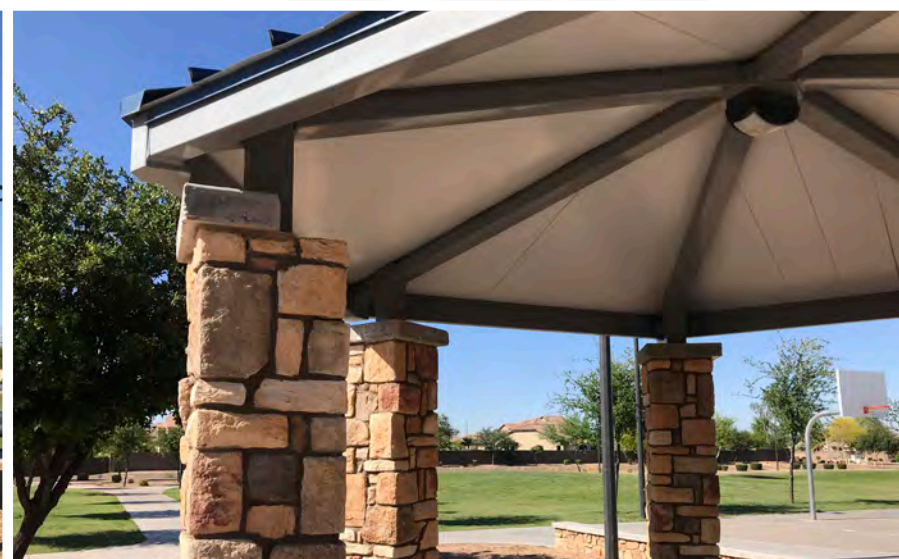
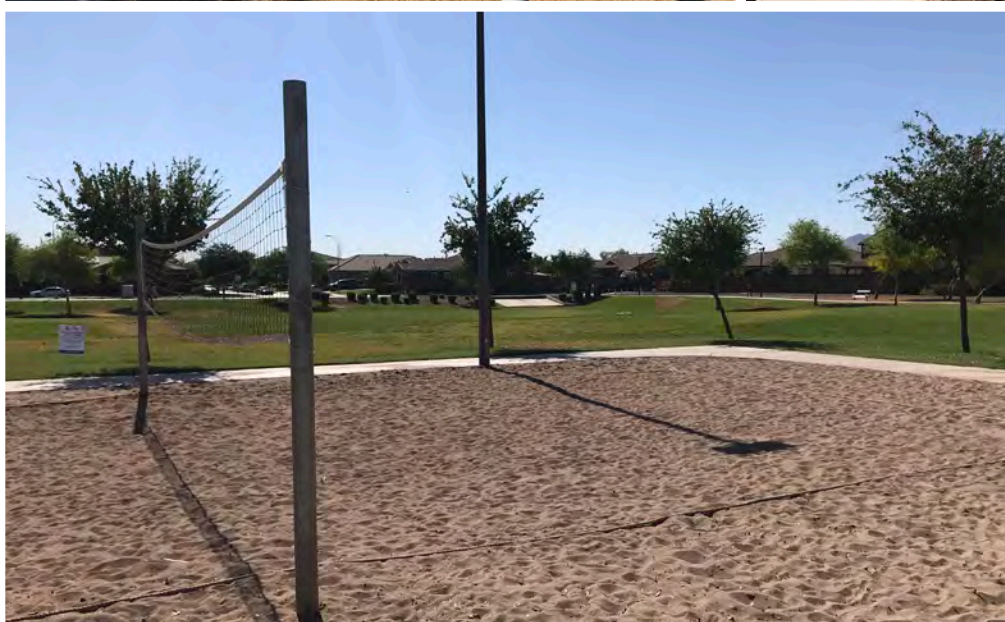
Amenity	Qty	Grade	Notes
BASKETBALL COURT (LIGHTED)	1	4	Newer condition; minor low spots/drainage
BBQ PIT/ GRILL	1	3	Good condition; signs of usage, consider deep clean
BENCH	14	2	Some newer benches have taken a beating, sun or vandalism
BIKE RACK/ LOOP	2	4	Minor wear; chipping
DOG BAG STATION	5	3	Signs of fading due to exposure
DRINKING FOUNTAIN	1	3	Signs of wear due to use; minor rust and water damage
IRRIGATION SYSTEM (AC)	10.88	4	Visual assessment only
LIGHTING (SITE, SPORTS, PED, ETC)	48	4	Newer condition poles and LED fixtures
OPEN TURF AREA (AC)	8.1	3	Good condition; minor low spots and slope erosion
PICNIC TABLE	3	4	Good condition; minor signs of wear
PLAYGROUND (SHADED)	2	4	Newer structure; minor signs of use and fading
RAMADA	2	4	Mostly like new condition; some light column damage (caps missing/damaged)
SIGNAGE (PARK ENTRY)	2	4	No signs of fading or damage
SIGNAGE (REGULATORY)	4	3	Fading and wear due to exposure

TRAIL - PAVED (MI)	0.76	4	Good condition; minor cracking
TRASH RECEPTACLE	10	3	Signs of wear due to use
VOLLEYBALL COURT (SAND)	1	4	Good condition

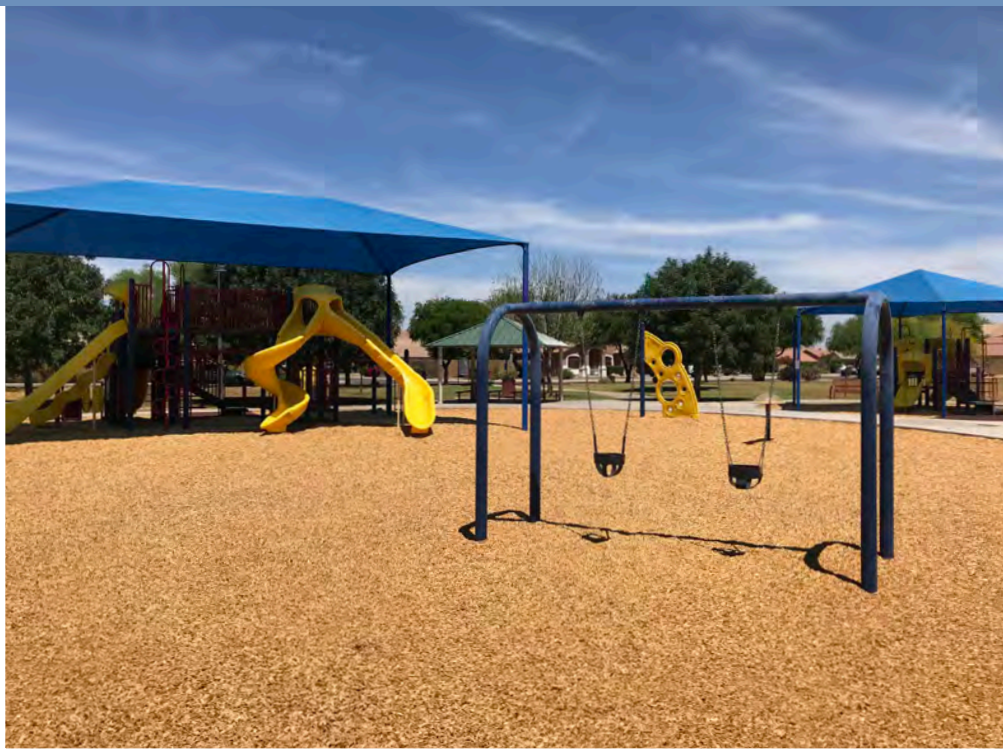
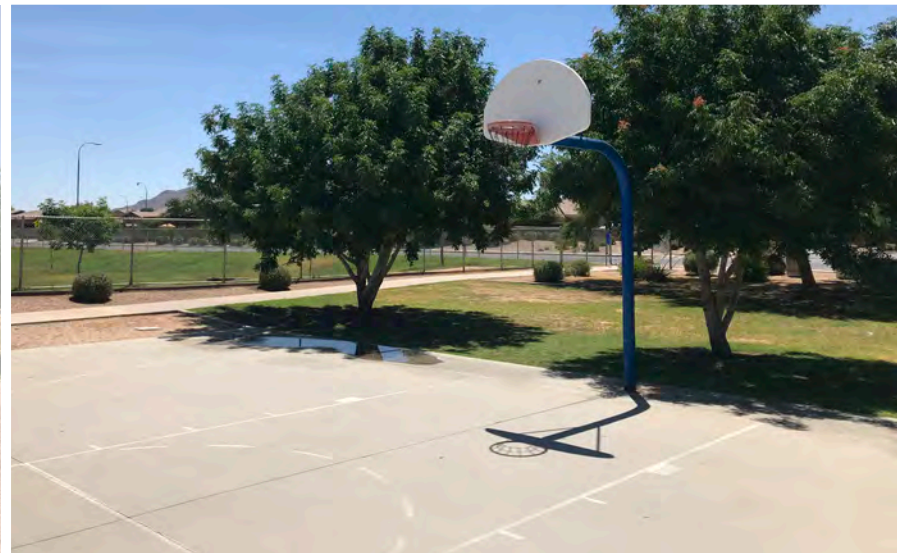
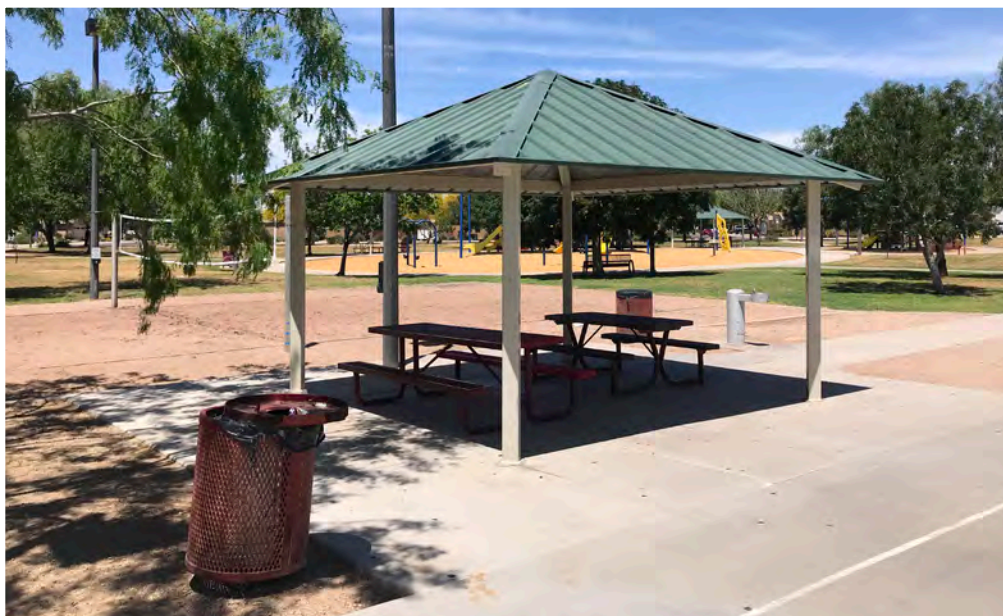
Amenity	Qty	Grade	Notes
BASKETBALL COURT (LIGHTED)	1	3	Low spots, standing water, and hoops showing signs of wear; surface in good condition
BBQ PIT/ GRILL	2	3	Signs of use; consider deep clean
BENCH	6	2	Rust, signs of weathering, wear, and chipped paint/coating
DOG BAG STATION	4	3	Signs of fading due to exposure
DRINKING FOUNTAIN	1	3	Signs of wear and use; no rust noted
IRRIGATION SYSTEM (AC)	4.46	3	Visual assessment only
LIGHTING (SITE, SPORTS, PED, ETC)	20	4	Lights and poles in generally good condition, high pressure sodium fixtures
OPEN TURF AREA (AC)	3.2	1	Low spots, uneven turf growth, brown spots, minor erosion and poor irrigation maintenance
PICNIC TABLE	6	3	Signs of wear and fading; chipped paint/coating
PLAYGROUND (SHADED)	2	3	Newer structure and shade fabric; surfacing recently replaced; minor low spots
RAMADA	3	3	Signs of wear and fading; minor rust spots
SIGNAGE (PARK ENTRY)	1	2	Faded, weathered, and cracking

SIGNAGE (REGULATORY)	4	3	Faded due to exposure
TRAIL - PAVED (MI)	0.39	3	Good condition; minor signs of settling and cracking
TRASH RECEPTACLE	7	3	Signs of use and fading due to exposure
VOLLEYBALL COURT (SAND)	1	3	Average condition given use; minor water damage on poles

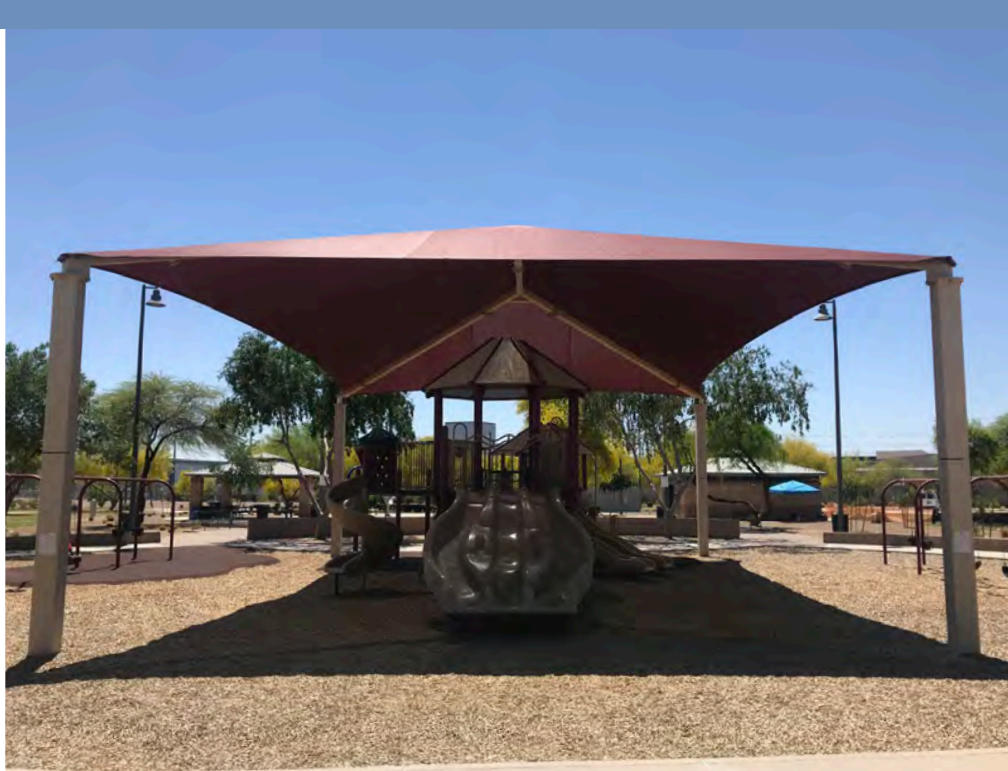
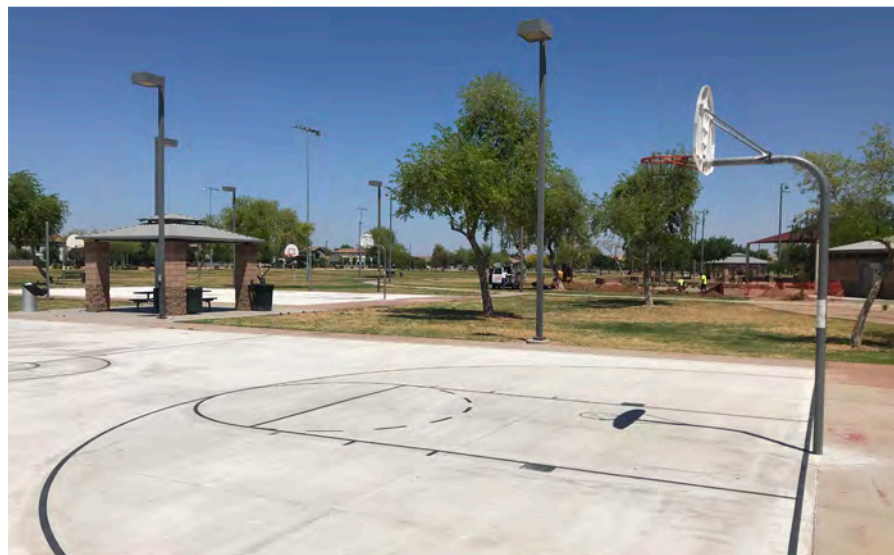
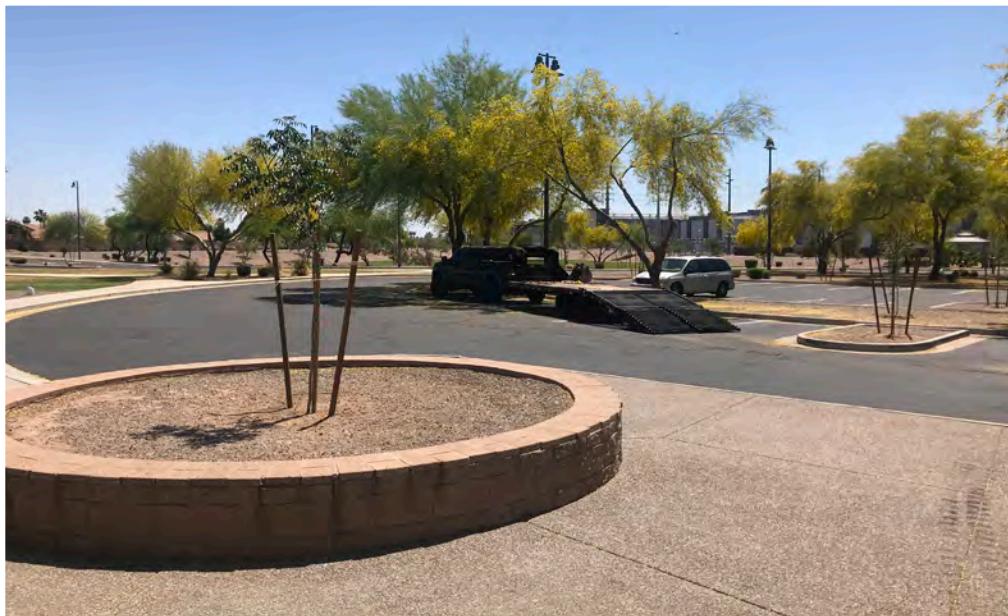
Amenity	Qty	Grade	Notes
BASKETBALL COURT (LIGHTED)	2	3	Good condition; signs of wear, minor cracking and marks, and hoops showing age
BBQ PIT/ GRILL	3	3	General signs of wear due to use; consider deep clean
BENCH	8	2	Wear due to age, significant signs of rust, and chipped paint/coating
BIKE RACK/ LOOP	1	3	Average wear due to use and nicks/dings
DOG BAG STATION	3	3	Wear and faded due to age and exposure
DRINKING FOUNTAIN	2	3	No signs of rust or water damage
FLAG POLE	2	4	Good condition
IRRIGATION SYSTEM (AC)	29.38	3	Visual assessment only
LIGHTING (SITE, SPORTS, PED, ETC)	78	3	Poles and highpressure sodium fixtures showing signs of weathering
MULTIUSE FIELD (LIGHTED)	2	2	Patchy turf, minor low spots, and patchy turf growth
OPEN TURF AREA (AC)	5.3	2	Significant patchy areas, uneven, and low spots, erosion
PARKING LOT (SPACES)	108	4	Great condition; recent resurface/stripping
PICNIC TABLE	11	3	Signs of wear with chipped paint/coating

PLAYGROUND (SHADED)	1	3	Newer structure and shade; wood fiber surfacing showing signs of settling
RAMADA	5	3	Average condition; general nicks/dings due to use and age; fading due to exposure
RESTROOM BUILDING	1	3	Average condition
SIGNAGE (PARK ENTRY)	1	3	Average condition; weathering due to exposure
SIGNAGE (REGULATORY)	3	3	Faded and worn due to exposure
SPRAY PAD	1	2	Surfacing is newer and equipment showing signs of wear and weathering
TRAIL - NON PAVED (MI)	0.42	3	Wear from use, low spots, surfacing displaced and in need of regrading/ additional DG
TRAIL - PAVED (MI)	1.56	3	Average condition; signs of age and minor cracking
TRASH RECEPTACLE	34	3	Signs of wear, chipped paint/coating, and minor rust
VOLLEYBALL COURT (SAND)	4	5	Newer court, recently renovated

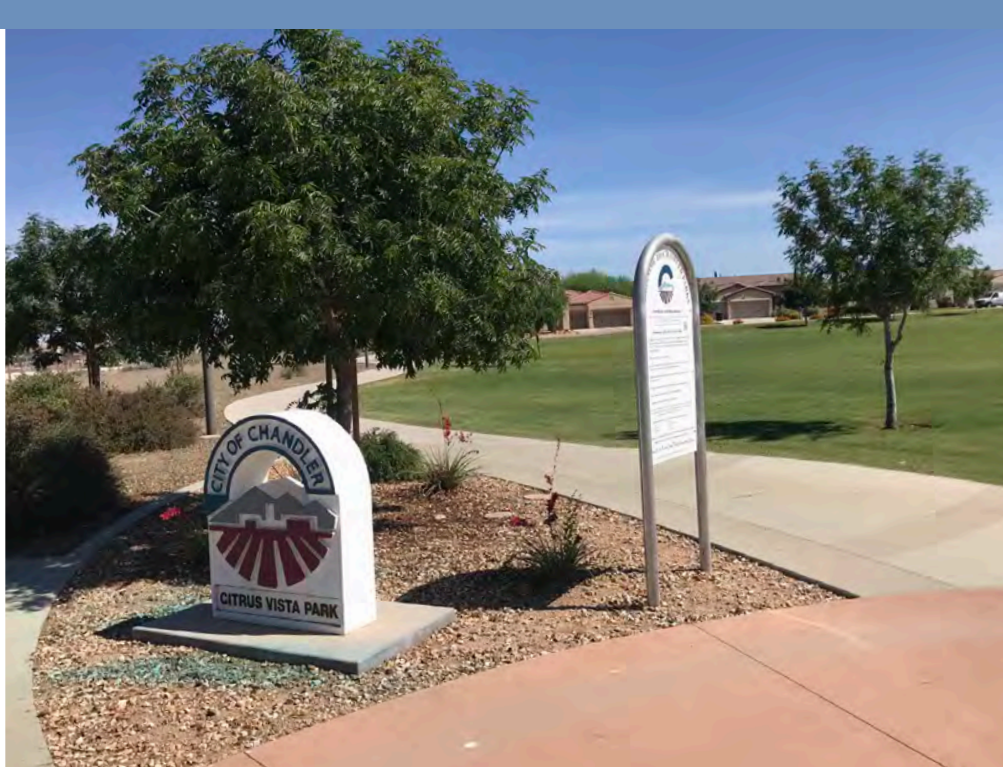
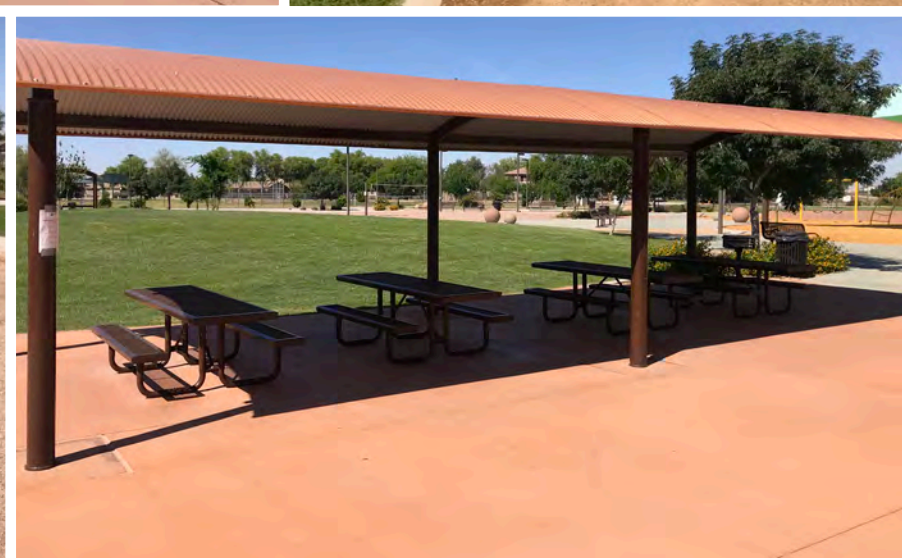
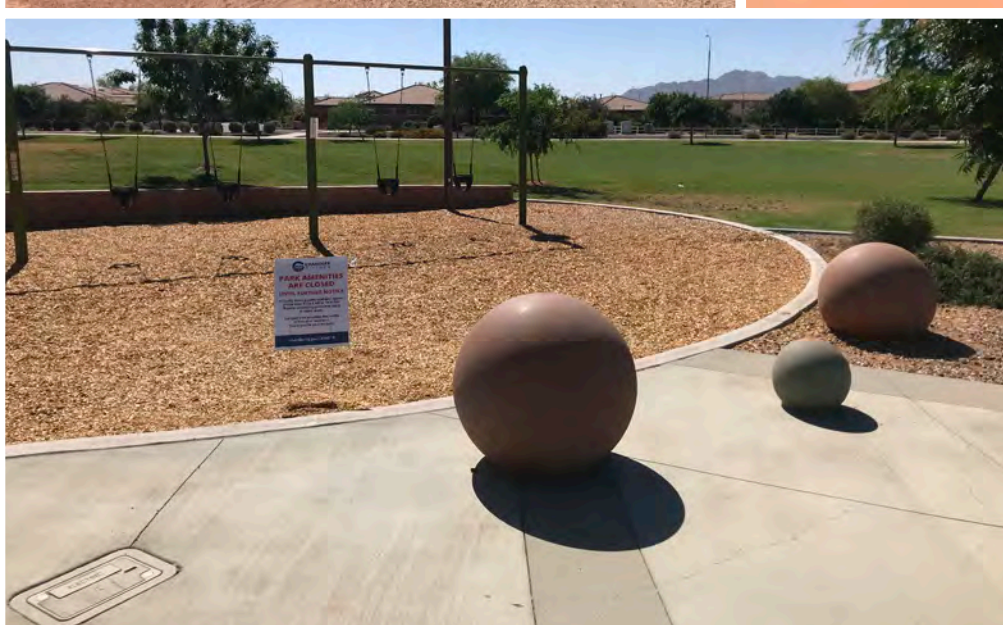
Amenity	Qty	Grade	Notes
BASKETBALL COURT (LIGHTED)	1	4	Good condition; hoops and poles like new
BBQ PIT/ GRILL	2	4	Good condition; signs of usage; consider deep clean
BENCH	16	4	Good condition; minor signs of use and exposure
BIKE RACK/ LOOP	2	4	Good condition; minor signs of wear
BOCCE BALL COURT	1	4	Good condition; surfacing displaced due to use
DOG BAG STATION	4	4	Good condition; minor signs of wear and fading due to exposure
DRINKING FOUNTAIN	2	3	Average condition; normal wear, minor water staining
HORSESHOE PIT	1	4	Good condition; surfacing displaced due to use
IRRIGATION SYSTEM (AC)	11.21	4	Visual assessment only
LIGHTING (SITE, SPORTS, PED, ETC)	35	4	Good condition, high pressure sodium fixtures
OPEN TURF AREA (AC)	6.9	4	Minor low and brown spots; turf in good condition
PICNIC TABLE	6	3	Signs of wear and weathering due to use
PLAYGROUND (SHADED)	2	4	Surfacing in good condition; equipment and shade in good condition

RAMADA	2	4	Good condition; no major signs of damage or aging
SIGNAGE (PARK ENTRY)	1	4	Good condition; colors vibrant
SIGNAGE (REGULATORY)	2	4	Good condition; minor signs of fading due to exposure
TRAIL - NON PAVED (MI)	0.29	3	Low spots, grading, and surfacing displaced
TRAIL - PAVED (MI)	0.55	4	Minor cracking and settling
TRASH RECEPTACLE	11	4	Good condition; minor signs of wear
VOLLEYBALL COURT (SAND)	1	4	Good condition; minor signs of wear and aging

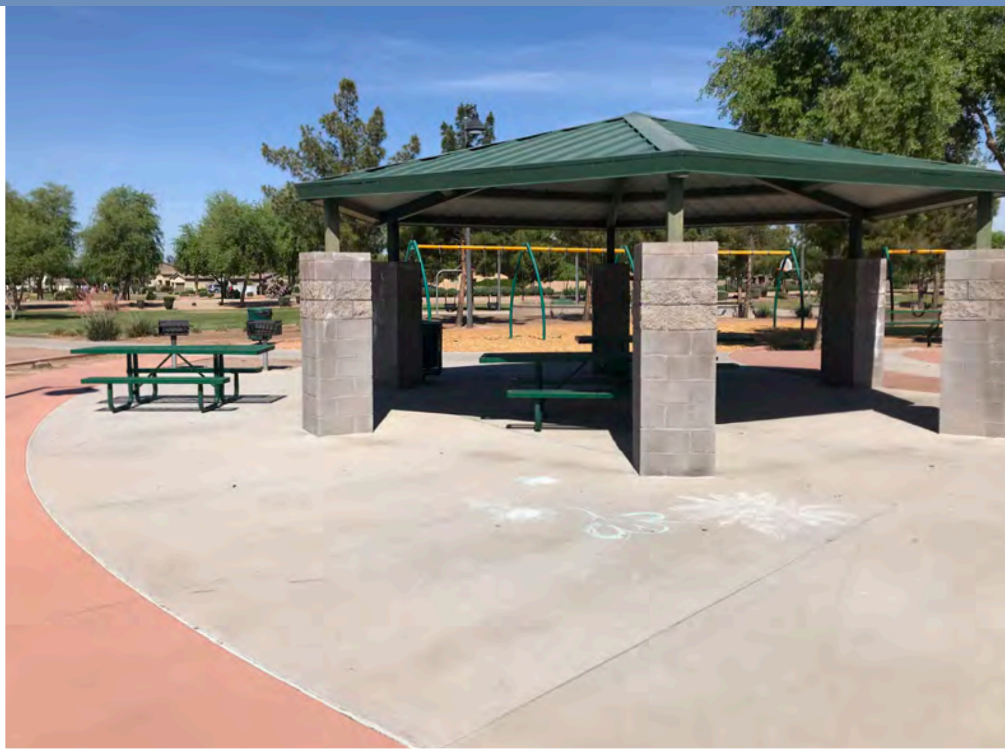
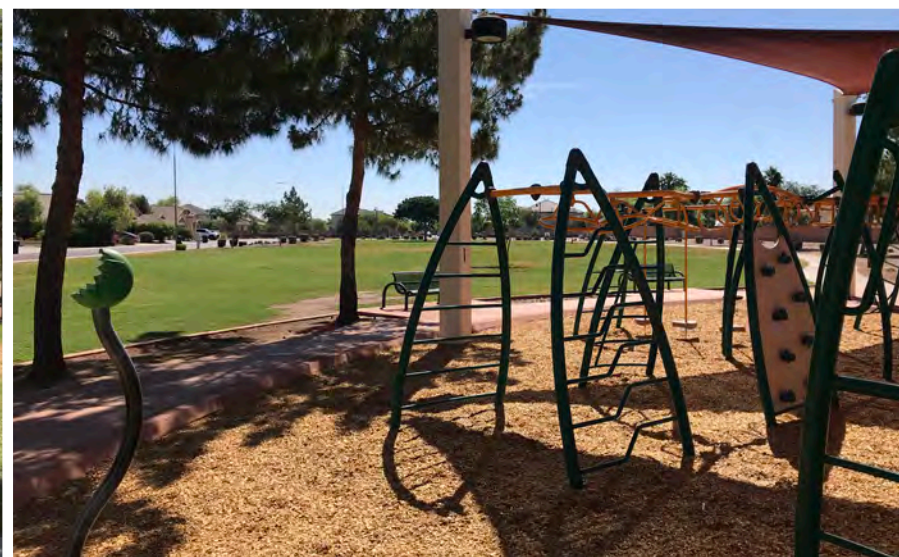
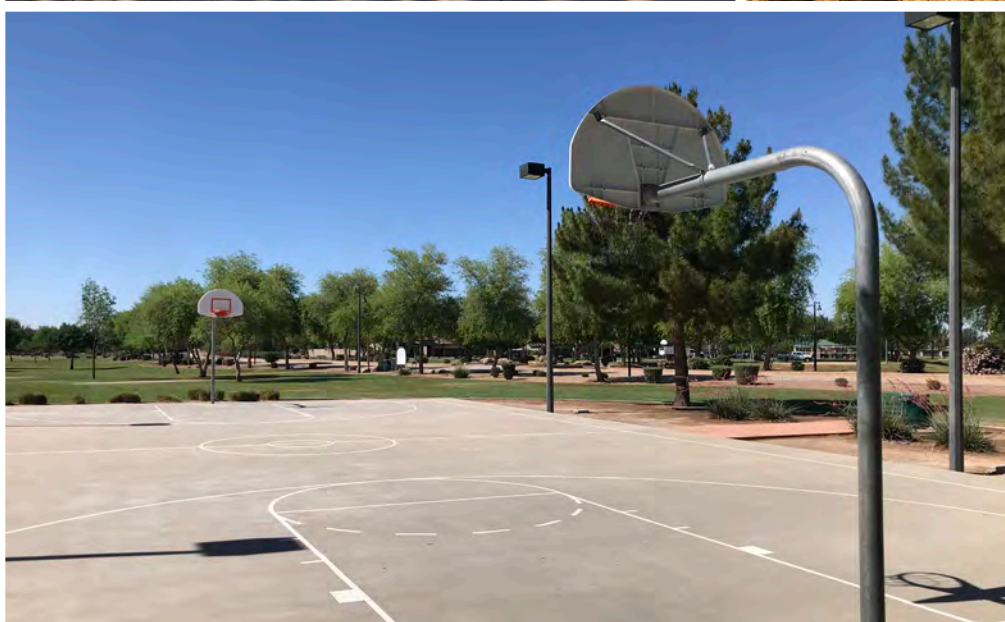
Amenity	Qty	Grade	Notes
BASKETBALL COURT (LIGHTED)	1	4	Good condition; no major signs of cracking; hoops and poles in newer condition
BBQ PIT/ GRILL	2	3	Signs of wear due to usage; consider deep clean
BENCH	12	3	Signs of use with minor chipping and fading
BIKE RACK/ LOOP	1	3	Minor dents and chipped coating; no visible rust
DOG BAG STATION	5	4	Good condition; minor fading and wear due to exposure
DRINKING FOUNTAIN	1	3	Minor signs of water and rust damage
IRRIGATION SYSTEM (AC)	7.95	3	Visual assessment only
LIGHTING (SITE, SPORTS, PED, ETC)	15	3	Poles and LED fixtures showing signs of age/ weathering
OPEN TURF AREA (AC)	4.7	2	Low spots, inconsistent turf, and bare spots
PICNIC TABLE	3	3	Signs of use, minor chipping, and fading
PLAYGROUND (NON-SHADED)	1	4	Surfacing in good condition; some signs of settling; newer structures and equipment
PLAYGROUND (SHADED)	1	4	Surfacing in good condition; some signs of settling; newer structures; equipment and shade fabric

RAMADA	1	4	Good condition; minor signs of fading and wear
SIGNAGE (PARK ENTRY)	2	3	Good condition; minor fading and chipping
SIGNAGE (REGULATORY)	5	3	Visible signs of fading due to exposure and age
TRAIL - PAVED (MI)	0.32	3	Signs of wear due to use and age, minor cracks, and settling
TRASH RECEPTACLE	13	3	Visible fading and wear due to exposure and use

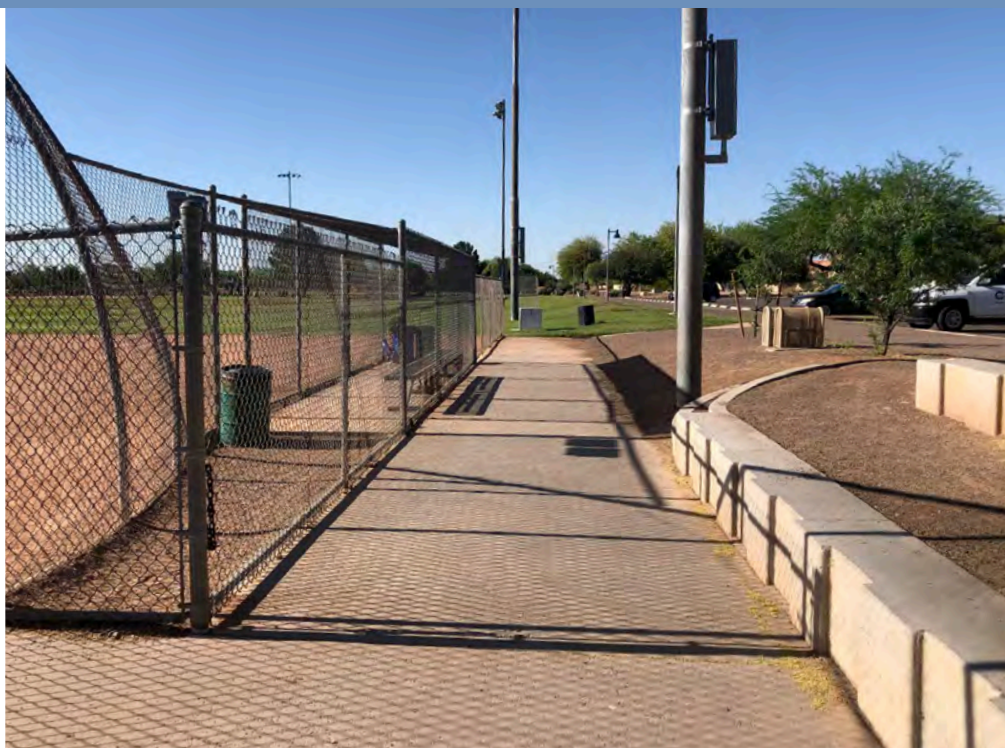
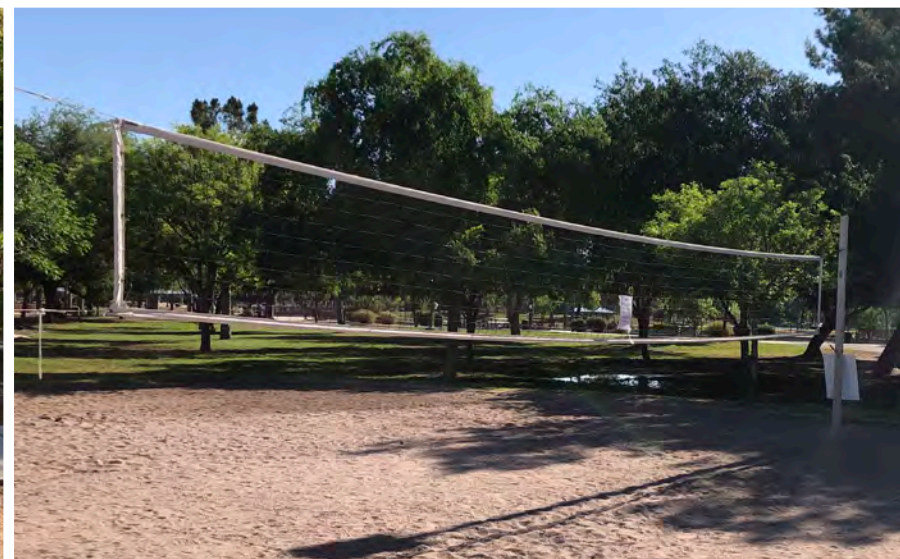
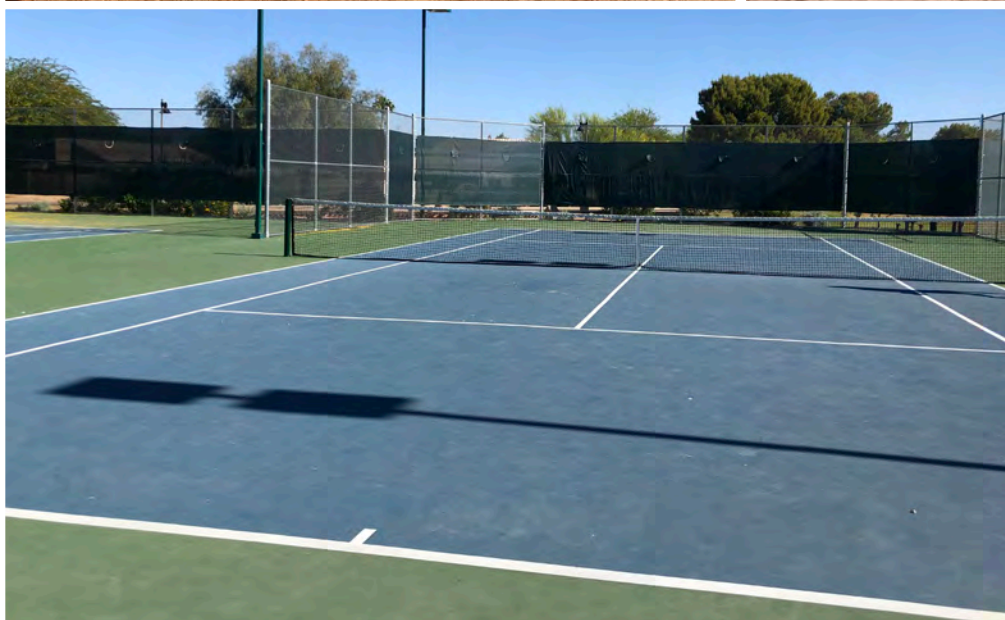
Amenity	Qty	Grade	Notes
BASEBALL FIELD (LIGHTED)	2	3	Consider replacing backstops; field in good condition; ball field shade and seating is new, good condition
BBQ PIT/ GRILL	18	3	Consider deep cleaning grills, particularly in pavilion area
BENCH	58	3	Average condition; styles vary
BIKE RACK/ LOOP	3	3	Average condition
BLEACHERS	2	4	Seating area and shade at ball fields are in good condition
DOG BAG STATION	10	3	Average condition; some fading
DRINKING FOUNTAIN	4	3	Average condition; typical signs of wear
IRRIGATION SYSTEM (AC)	44.40	3	Visual assessment only
LAKE / POND	3.40	3	Consider additional areas to get closer to lake; various landscape areas around lake eroding
LIGHTING (SITE, SPORTS, PED, ETC)	168	3	Dated light fixtures
MAINTENANCE YARD/ BUILDING	1	3	Average; facility showing signs of age
MULTIUSE FIELD (LIGHTED)	1	3	Turf in average condition
OPEN TURF AREA (AC)	12.0	2	Turf in good to poor condition; large shade trees are creating patchy and muddy areas on open turf areas not associated with fields

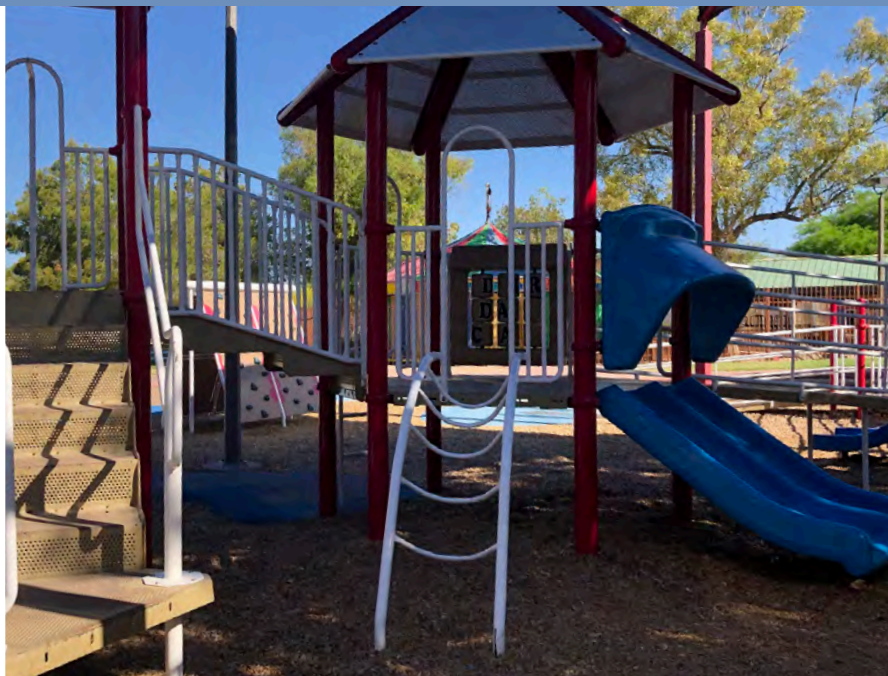
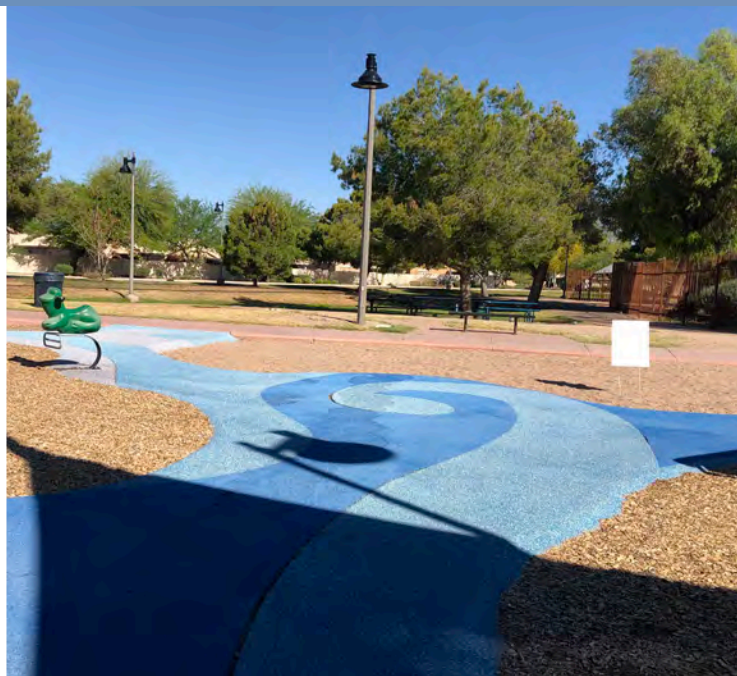
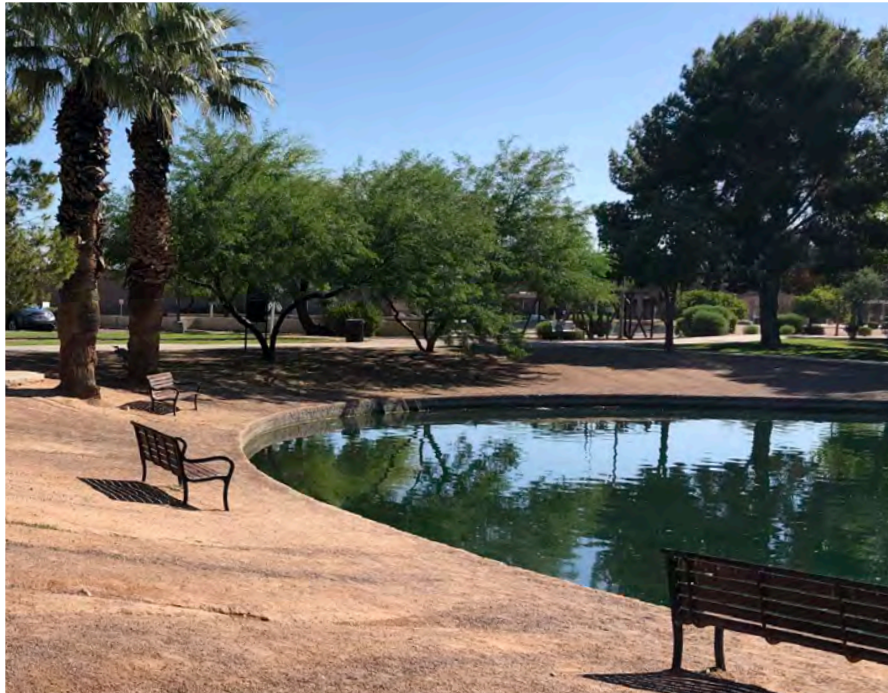
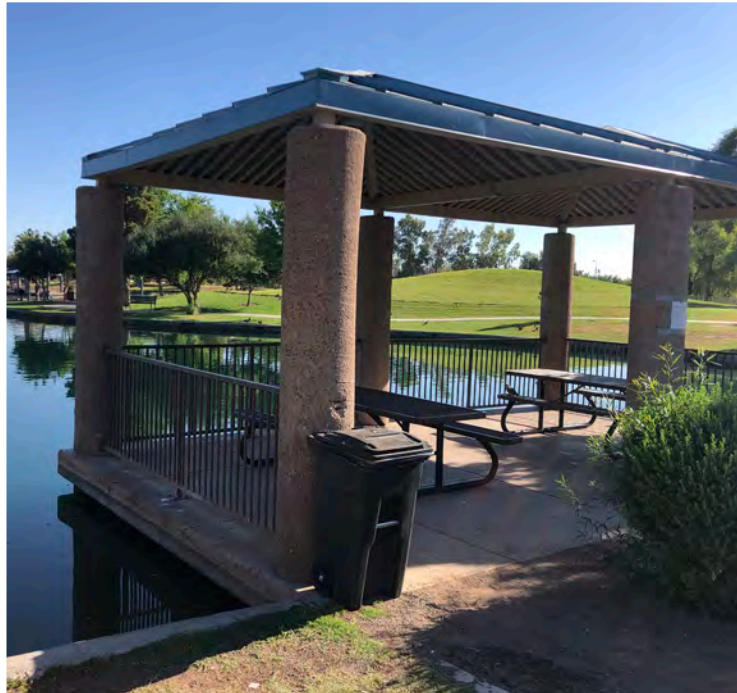
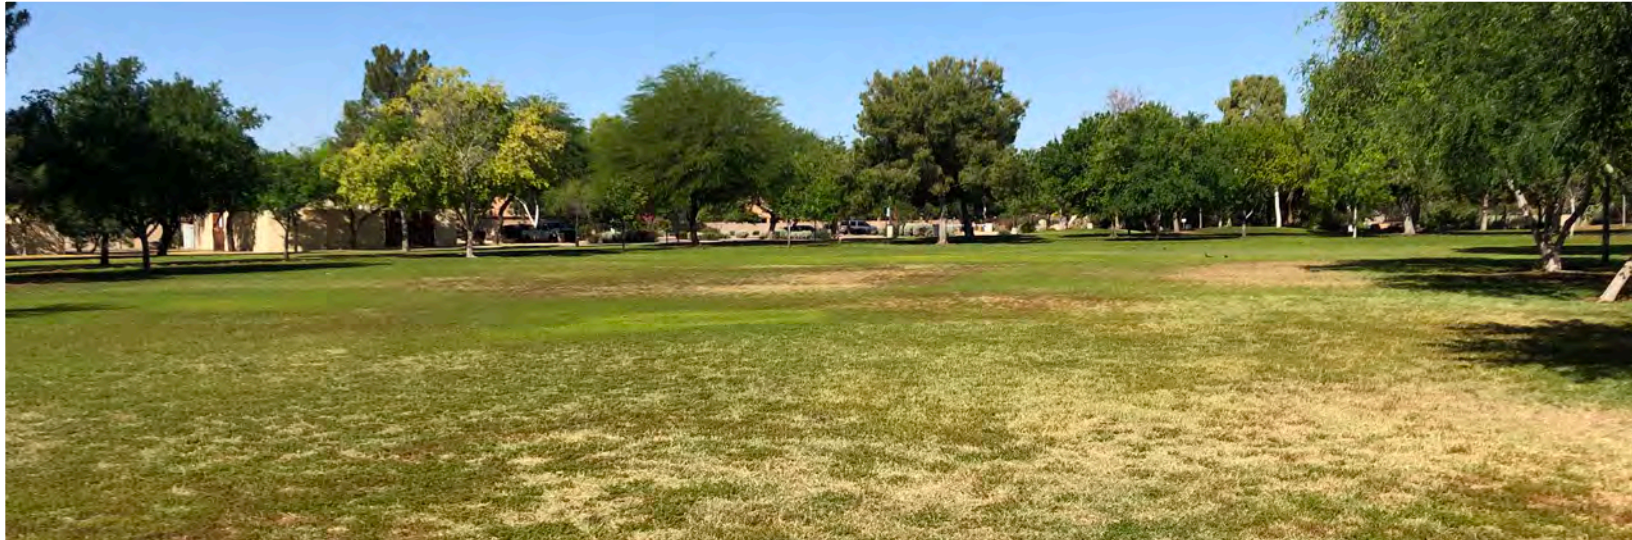
Sidewalk around Playground Area

A sidewalk panel replacement is recommended due to several cracked sidewalk panels around the playground area.
