CHAPTER 2

PARKS & FACILITIES ASSESSMENTS

MAGGIO RANCH PARK

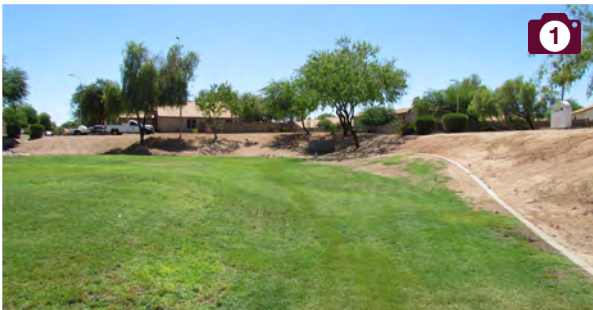
Overall Drainage

The park provides offsite storm drain outfall for Maggio Way and Sean Drive via storm drain outlet pipes in the north east corner of the park. The outlets utilize riprap in the decomposed granite areas. The turf area in the northeast corner is depressed from the central turf area creating a drainage basin.

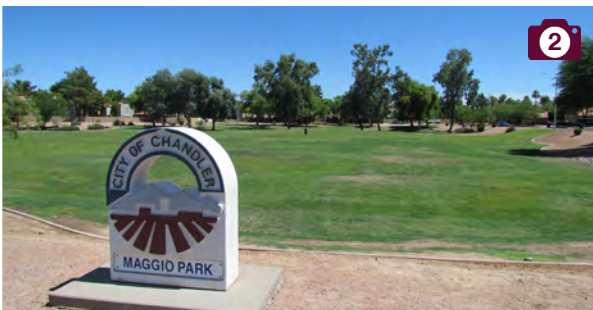
South Turf Area

The south turf area is in fair condition with some hard compaction areas throughout. Some of the steeper bank slopes along Maggio Way are worn and new curb and decomposed granite on steeper slopes is recommended. An aeration and soil agronomy test to evaluate soil condition is also recommended.

North Turf Area

The north turf area is in a worn condition. Several established and mature shade trees make it difficult for turf to grow in the playground area. It is recommended that staff look into reducing turf in shaded areas.

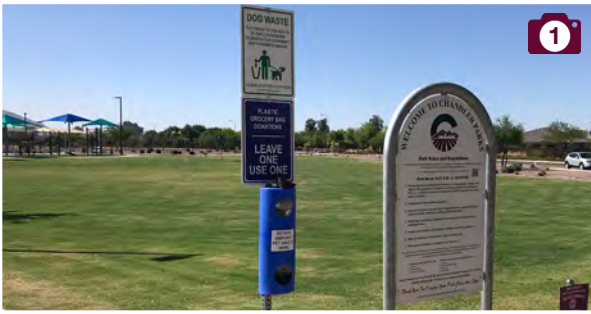
Turf Areas

The turf is in excellent condition with strong growth. An aeration and soil agronomy test to evaluate soil condition and recommendations for amendments is suggested.

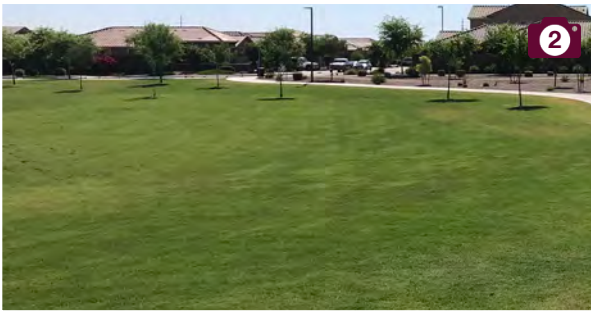
Overall Drainage

The park has three turf areas on the northwest, southeast, and the middle area around the playground which make up the park. The park does not receive offsite storm water runoff from the adjacent street frontage. The site self retains onsite drainage to the surrounding turf areas.

Playground

The synthetic turf surfacing is in average condition. The header curbs and sidewalk areas are in new condition and the equipment is also in new condition.

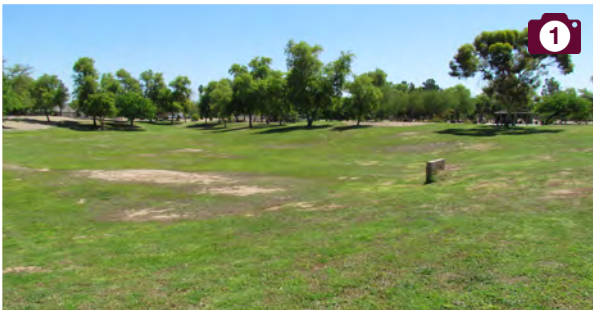
Overall Drainage

The park has four large turf areas. The southern basin has a headwall in decomposed granite, while the northern area has a headwall in the turf area. The northern turf basin does not appear to receive offsite flows and serves as overflow for the southern turf basin. It is recommended that the offsite volume, which outfalls into the southern turf basin, be evaluated as it does not appear to need to utilize the northern basin to equalize the storage volume.

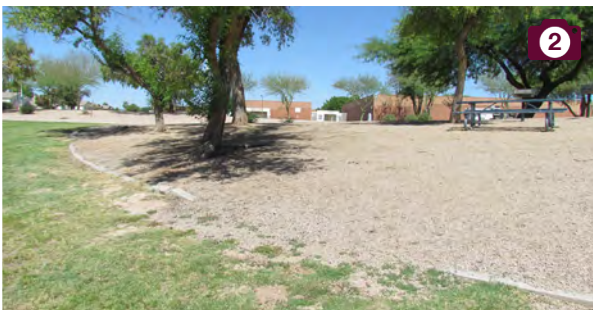
Concrete Header Curb

There are several areas within the perimeter of the turf basins where the concrete header curb is broken or displaced. Header replacement is recommended to provide separation from turf and decomposed granite.

Turf

The overall turf is in below-average condition with several worn areas throughout all the basins, including sideslopes. The condition is due to lack of irrigation maintenance not activity. The turf has silty, crusty film from incoming offsite drainage in the southern turf area. The ground appears to be very compacted. An aeration and soil agronomy test is recommended to evaluate soil condition.

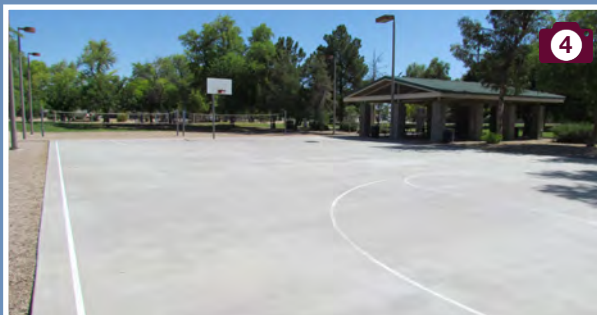
Site Lighting

The park lighting (pathway, basketball court, and volleyball courts) have high-pressure sodium light fixtures. LED fixture replacement is recommended.

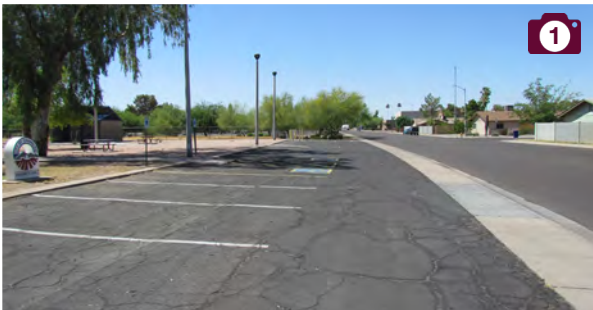
Parking Area

The existing parking lot was crack sealed and seal coated recently. The parking area needs to be replaced as the asphalt-concrete pavement has reached its life expectancy.

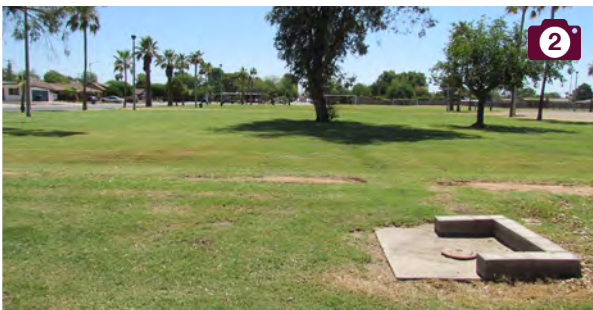
Turf Area

The park is watered with flood irrigation.

The turf area is in fair condition but the berm separating the two irrigation flood valves is worn.

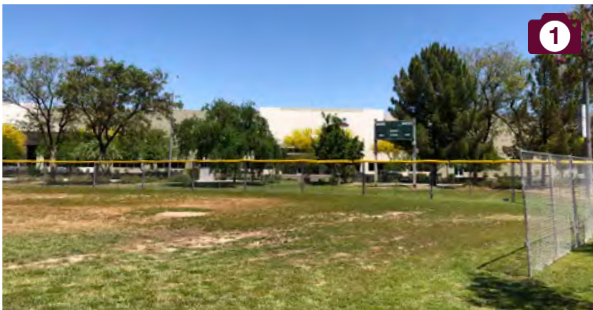
Turf Fields

Baseball field turf areas are in poor condition with several worn areas and very compacted ground. The condition is due to lack of irrigation maintenance not activity. An aeration and soil agronomy test to evaluate soil conditioning is recommended.

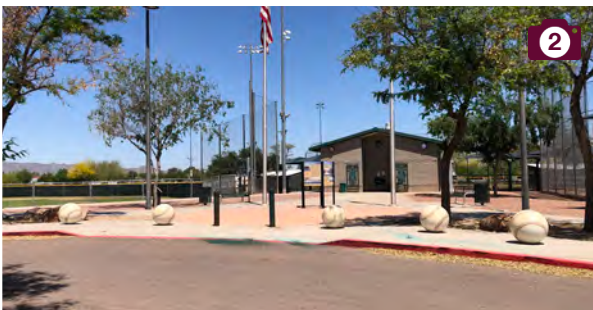
West Parking Area

The parking area is in good condition and has positive drainage to the west. A crack seal and seal coat of all surface cracks every three years is recommended. The existing pavement and subbase can age another 10 years with recommended crack seal/seal coat due to positive drainage conveyance.

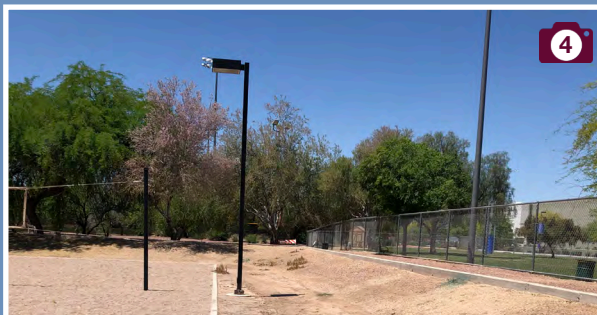
Sand Volleyball Court

The sand volleyball court is in good condition. The court has high-pressure sodium lighting. LED fixture replacement for the sand volleyball court is recommended.

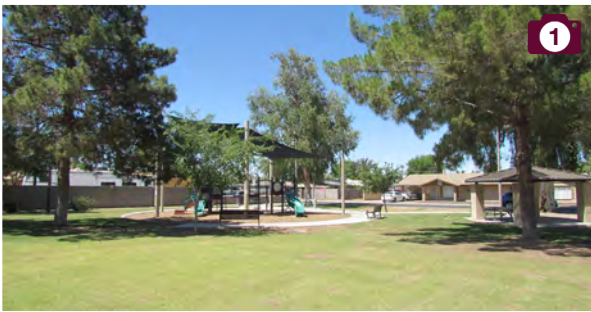
Turf Area

The turf area is in good condition with some minor worn areas. Some hard compaction areas throughout turf areas are visible. An aeration and soil agronomy test to evaluate soil condition is recommended.

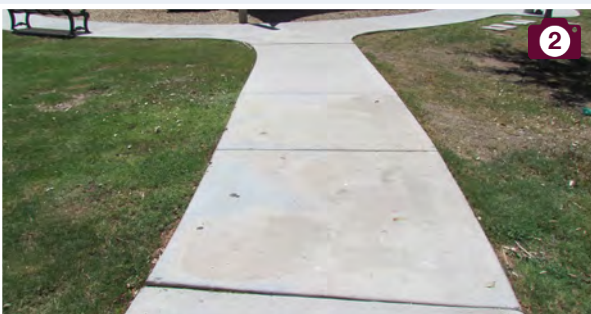
Sidewalk

The concrete sidewalk is in good condition. Some minor heaving on a few panels is present.

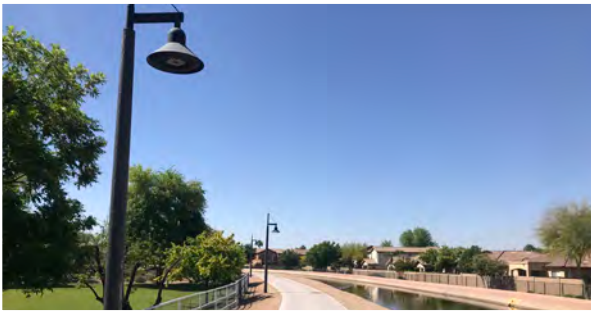
Site Lighting

The site lighting, high-pressure sodium fixtures and poles are in a mix of average and good condition due to varying installation ages. The replacement of fixtures with LED can be deferred until the current fixtures reach their lifecycle.

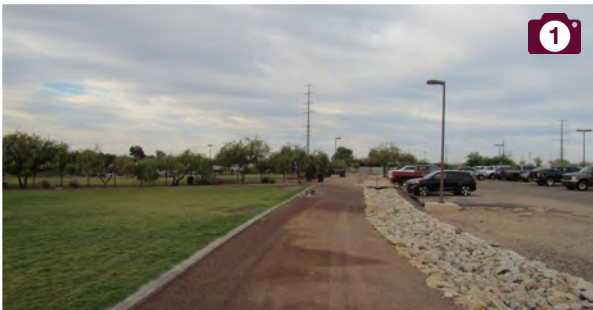
Overall Drainage

The park is on top of a former landfill and does not provide any offsite drainage storage as the overall site elevation is higher than the surrounding areas. The park uses a lot of riprap drainage swales to collect and convey onsite runoff from the parking area to the west.

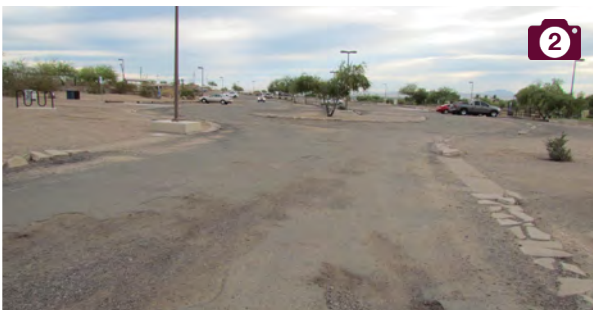
Parking Area

The parking area is in poor shape. Several pot holes and aggregate-exposed asphalt millings pavement areas are present throughout.

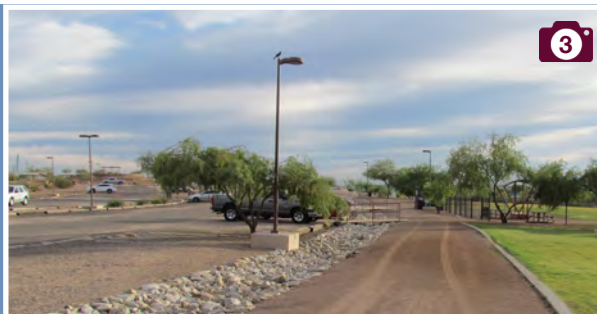
Dog Park

The turf in the dog park is in good condition with some worn areas, fencing, and header curb. The site furniture/amenities are in good condition.

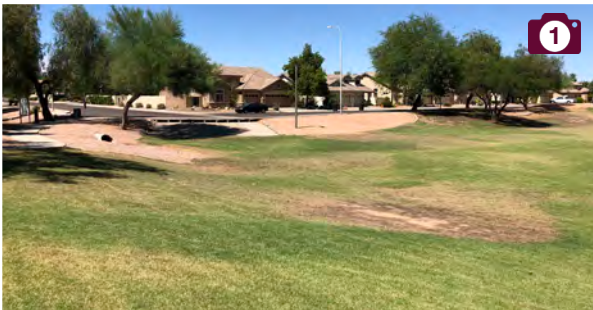
East Turf Basin Area

The east turf basin turf is in good condition with some worn/silted areas at the basin low point in the middle. The area is very compacted throughout. An aeration and soil agronomy test to evaluate soil condition and recommendations for amendments is suggested.

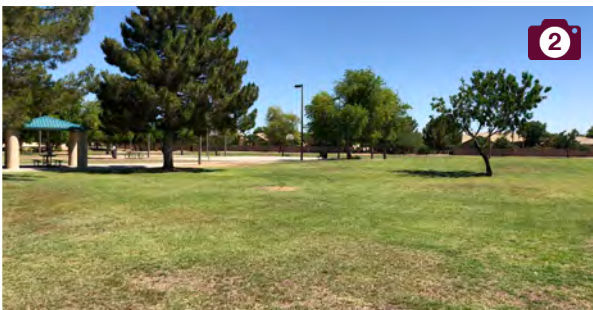
Playground/West Turf Area

The west turf area is in good condition with some worn areas. The area is very compacted throughout. An aeration and soil agronomy test to evaluate soil condition and recommendations for amendments is suggested.

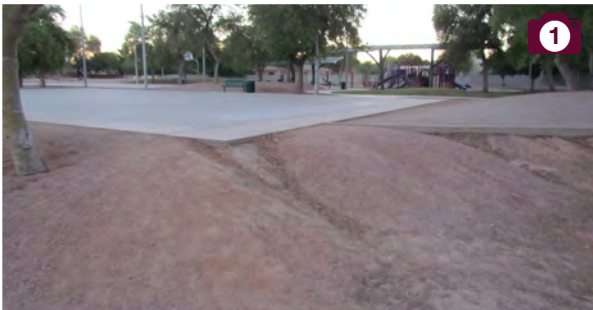
Overall Drainage

The park provides offsite drainage storage for Coronado Street, which has two surface flow scuppers at the south and north park frontage areas. These two collection points both convey runoff to decomposed granite areas. The south conveys storm water along the decomposed granite perimeter of the park. The north scupper outlets to a basin around the basketball courts, which has caused some erosion on the sideslopes due to the steep bank slopes from the depth of basin to the finish floor of the basketball court.

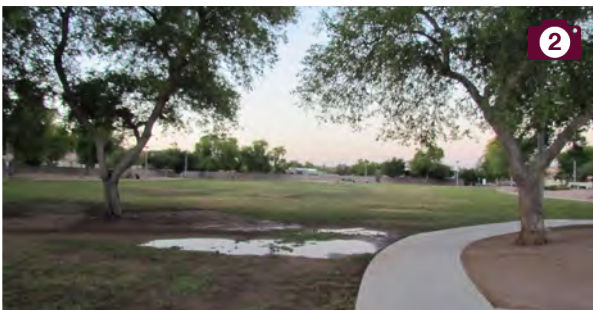
Turf

The turf is in overall good condition, but does have heavy compaction throughout the middle of the turf area. There are areas of standing water from the spray irrigation. The areas around the playground have nice established trees providing good shade; however, the tree areas within the turf turn into muddy spots as the grass does not grow from the shade. Recommend aeration and soil agronomy to evaluate soil conditioning. Recommend turf reduction in mature shade tree areas and more decomposed granite with less irrigation.

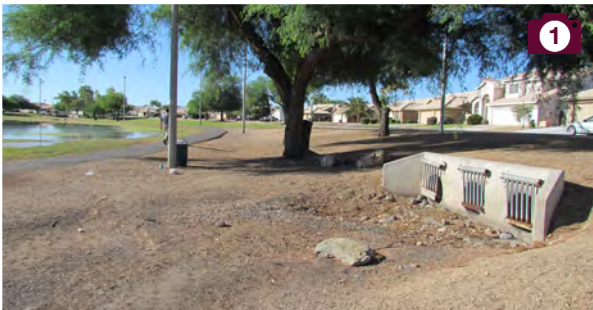
Overall Drainage

The Park provides offsite drainage runoff conveyance and storage for the adjacent street frontages. The McQueen Road offsite drainage is conveyed to a decomposed granite basin at the southwest corner of the park. Superstition Blvd has a stormdrain which outlets offsite drainage to the southern turf basin. Thatcher Blvd & Superstition Blvd have a large box culvert which provides offsite drainage conveyance through the southern turf area of the site.

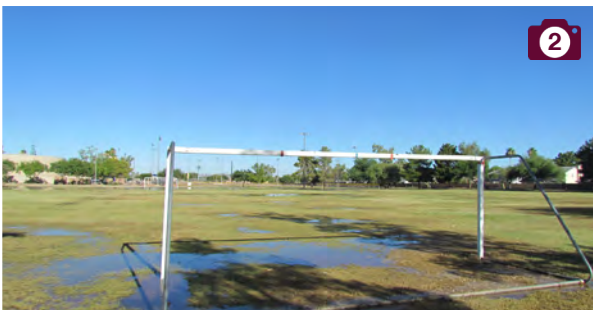
Turf Areas

The turf is in average condition was being flood irrigated at the time of this site visit. The area was compacted throughout. An aeration and soil agronomy test to evaluate soil condition and recommendations for amendments is suggested.

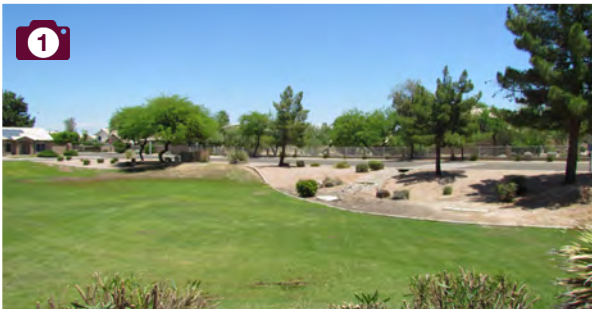
Overall Drainage

The park has three turf areas. The east turf area is a basin providing retention for offsite storm water from Ponderosa Ave and Galveston Street. Both have curb inlets from the street which discharge to the basin. The west decomposed granite area is another basin that provides storage for the offsite flows from Galveston Street. The north park boundary is along a drainage basin area serving as an outfall for the northern subdivision, which conveys drainage runoff along a central alley.

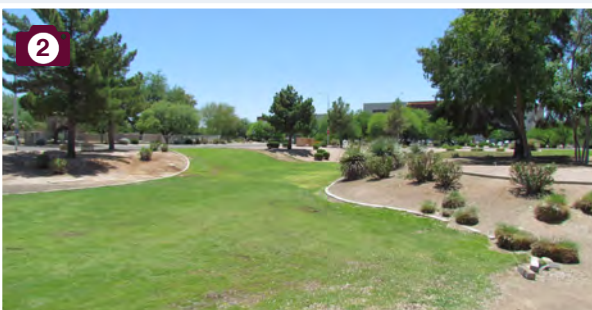
Concrete Header Curb

There are several areas within the perimeter of the turf basins where the concrete header curb is broken or displaced. These need replacement to provide separation from turf and decomposed granite.

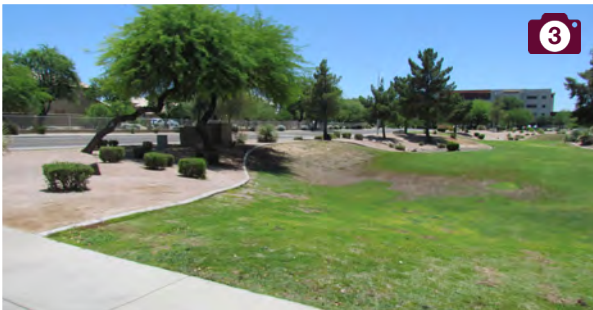
East Basin Turf

The turf is in good condition on basin floor, but is in poor condition on bank sideslopes. There are several worn areas throughout all the basins, including worn sideslopes. It is recommended that staff look at removing turf from steep basin sideslopes and realign header curb. The turf has silty, crusty film from incoming offsite drainage in the southern turf area. This area utilizes sprinkler irrigation and does not receive flood irrigation.

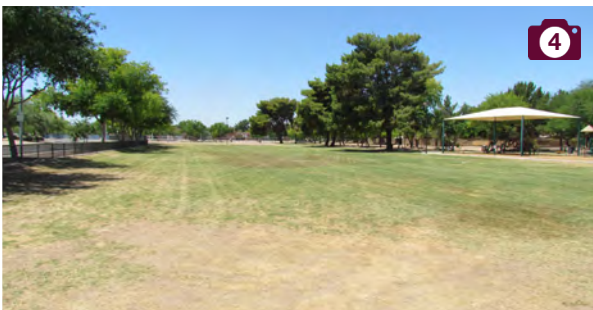
West Turf Area

This turf area is flat and does not serve as a retention basin. The turf is in average condition with several worn areas. The ground is very compacted. This area also utilizes flood irrigation for watering. The worn condition of slopes is due to lack of irrigation maintenance not activity.

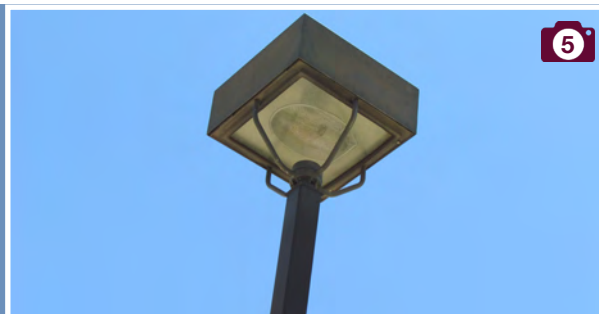
Site Lighting

The park lighting (pathways) have high-pressure sodium light fixtures. LED fixture replacement for court lighting is recommended.

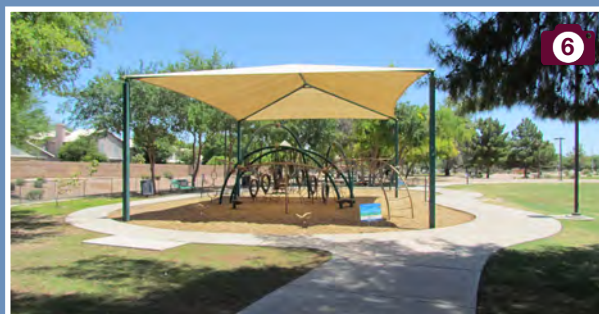
Playground

The playground area, header curbs, and sidewalk areas are in good condition and the equipment is also in new condition.

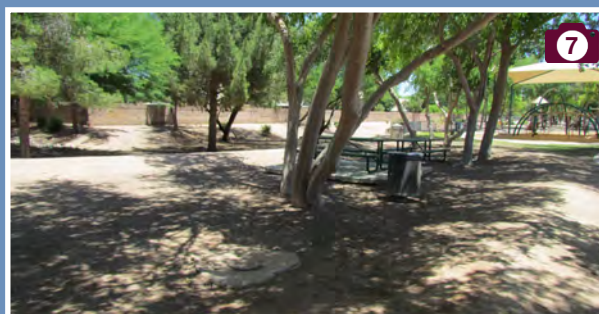
Picnic Area

The picnic tables are on exposed concrete slabs within the flood irrigation flood pool.

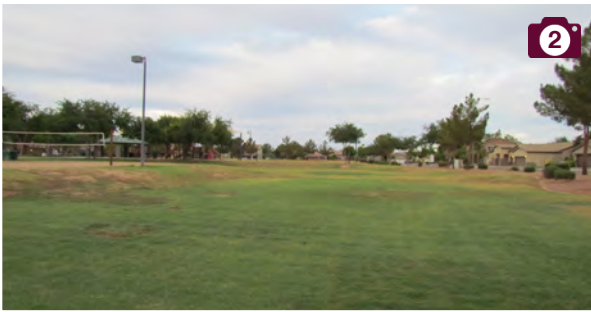
West Turf Open Area

The west turf area has several worn/non-growing areas on the berm slopes and in the areas with the established trees. The condition of slopes is due to lack of irrigation maintenance not activity. The area is very compacted throughout. An aeration and soil agronomy test to evaluate soil conditioning is recommended. In addition, it is suggested that staff reduce turf to decomposed granite in areas with established shade trees.

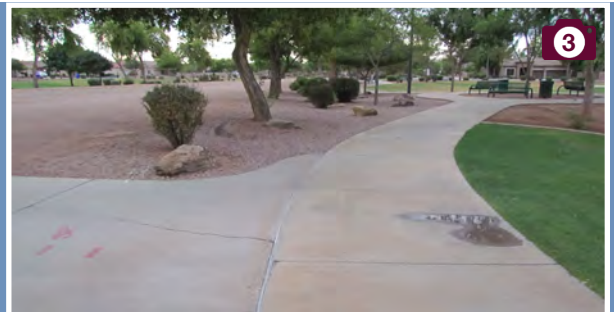
North Turf Area

The north turf area has several worn/non-growing areas on the berm slopes and in the areas with the established trees. The condition of slopes is due to lack of irrigation maintenance not activity. The area is very compacted throughout. An aeration and soil agronomy test to evaluate soil condition is recommended.

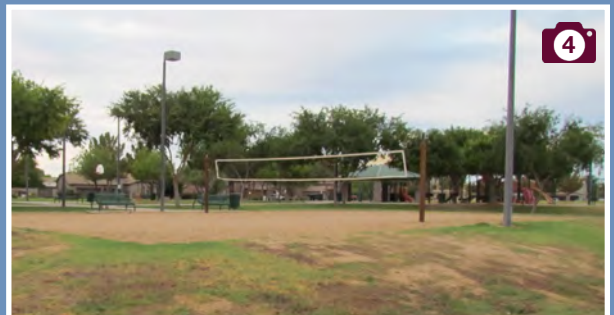
Sand Volleyball Court

The sand volleyball court is in average to poor condition. The court has high-pressure sodium lighting. LED fixture replacement for court lighting is recommended.

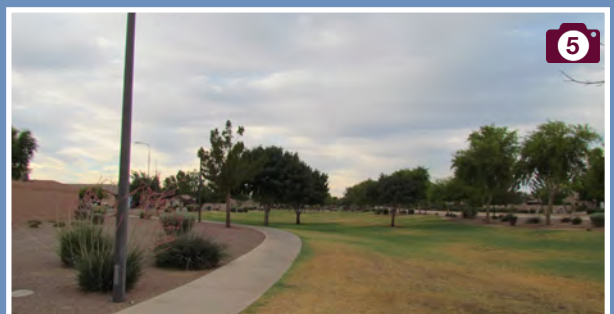
Site Lighting

The pedestrian pathway lighting is high-pressure sodium. LED fixture replacement is recommended.

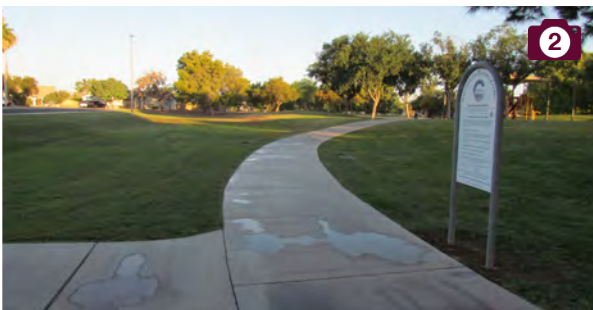
Overall Drainage

The park has two halves that are connected through a linear corridor. The west half of the park provides a lower basin for a storm drain pipe outlet on the north side of the park with a large riprap lined basin floor. Offsite drainage from Hearthstone Way is conveyed to the basin by concrete scupper. The basin also provides storage for the adjacent subdivision to the north with the storm drain outlet within the basin.

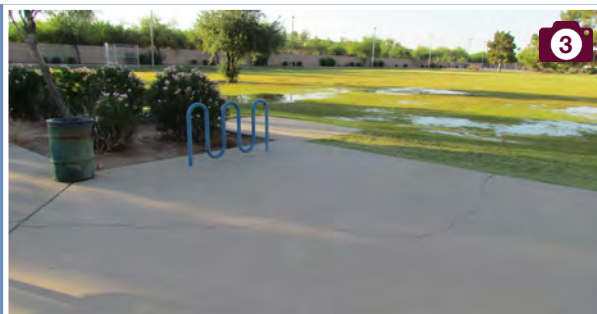
Turf Area West

The west turf areas are in average condition. The ground is compacted. It is recommended that staff look at eliminating turf on severe perimeter sideslopes, regrading and placing decomposed granite.

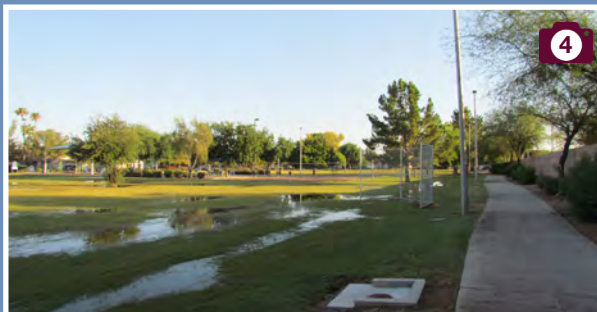
Irrigation System

The east area of the park utilizes flood irrigation on all turf areas. Concrete sidewalk relocation providing better separation from the tree root zones is recommended.

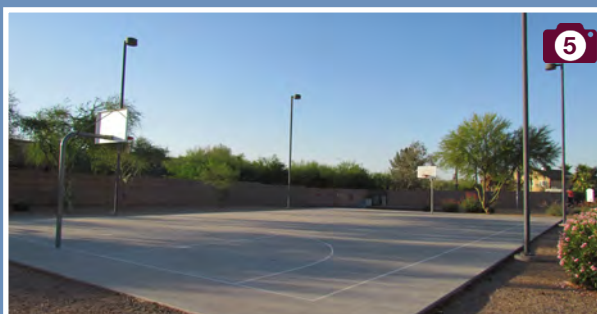
Courts

The sand volleyball court is in average condition and the concrete post-tension court is in goof condition. The court has high-pressure sodium lights. LED fixture replacement for court lighting is recommended.

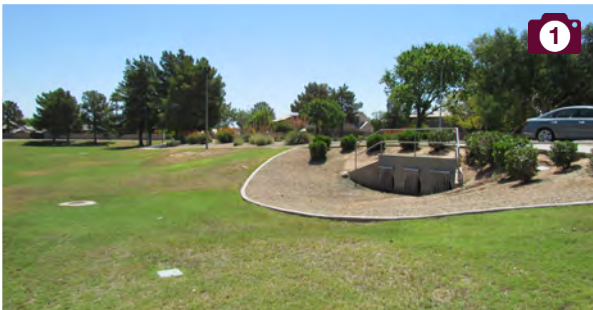
Overall Drainage

The park has three turf basin areas around the perimeter of the park, which provides storm water runoff from offsite flows. There are several storm drain outfall points along the perimeter of the park.

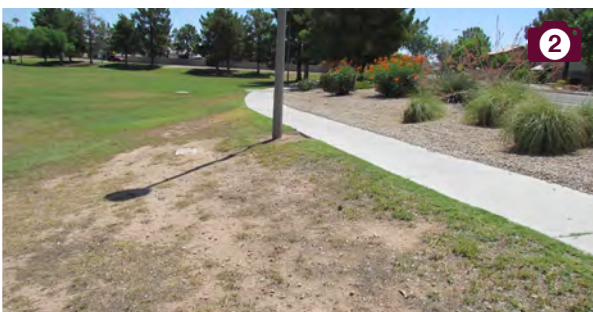
The turf sideslopes are very worn and compacted. Turf on floor of basin is in average condition but is very compacted with some worn spots. A reduction of turf in the mature tree canopy areas is recommended. The worn condition of slopes is due to lack of irrigation maintenance not activity.

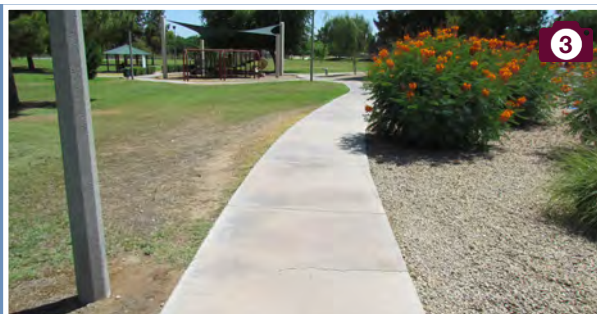
Sidewalk

The concrete sidewalk is in average condition. There are a few panels that show some vertical separation.

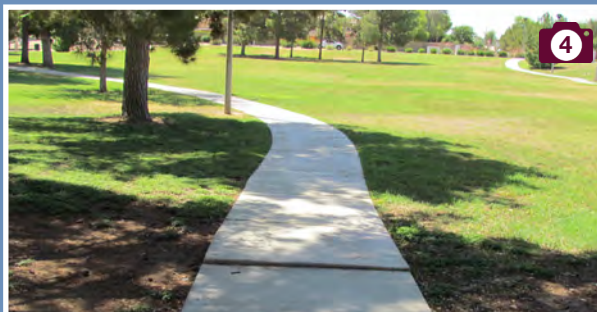
Established Trees

There are several areas with established trees being located near the sidewalk, which has caused some cracking/heaving issues. The City has replaced some of the sidewalk but they were replaced in the same location as the existing tree and will cause further uprooting in the future. It is recommended that a concrete sidewalk relocation plan be undertaken to provide better separation from the tree root zones.

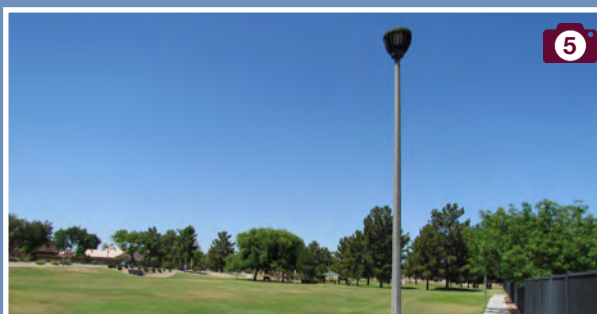
Site Lighting

The park pathway light fixtures are high-pressure sodium. LED fixture replacement for the pathway lighting is recommended.

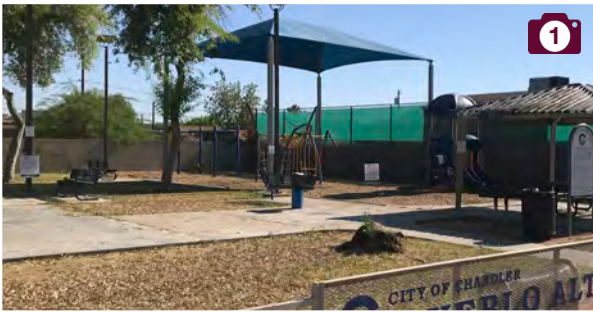
Small Turf Areas

The park has some small turf areas throughout the park amenities, between the playground, ramada, and basketball court. The turf is in poor condition due to size and existing trees. The ground is very compacted. Recommend removal due to non-usable size.

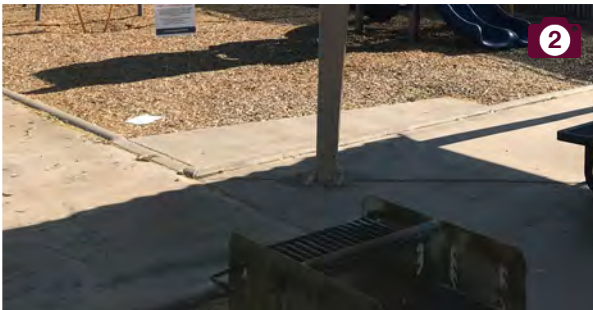
Concrete Plaza Areas

The concrete is in average condition. No structural or safety issues, only discoloration and worn panels.

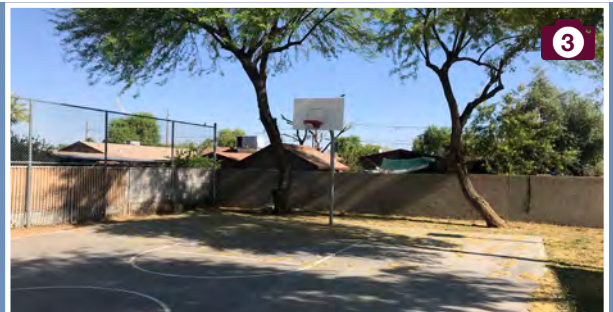
Basketball Court

The concrete basketball court is in good condition. Location is along a residential property line and not ideal.

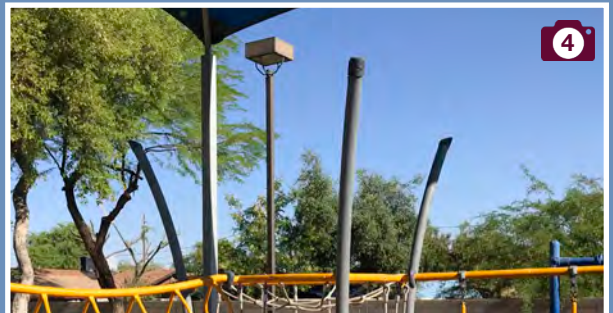
Site Lighting

The site lighting is high pressure sodium fixtures, LED fixture replacement recommended.

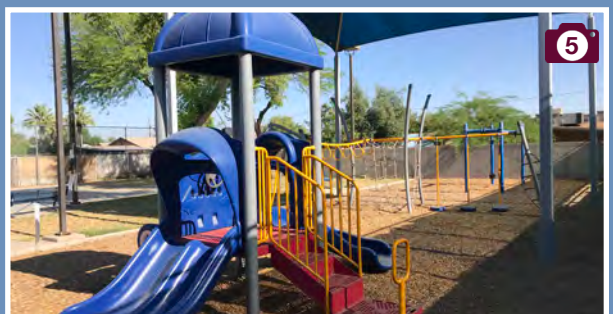
Playground area is in good condition, access ramp has settled.

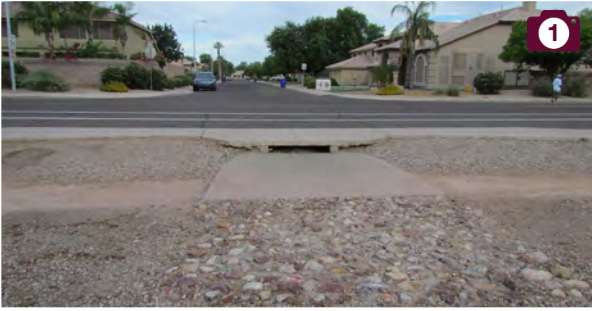
Overall Drainage

The park has a large circular turf area. The site has large decomposed granite areas along the offsite street frontage. There is a scupper at the midpoint of Adams Avenue that outlets to the decomposed granite basin area.

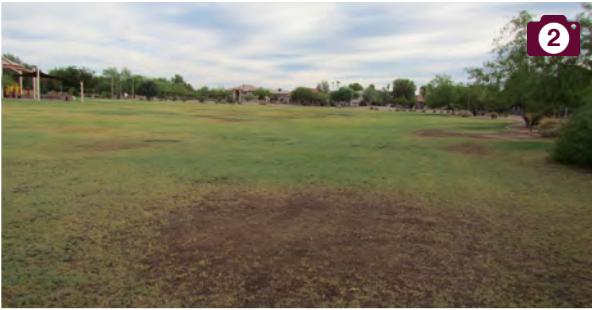
Turf Area

The overall open space turf is in good condition with some worn areas. The ground appears to be compacted throughout. An aeration and soil agronomy test to evaluate soil condition is recommended.

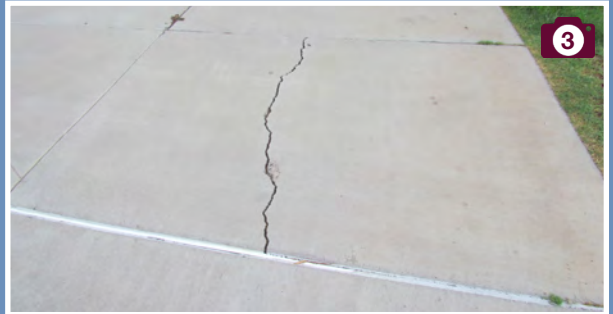
Sidewalk

The concrete sidewalk has some cracking throughout.

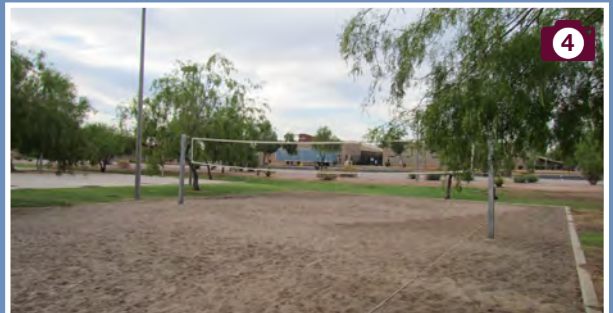
Sand Volleyball Court

The sand volleyball court is in good condition. The court has high-pressure sodium lighting. LED fixture replacement for court lighting is recommended.

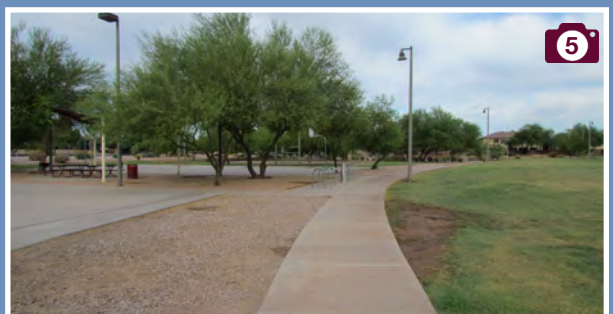
Site Lighting

The pedestrian pathway lighting is high-pressure sodium. LED fixture replacement for court lighting is recommended.

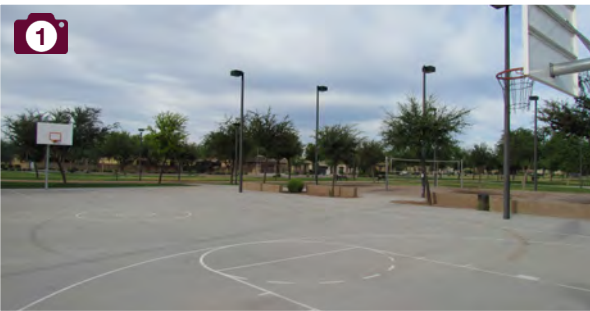
Basketball Court

The concrete is in good condition. The court lighting has high-pressure sodium lighting. LED fixture replacement for court lighting is recommended.

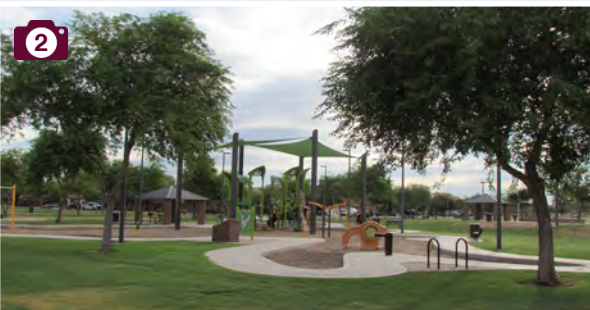
Playground

The playground area, header curbs, and sidewalk areas are in good condition and equipment is in good condition. The playground has LED lighting fixtures.

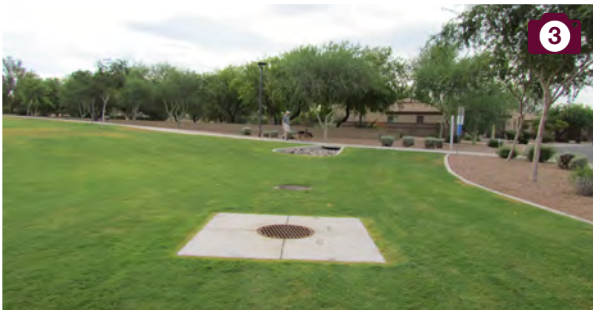
Overall Drainage

The park retains onsite drainage with the turf areas and has drywells to drain turf basin areas. The park does not receive any offsite drainage from the adjacent street frontage.

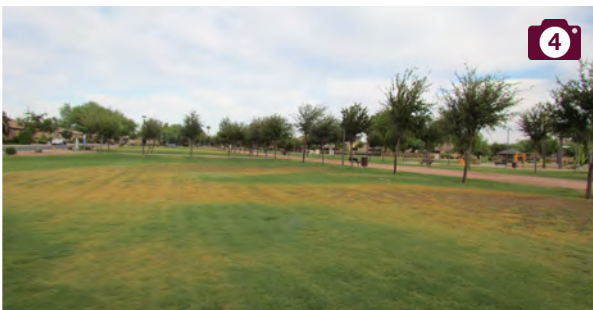
Turf Area

The overall open space turf area is in good condition with some worn areas. The overall ground appears compacted throughout. An aeration and soil agronomy test to evaluate soil condition is recommended.

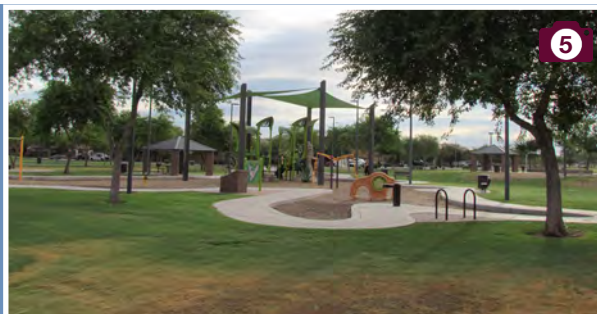
Turf Area around Playground Area

The turf around the playground area is in good condition, but there are worn areas. An aeration and soil agronomy test to evaluate soil condition is recommended. The worn condition of slopes is due to lack of irrigation maintenance not activity.

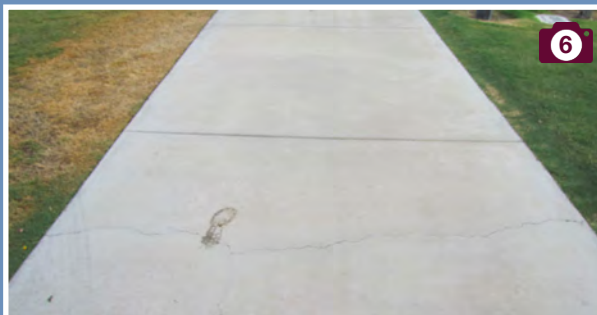
Sidewalk

The concrete sidewalk has some cracking throughout.

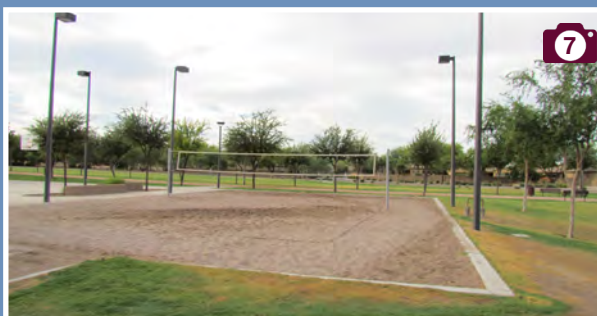
Sand Volleyball Court

The sand volleyball court is in good condition. The court has high-pressure sodium lighting. LED fixture replacement for court lighting is recommended.
