# CHAPTER 2

# PARKS & FACILITIES ASSESSMENTS

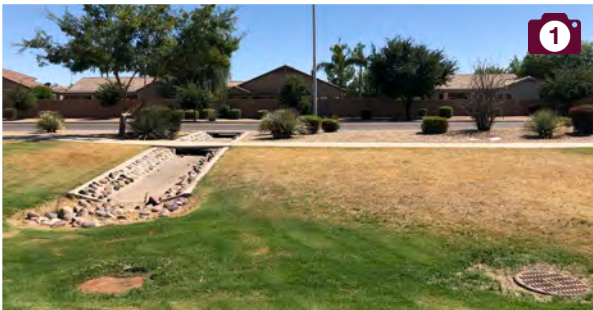
### Overall Drainage

*The park's west turf area provides retention storage for offsite drainage from the adjacent street frontage.*

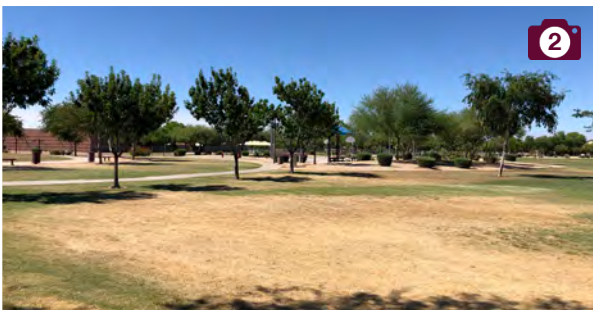
### East Turf Area

*The east turf basin turf is in below-average condition with some worn areas. The condition is due to lack of irrigation maintenance not activity. The area is very compacted throughout. An aeration and soil agronomy test to evaluate soil condition and recommendations for amendments is suggested.*

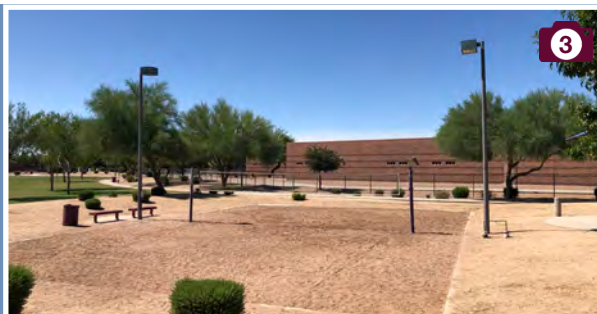
### Sand Volleyball Court

*The sand volleyball court is in good condition. The court has high-pressure sodium light fixtures. LED fixture replacement for court lighting is recommended.*

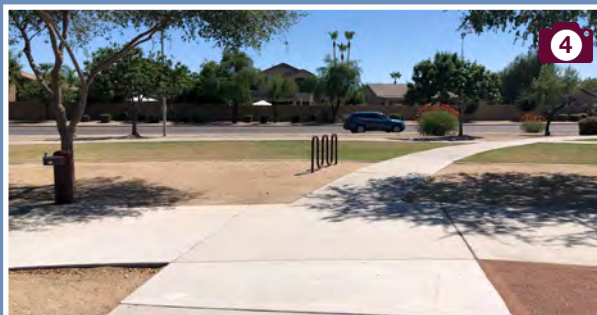
### Sidewalk and concrete plaza areas

*The concrete sidewalk is in good condition but there are some cracked panels throughout the pathways and plaza areas.*

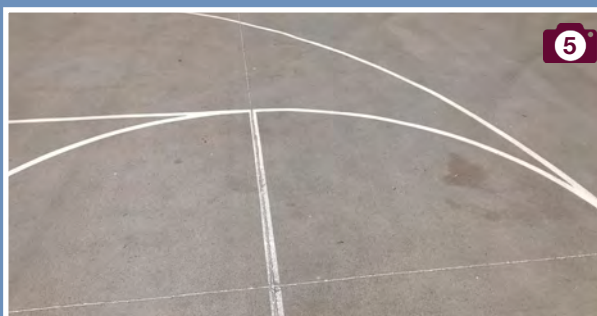
### Basketball Court

*The concrete post-tension court is in good condition and the lighting is high-pressure sodium. LED fixture replacement for court lighting is recommended.*

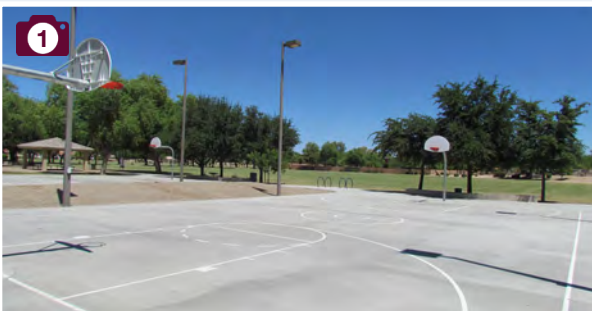
### Basketball Court (East and West)

*The concrete post-tension court is in good condition and the lighting is high-pressure sodium. LED fixture replacement for court lighting is recommended.*

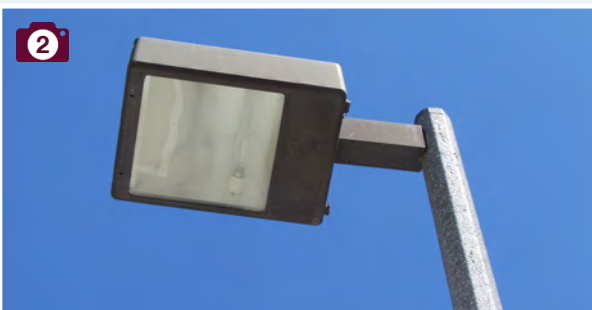
### Site Lighting

*The pedestrian lights are high-pressure sodium fixtures. LED fixture replacement along pathways is recommended.*

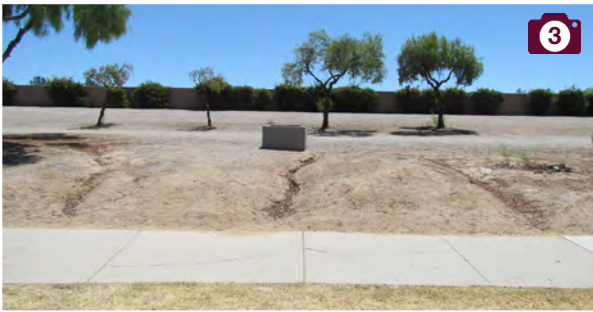
### Overall Drainage

The park does not have or provide any offsite drainage conveyance from the surrounding streets. There is a large regional retention basin west of the park. The park provides onsite drainage storage throughout the park within the established turf areas. There are some rilling areas along the south of the park at the elevated flood irrigation gate structure.

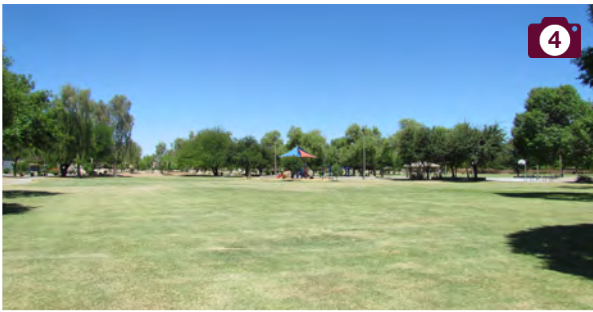
### South Turf Area

The south turf area is in average condition with some hard compaction throughout the turf areas. An aeration and soil agronomy test to evaluate soil condition is recommended.

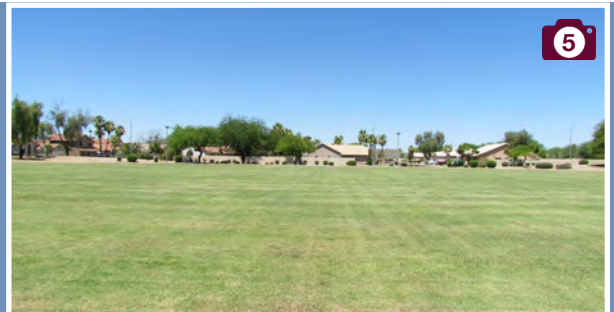
### North Turf Area

The north turf area is in good condition. There are some hard compaction areas throughout the turf. An aeration and soil agronomy test to evaluate soil condition is recommended.

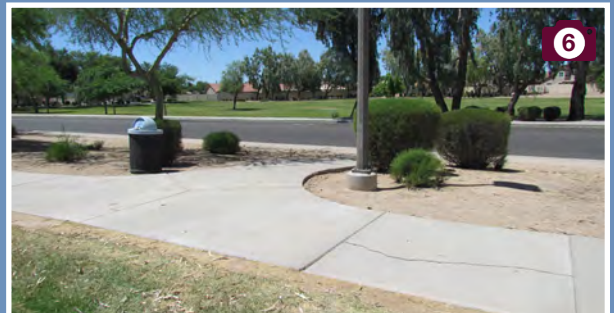
### Sidewalk and Concrete Plaza Areas

The concrete sidewalk is in average condition as there are several cracked panels throughout the pathways and plaza areas.

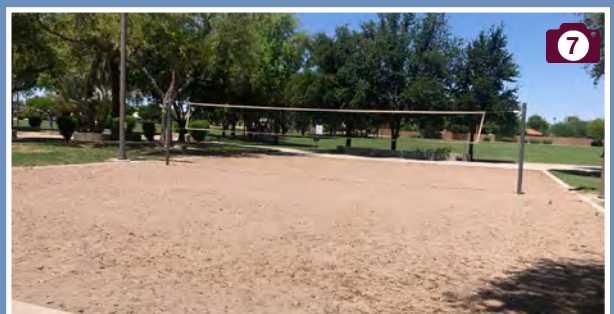
### Sand Volleyball Court

The sand volleyball court is in good condition (net has been removed due to COVID-19). The court has high-pressure sodium lighting. LED fixture replacement is recommended.

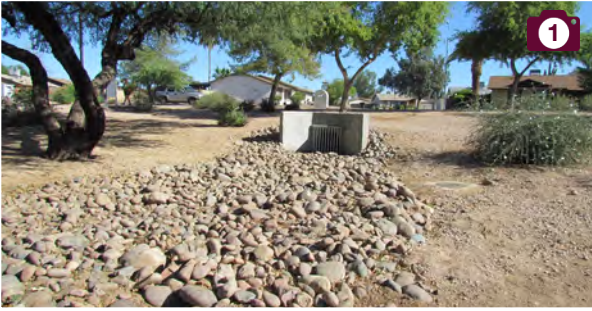
### Overall Drainage

The park has three large storm drain outfalls in the north, northeast, and southwest corners of the park that convey offsite drainage to the park area. The northeast corner basin is primarily in a decomposed granite area and is very silted. The southwest corner is primarily within the decomposed granite area, but does reach the lower turf area in the basin.

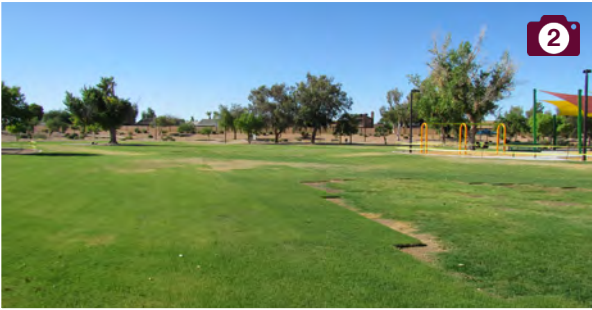
### Turf

The turf is in good condition. There are some worn areas that the City recently has been addressing with new sod. An aeration and soil agronomy test to evaluate soil condition is recommended. The worn condition of slopes is due to lack of irrigation maintenance, not activity.

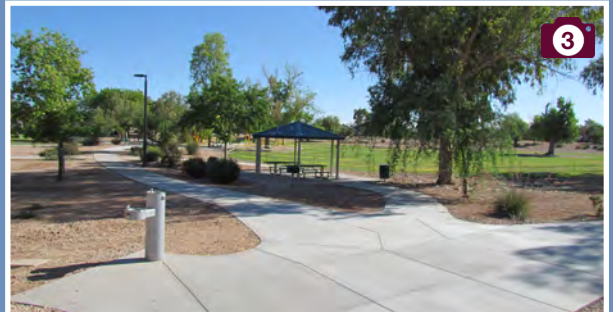
### Sidewalk

The concrete sidewalk is in good condition.

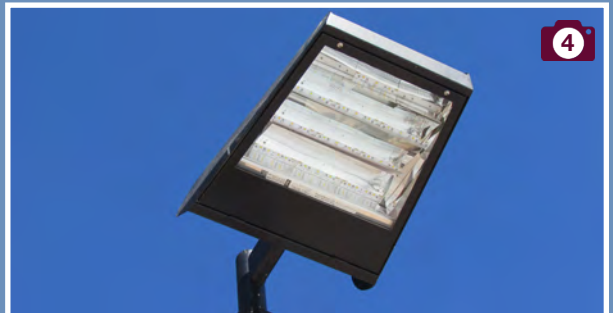
### Site Lighting

The concrete post-tension court is in great condition and has LED lighting. The park pathway lighting is also LED.

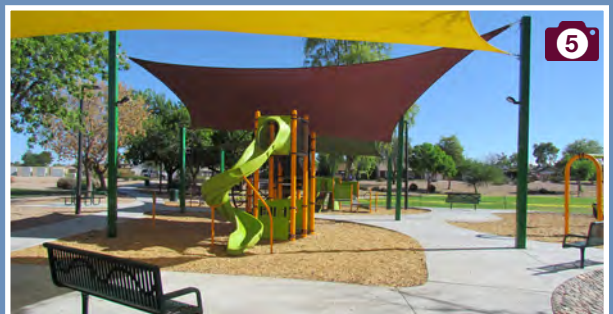
### Playground

The playground area is in good shape, the header curbs and sidewalk areas are also in good condition and the play equipment is in good condition.

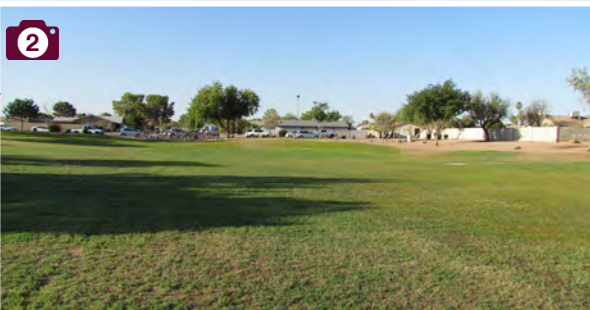
### Turf

The turf is in good condition. There are some hard compaction areas throughout the turf. An aeration and soil agronomy to evaluate soil condition is recommended.

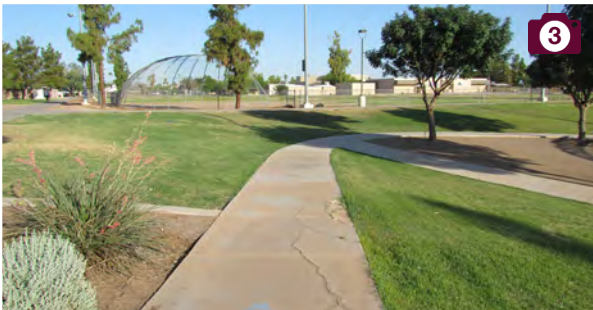
### Park Pathway

The perimeter pathway is a combination asphalt/concrete sidewalk pathway that has utilized concrete repairs within the asphalt. The pathway has cracks within the asphalt pathway. Staff should evaluate the overall pathway and the perimeter sideslopes for future replacement. There are a few panels with cracks that have been marked for removal.

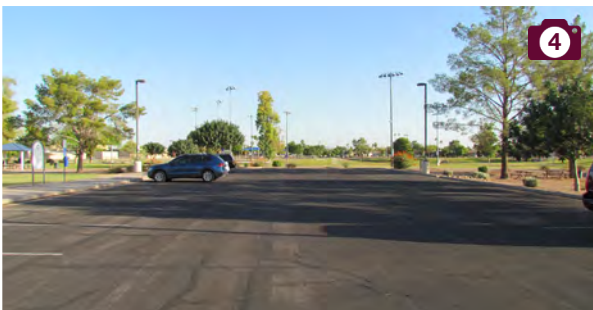
### South Parking Area

The parking area was recently crack sealed and seal coated. The parking area has positive drainage as runoff is conveyed to the east to the basin by open curb cut and scupper pans. Even with the recent crack seal and the seal coat the parking area is in average condition. The asphalt-concrete pavement seems to have exceeded its lifespan and will need to be replaced in a couple years.

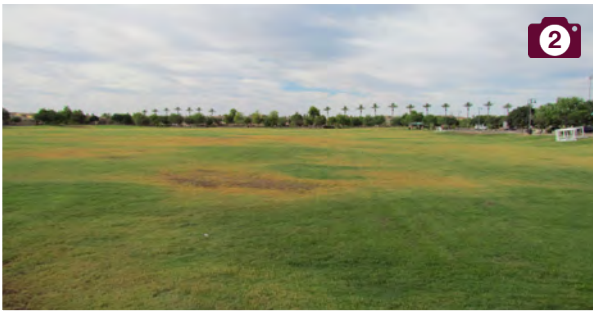
### East Multi-Use Fields

*The turf is in poor condition with some worn areas in middle field area and along side slopes throughout. The condition of slopes is due to lack of irrigation maintenance not activity. The ground is compacted throughout. An aeration and soil agronomy test to evaluate soil condition and recommendations for amendments is suggested.*

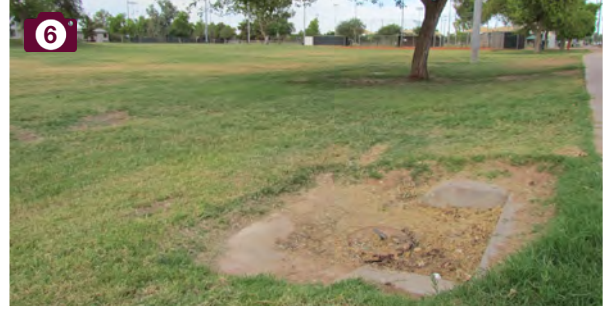
## Sidewalk

The concrete sidewalk is in good condition. There are some cracked panels throughout the pathways and plaza areas.

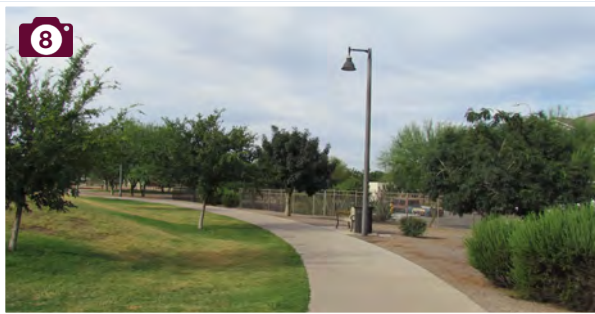
## Site Lighting

The pedestrian and parking area lights are high pressure sodium fixtures that are in good condition. Recommend replacement of fixtures with LED when the current fixtures reach SUSTAINABLE PROJECTS.

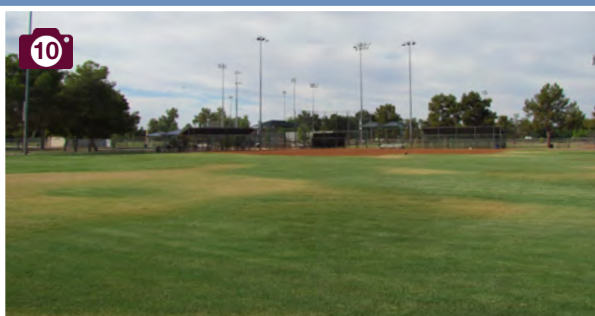
## South Baseball Fields

The south baseball fields have some some yellow areas but overall condition is good.

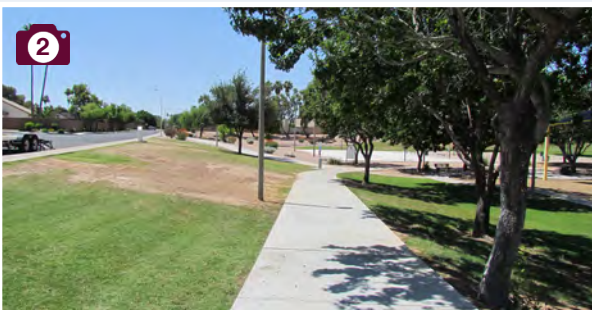
### Ithica Street Turf Side Slope

The turf side slope has several large worn areas. There is some rilling on the decomposed granite slope off the sidewalk. An aeration and soil agronomy test to evaluate soil conditioning is recommended.

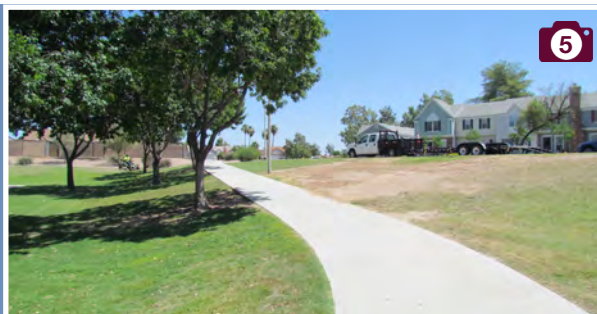
### Established Trees

*There are several areas with established trees being located near the sidewalk causing some cracking/heaving. The City has replaced some of these areas, but they are being replaced in the same location as the existing tree and will cause further uprooting in the future. A concrete sidewalk relocation providing better separation from the tree root zone is recommended.*

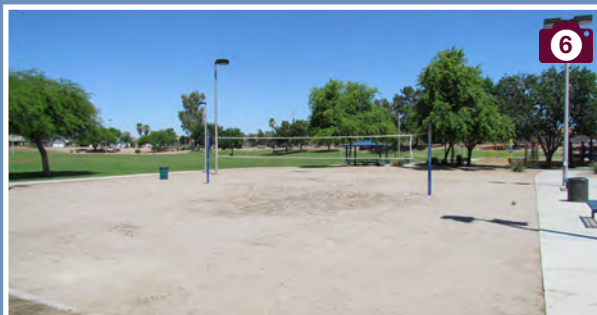
### Sand Volleyball Court

*The sand volleyball court is in good condition. The court has high-pressure sodium lighting. LED fixture replacement for the sand volleyball court is recommended.*

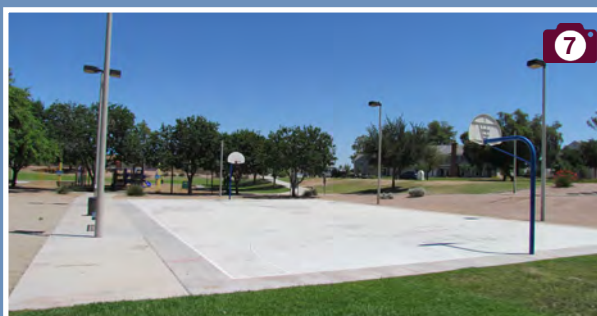
### Basketball Court

*The concrete post-tension court is in good condition and the lighting is high-pressure sodium. LED fixture replacement for court lighting is recommended.*

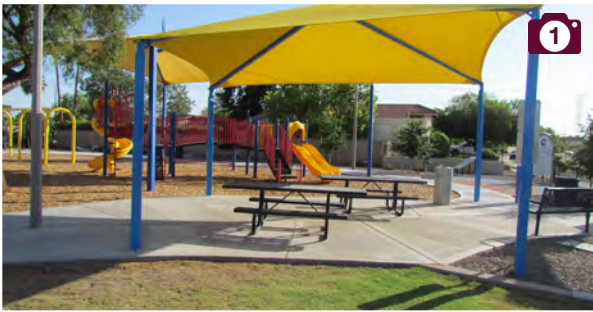
### Sidewalk and Playground

*The concrete sidewalks and playground are brand new and in good condition.*

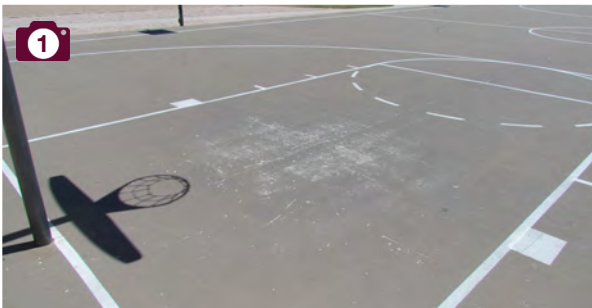
### Basketball Court

The concrete post-tension court has some wear in the acrylic surfacing. The existing court lighting is high-pressure sodium. LED fixture replacement for court lighting is recommended.

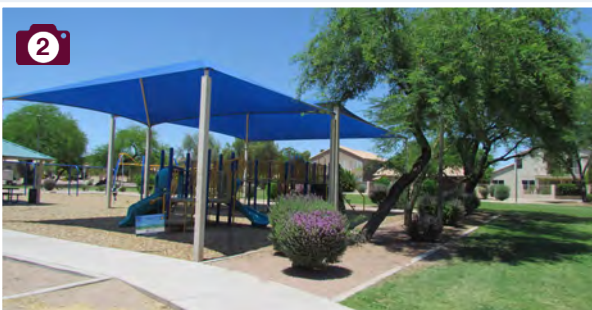
### Playground

The playground area, header curbs, and sidewalk areas are in average condition and the play equipment is in good condition.

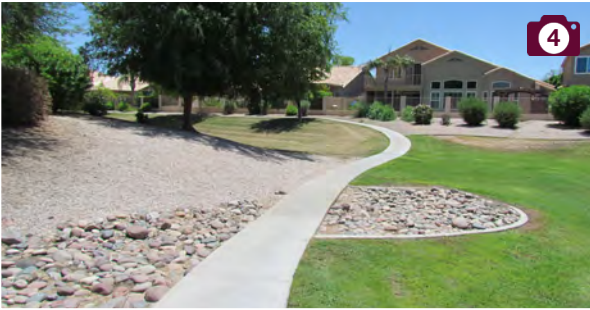
### Concrete Header Curb

There are several areas within the perimeter of the turf basins where the concrete header curb is broken or displaced. Replacement to provide separation from turf and decomposed granite is recommended.

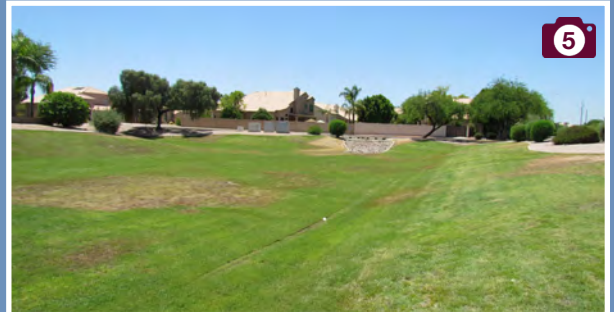
### Turf Lower Basin

The turf floor of the basin is in moderate condition there is a worn area in the middle of the basin. The sideslopes along the perimeter of the retention basin have some wear spots. The worn condition of slopes is due to lack of irrigation maintenance, not activity.

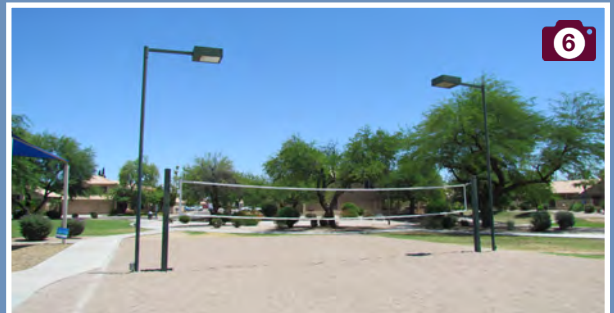
### Sand Volleyball Court

The sand volleyball court is in average condition and the curb and net are in working condition. The lighting utilizes sodium fixtures. LED fixture replacement for court lighting is recommended.

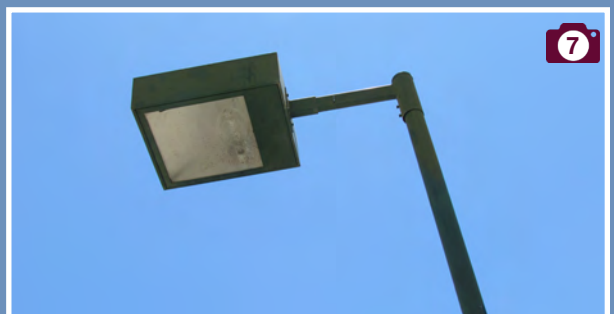
### Site Lighting

The park lighting (basketball court and volleyball courts) have high-pressure sodium light fixtures. The pathway lighting has new LED fixtures with stone poles. LED fixture replacement for court lighting is recommended.

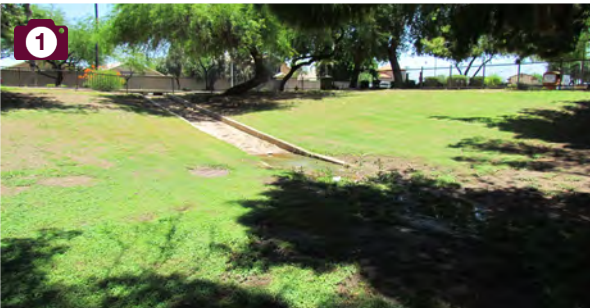
### Ray Road Drainage

Ray Road has a concrete scupper pan which outlets to the park to a turf basin outside the main turf area. This basin has two 4" storm drain pipes which bleed off/equalize this outer perimeter basin to the overall park turf basin. This basin has a drywell. The end of the spillway has standing water as the drywell in the turf area is higher than the spillway outlet.

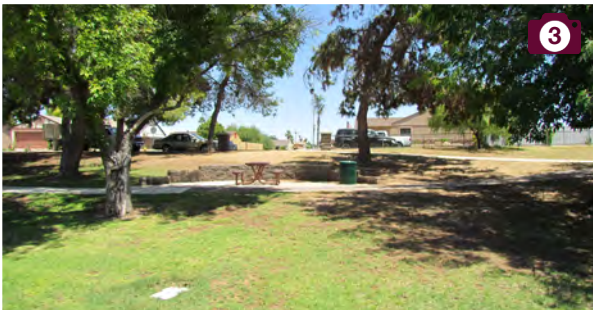
### **Turf Area**

*The park slopes are steep along perimeter, especially adjacent to Terrace Road. It is recommended that staff look at eliminating turf on severe perimeter sideslopes and regrading and placing decomposed granite.*

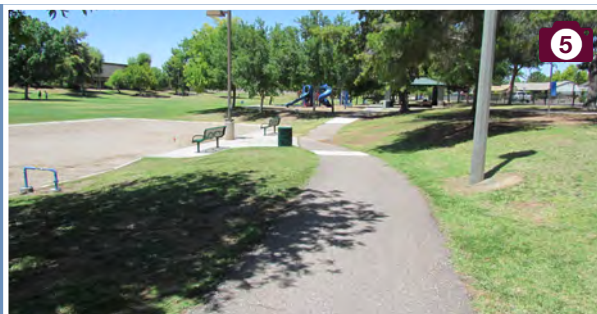
### **Park Pathway**

*The perimeter pathway is a combination asphalt/concrete sidewalk pathway that has utilized concrete repairs within the asphalt. The pathway has cracks within the asphalt areas. The City should evaluate the overall pathway and the perimeter sideslopes to regrade and replace the pathway in the future.*

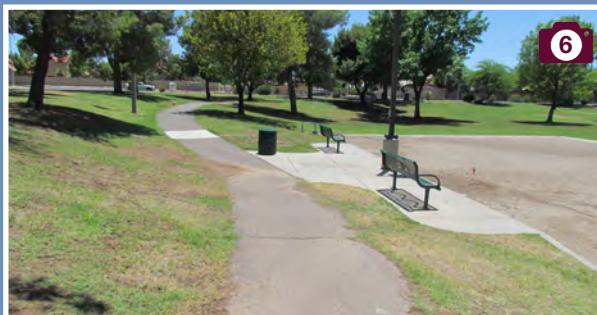
### **Sand Volleyball Court**

*The sand volleyball court is in average condition. There is a drainage issue with water draining from the steep sideslope across the asphalt path and concrete to the sand area. LED fixture replacement for court lighting is recommended.*

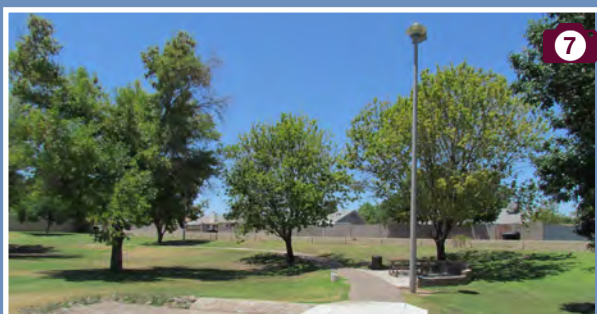
### **Site Lighting**

*The park pathway lighting and volleyball court have high-pressure sodium light fixtures. LED fixture replacement for court lighting is recommended.*

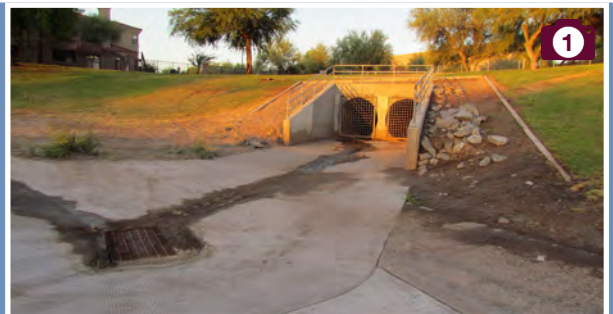
### Overall Drainage

*Thude Park is a regional retention basin facility with storm drain outlets at and along the perimeter of the park.*

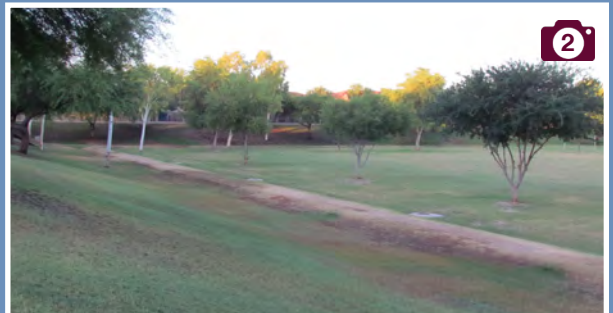
### Turf Area

*The park perimeter has some worn areas, but overall the slopes look good. Some of the decomposed granite slopes are showing minor rilling, but overall in good condition.*

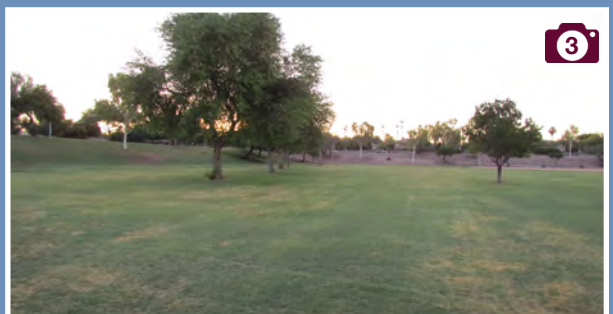
### Turf Lower Basin

*The turf floor of the basin is in average condition. There are some worn areas and the basin is compacted throughout. An aeration and soil agronomy to evaluate soil condition is recommended.*

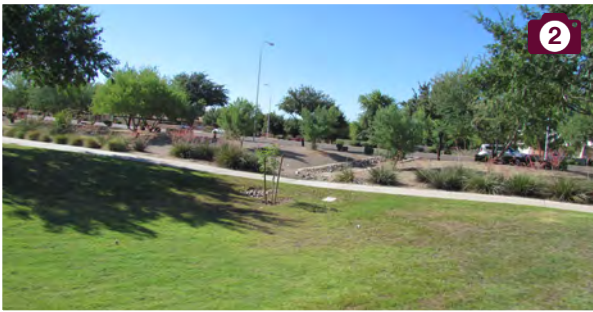
### Site Lighting

*The pedestrian and parking area lights are high-pressure sodium fixtures, which are in good condition.*

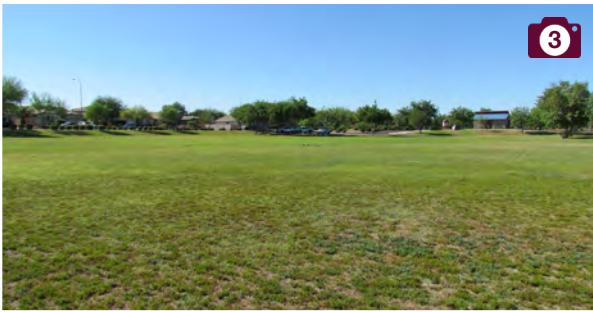
### Overall Drainage

The park provides offsite storm drain outfall for Cottonwood Street and Chandler Boulevard via concrete scuppers. The two scupper pan outlets on Cottonwood Street are fairly close to the playground area and park northeast corner sidewalk. The east scupper brings offsite drainage across the sidewalk to get to the turf area. The west scupper near the playground has rip rap swale to a sidewalk scupper which conveys runoff to the turf basin area.

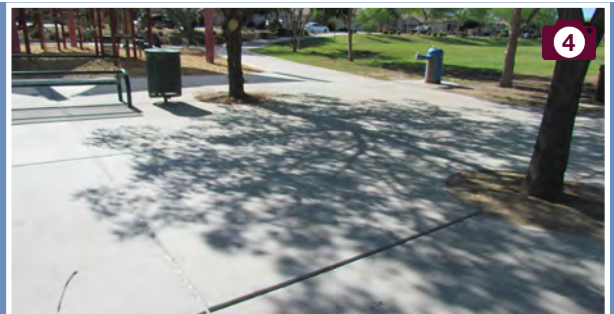
### Sidewalk

The concrete sidewalk is in good condition. There are a few panels with some heaving in the playground plaza area.

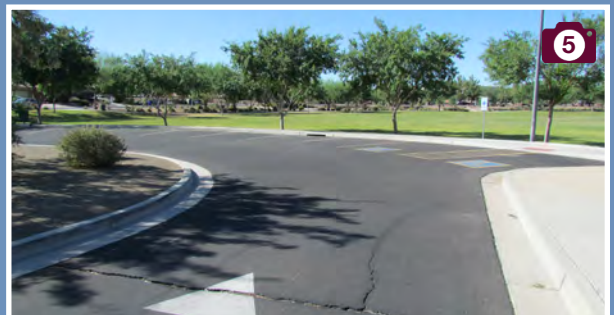
### Parking Area

The parking area is in good condition. It appears to have been seal coated in the last couple of years. There are a few 3/4" to 1" cracks that should be crack sealed to prevent further infiltration of moisture. Drainage has positive conveyance to scuppers that outlet to surrounding turf area. A crack seal and seal coat every three to five years is recommended.

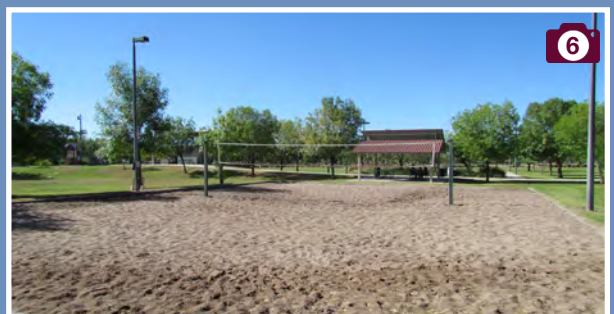
### Basketball and San Volleyball Courts

The concrete post-tension court and sand volleyball court are in good condition and the lighting is high-pressure sodium.

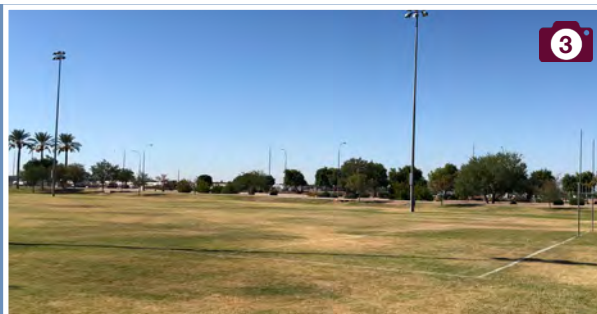
### Northwest Turf Area

The northwest multi-use fields are in good condition. There are compacted areas throughout. These fields are flood irrigated from the perimeter concrete lined channel. The fields have metal-halide Musco sports lighting. An aeration and soil agronomy test to evaluate soil condition and recommendations for amendments is suggested.

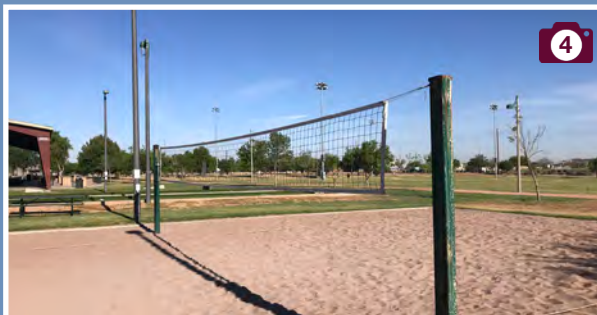
### Sand Volleyball Court

The sand volleyball area is in good condition. The net posts show some wear. The lighting is high-pressure sodium. Replacing the lighting with LED fixtures is recommended.

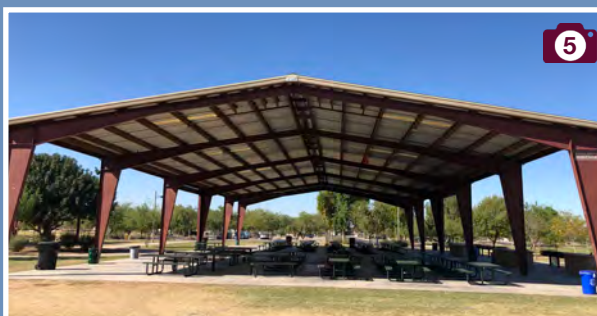
### Group Ramada (Main)

The group ramada structure is in average condition. The concrete area pad is in good condition, with minor hairline cracking in some areas. There is some staining and discoloration from use. The group ramada concrete may benefit from a soda wash treatment to clean the surface area. Additional application of an epoxy or polymer sealant to help protect it from staining/discoloring and surface wear is also suggested.

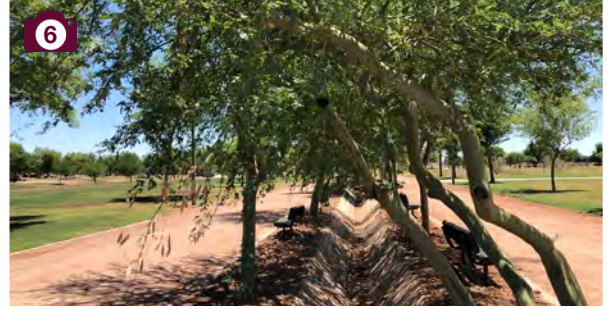
## Flood Irrigation

The park has a large network of concrete lined channels providing flood irrigation to the turf areas throughout the park.

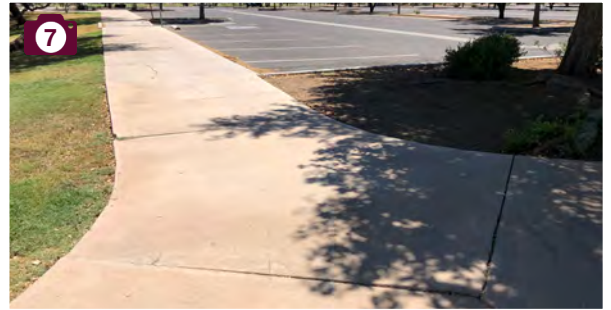
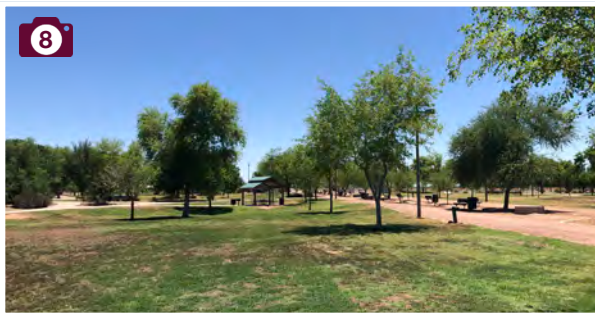
## Sidewalk

The concrete sidewalk is in good condition. There are some cracked panels throughout the pathways and plaza areas.

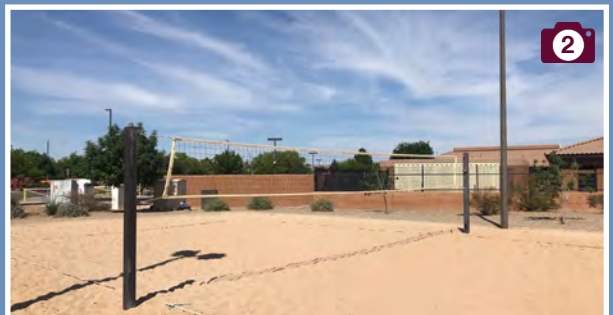
### Sand Volleyball Court

*The sand volleyball is in good condition. The court has high pressure sodium light fixtures. Recommend LED fixture replacement for court lighting.*

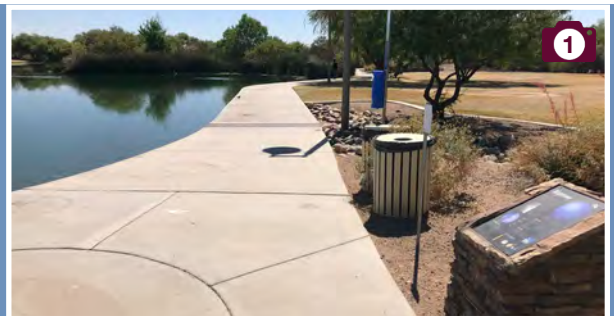
### Lake Edge / Concrete Multi-Use Pathway

*The concrete multi-use path and lake are in good condition.*

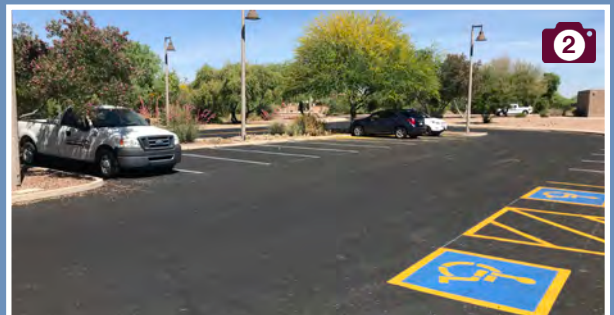
### Parking Areas

*The parking areas are in good condition and have been seal coated recently. It is recommended that seal coat and crack seal of the parking areas is done every two to three years to maintain the asphalt in good condition.*

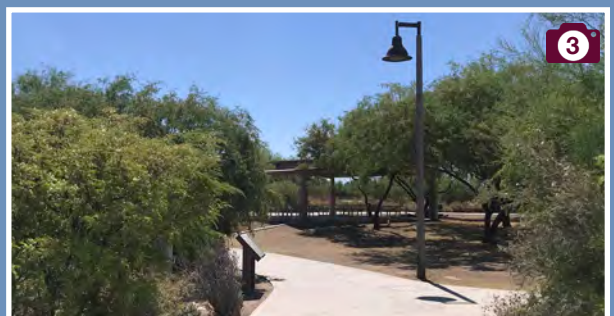
### Site Lighting

*The site lighting is high pressure sodium fixtures with a combination of light poles, bollards with decorative fixtures throughout the park. The fixtures and poles are in average condition, replacement of fixtures with LED should be deferred until current fixtures reach their lifecycle.*

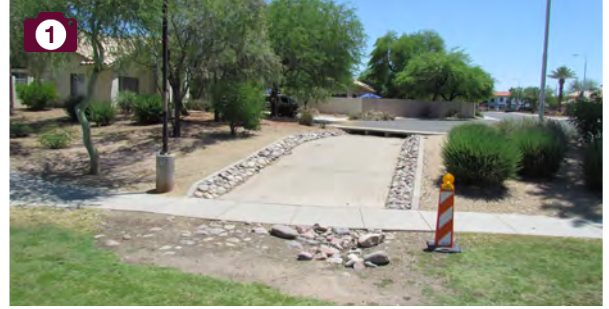
## Windmills Blvd

Windmills Boulevard utilizes a concrete scupper at the northwest corner and utilizes a riprap spillway to the turf area.

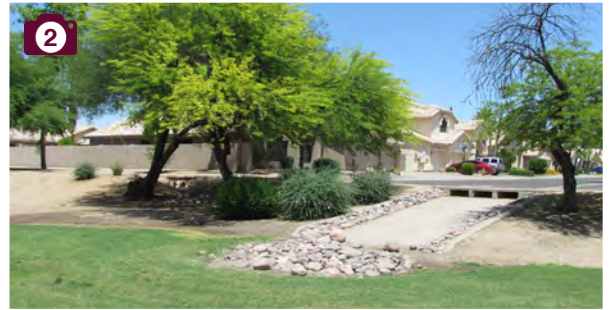
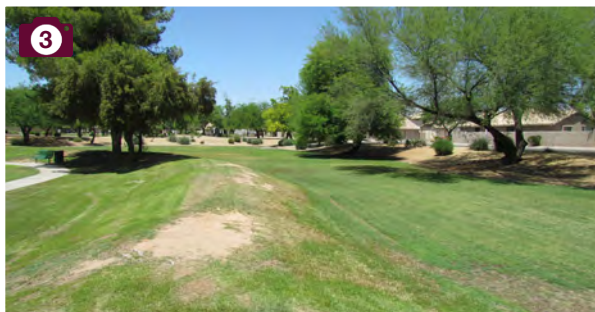
## Biscay Avenue

Biscay Avenue has two scuppers which convey drainage to the park area.

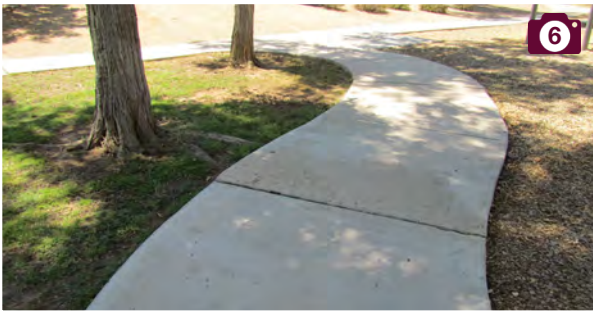
## Sidewalk

The concrete sidewalk is in good condition. There are a few panels that show some vertical separation.

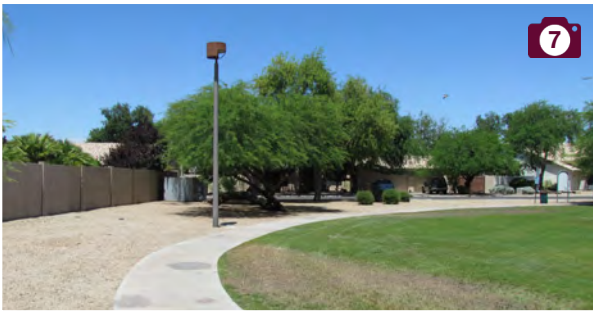
### Established Trees

*There are several areas with established trees being located near the sidewalk causing some cracking/heaving. The City has replaced some of these areas, but they are being replaced in the same location as the existing trees which will cause further uprooting in the future. A concrete sidewalk relocation to provide better separation from the tree root zone is recommended.*

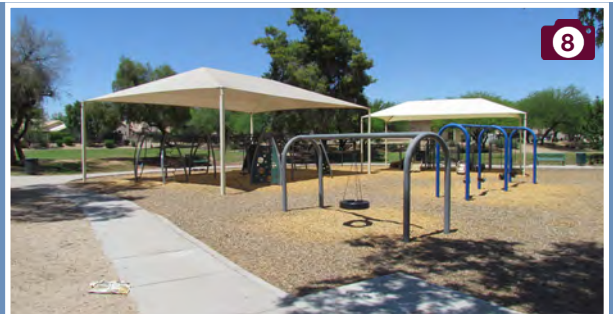
### Playground

*The playground area, header curbs, and sidewalk areas are in good condition and the play equipment is also in good condition.*

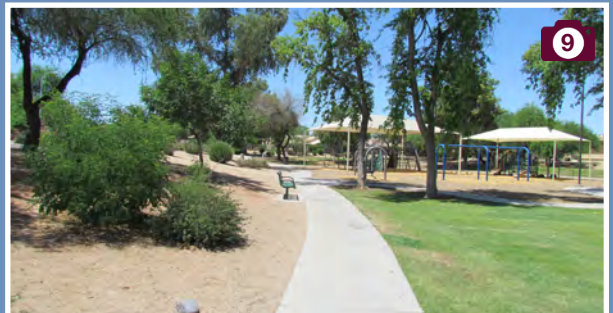
### Park Pathway

*Staff should evaluate the overall pathway and the perimeter sideslopes for regrading and replacement.*

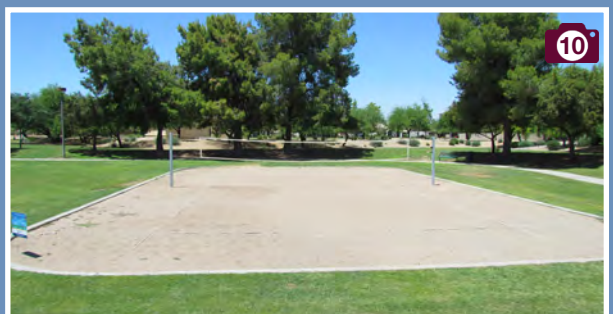
### Sand Volleyball Court

*The sand volleyball court is in good condition. The court does not have lighting.*

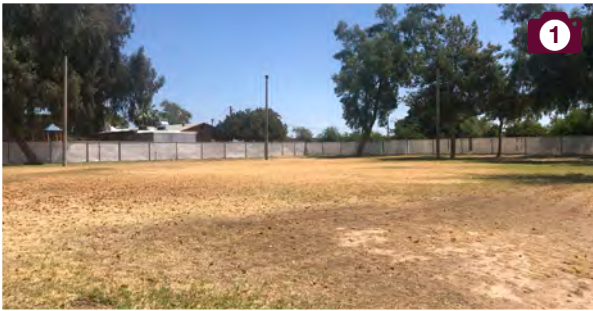
### Turf Area

The turf area is in poor condition and appears very compacted and worn throughout. An aeration and soil agronomy test to evaluate soil condition and recommendations for amendments/new turf is suggested.

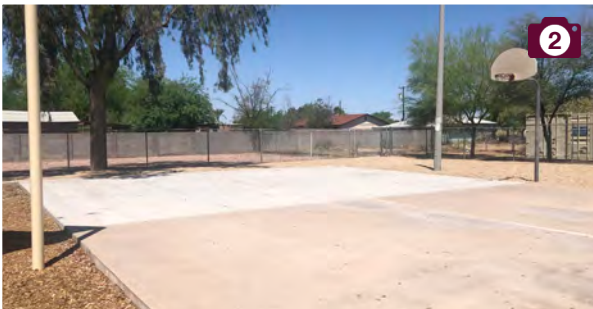
### Basketball Court

The concrete basketball court is in poor condition. The concrete pad has been replaced on one half of the court. The lighting is high-pressure sodium. Replacement of half of the slab and the light fixtures with LED is recommended.
