CHAPTER 2

PARKS & FACILITIES ASSESSMENTS

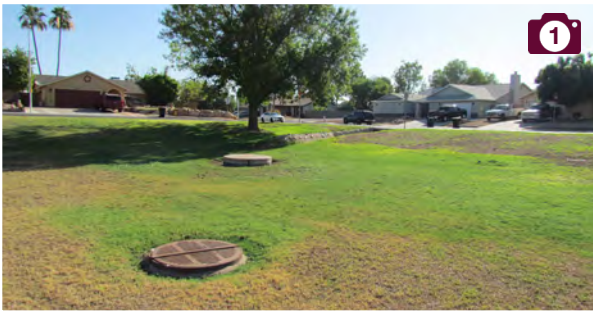
Turf

The overall turf is in average condition. There are several worn areas throughout all of the basin areas including worn sideslopes. The condition of slopes is due to lack of irrigation maintenance not activity. The turf has silty, crusty film from incoming offsite drainage in the southern turf area. The ground appears to be very compacted. It is recommended that aeration and a soil agronomy test take place to evaluate the soil condition.

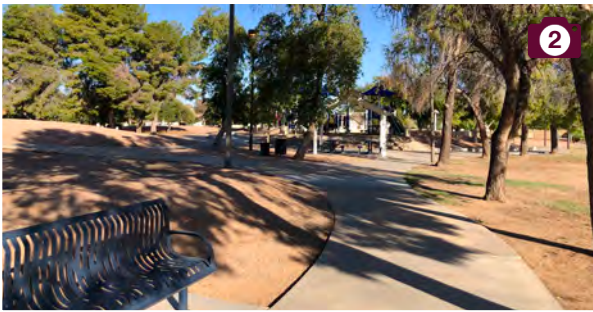
Sidewalk

The concrete sidewalks are in average condition. There are several panels that have been replaced and some additional cracked sidewalk panels with some visible vertical separation. There are several established trees close to the sidewalks which have caused uprooting and heaving of some panels. A concrete sidewalk relocation is also recommended to provide better separation from the tree root zones in some locations.

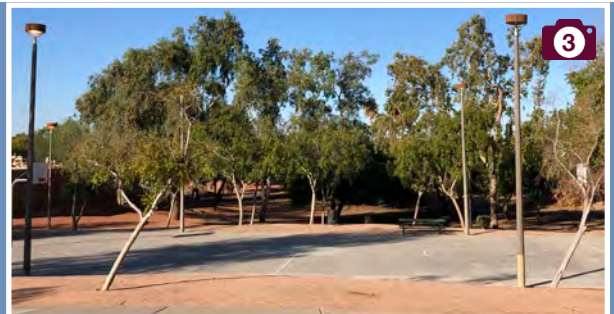
Basketball Court

The concrete post-tension court shows some signs of wear in the surfacing, but is in good condition overall. The existing court lighting is high-pressure sodium, LED fixture replacement is recommended.

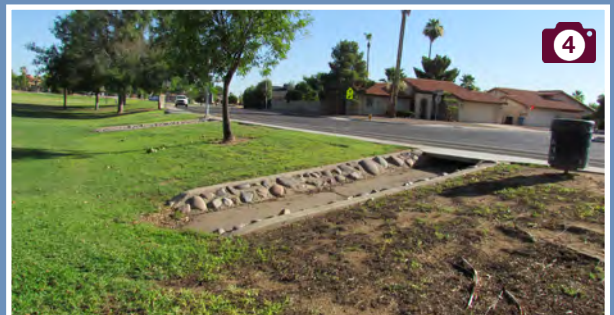
Overall Drainage

The park has a large turf area that is divided into two turf depressed basins by a concrete sidewalk. The turf areas provide storm water storage for offsite drainage runoff from Bullmoose Drive and Knox Road. Offsite drainage is conveyed into the turf basin areas from the surface by scuppers with concrete scupper pans.

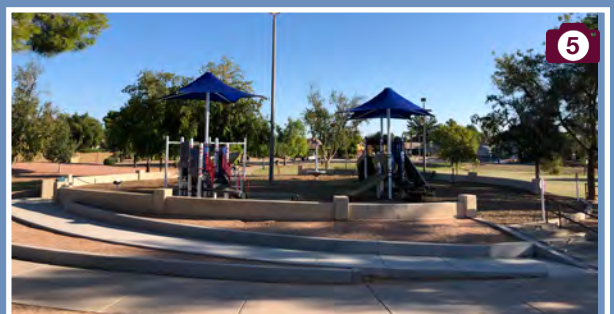
Playground

The playground area in average condition. The concrete header curbs and sidewalk areas are also in average condition along with the playground equipment.

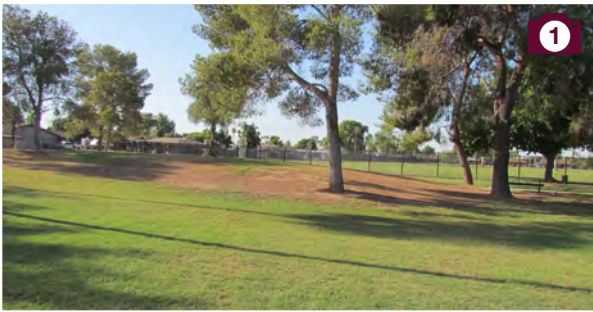
Southeast Turf Area

This area of turf utilizes flood irrigation for watering. The turf is worn on the sideslopes of the berms. The condition of slopes is due to lack of irrigation maintenance not activity. Additionally, the area has several established trees, which provide large amounts of shade. It is recommended that staff look at eliminating turf on severe perimeter sideslopes, regrading and placing decomposed granite in worn areas.

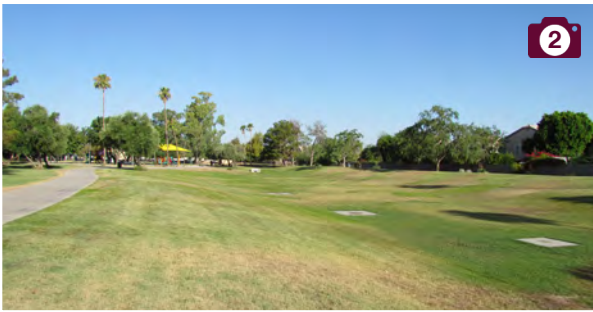
North West Turf Basin

The turf floor of the basin is in overall good condition. There are drywells with concrete pads per the current city detail along the floor of the basin. The turf has some wear on some of the sideslopes and the soil is relatively compacted throughout. Aeration and a soil agronomy test are recommended to evaluate soil conditions.

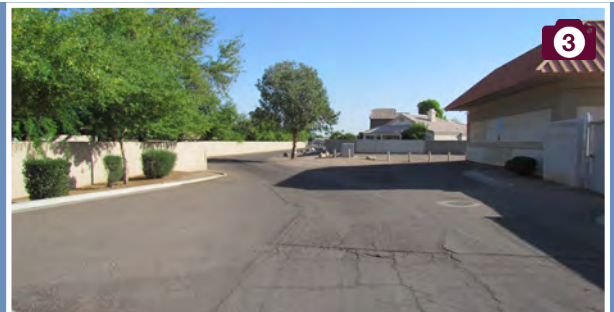
Parking Area

The asphalt concrete parking lot, shared with the water treatment plant, is in poor condition due to the 'alligator' cracking areas which have resulted in surface ponding. The asphalt concrete has exceed its lifecycle and is in need of replacement.

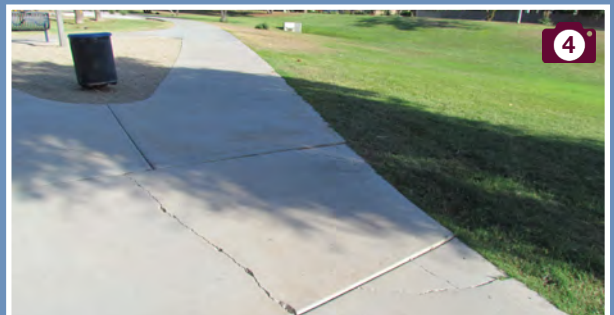
Sidewalk

The concrete sidewalk is in average condition. There are a few panels that show some vertical separation.

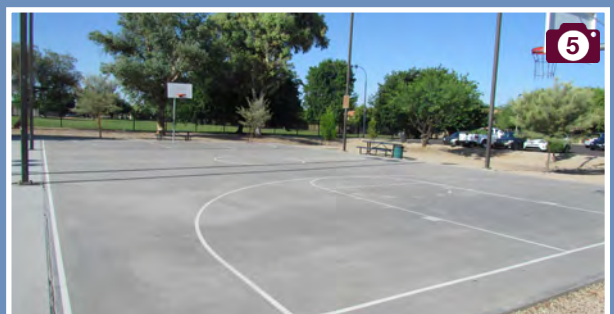
Basketball Court

The concrete post-tension court in good condition. The existing court lighting is high-pressure sodium, LED fixture replacement is recommended for court lighting.

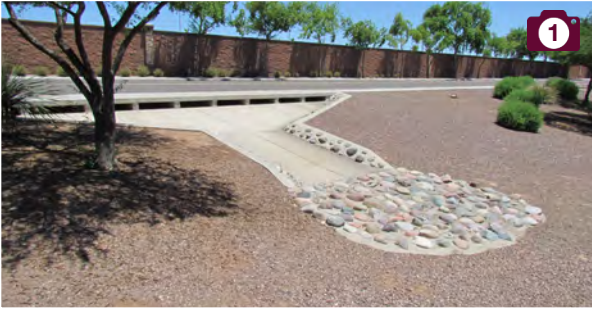
Overall Drainage

The park turf basin provides retention for the surrounding offsite storm water runoff from Le Grand Loop. The park has several scuppers and storm drain pipe outlets around the perimeter of the park, which convey offsite street flows to the basin of this park.

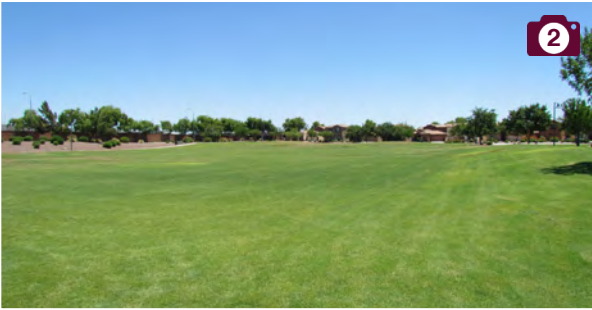
Turf at Lower Basin

The turf floor of the basin is in overall good condition. There are some worn areas within the floor of the basin area. The turf areas are compacted throughout. Aeration and soil agronomy is recommended to evaluate soil condition.

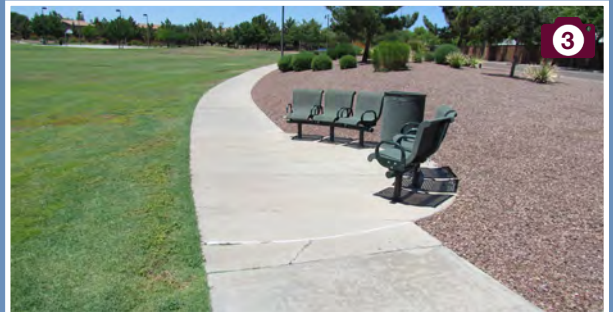
Sidewalk

The concrete sidewalk is in good condition. There are a few panels with cracking and vertical separation.

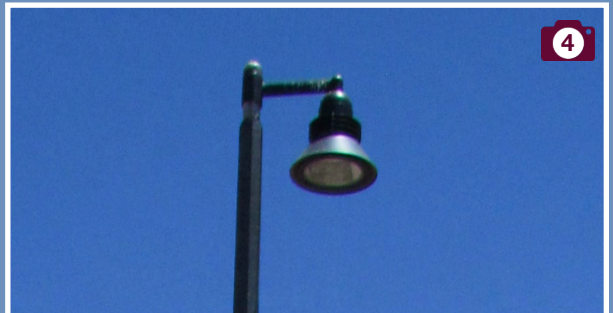
Site Lighting

The pathway lighting around the park is high-pressure sodium and fixtures appear to be in good condition.

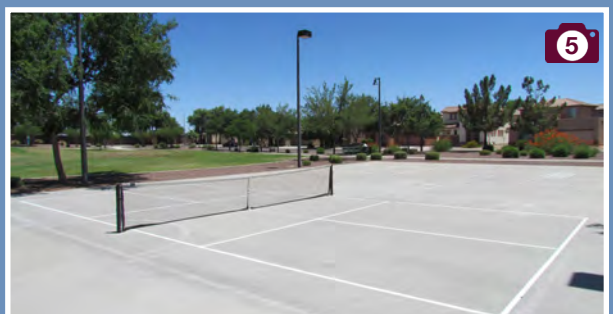
Basketball and Pickleball Courts

The concrete post-tension courts are in good condition. The lighting is high-pressure sodium, LED fixture replacement is recommended for court lighting. Adjust irrigation to minimize overspray.

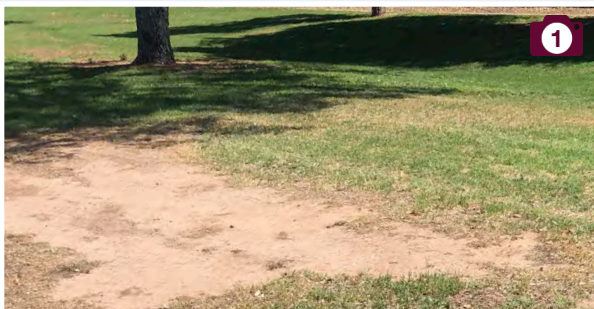
North Turf Area

The turf is in good condition with some worn areas throughout. The ground appears to be compacted throughout. An aeration and soil agronomy test to evaluate soil condition and recommendations for amendments is suggested. Irrigation appears to be functioning improperly causing bare/brown spots and in many areas.

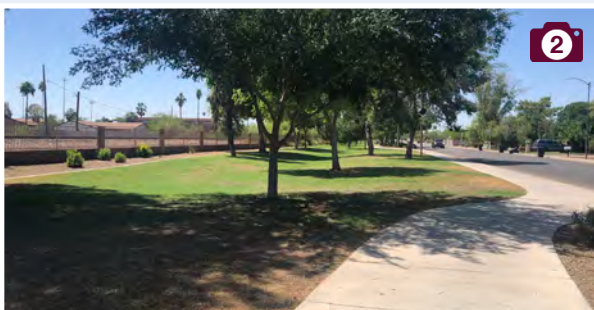
Sidewalk

Concrete sidewalk is in good condition.

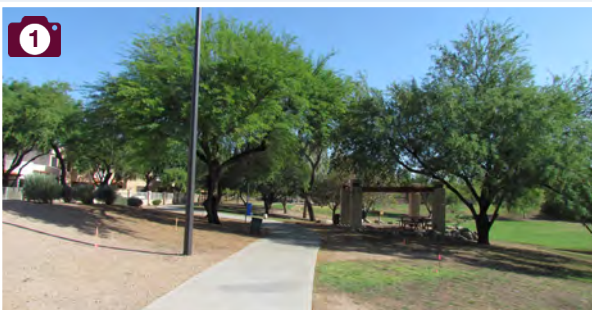
Established Trees next to concrete sidewalks

There are several areas with established trees located near the sidewalk, which has caused some cracking/heaving. Although the City has replaced some of these areas, the trees will continue impact sidewalk and cause further uprooting in the future. Relocation of the concrete sidewalk is recommended to provide increased separation from the tree root zone.

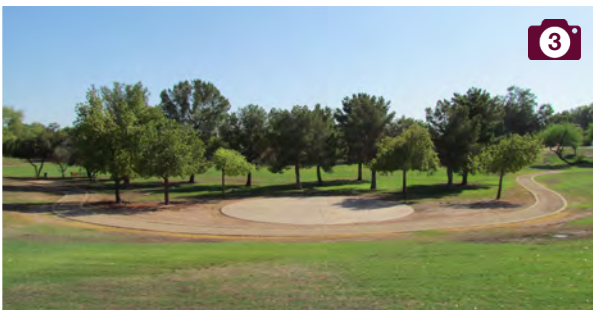
Turf at Baseball Fields

The baseball field turf areas are in average condition. The fields utilize flood irrigation for watering. It is recommended that aerating and soil agronomy tests be undertaken to determine soil conditions and amendments.

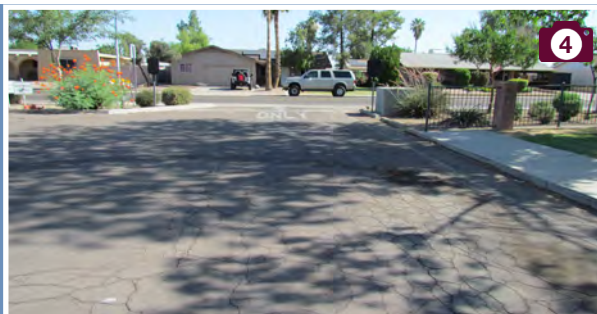
North Parking Area

The parking area is nearing its life expectancy and should be replaced. Due to the asphalt concrete's extensive 'alligator' cracking, crack seal and sealcoat is not recommended. Grading and drainage improvements should also be considered to ensure the pavement replacement does not fail. parking area.

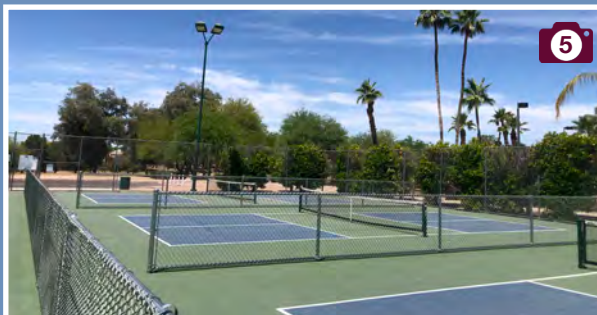
Courts

The tennis and pickleball courts are in good condition and have high-pressure sodium lighting. A LED fixture replacement is recommended for court lighting.

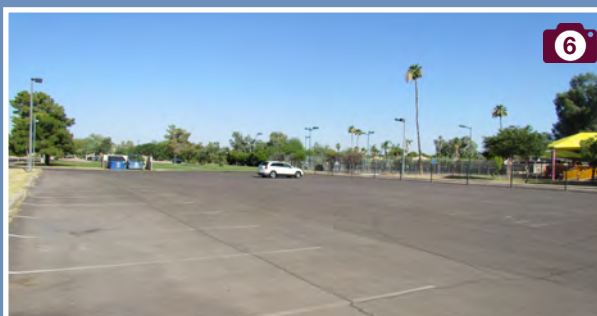
Southeast Parking Area

This parking area is in poor condition with several ponding areas and extensive 'alligator' cracking. The asphalt concrete is nearing its life expectancy and should be replaced. Due to the number of cracks and overall condition of the parking lot, crack seal and seal coat will not extend its life. To ensure pavement replacement does not fail, grading and drainage should also be considered.

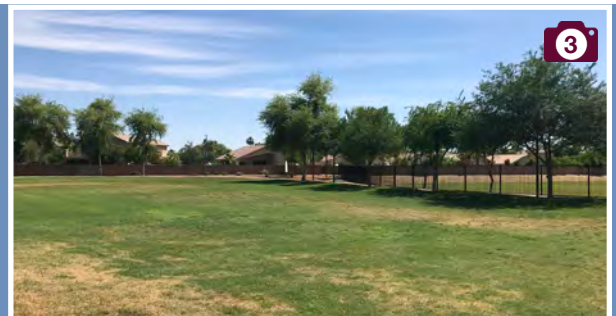
Turf Areas

The turf areas are in good condition with some worn and compaction throughout. The worn condition of slopes is due to lack of irrigation maintenance not activity. An aeration and soil agronomy test to evaluate soil condition and recommendations for amendments is suggested.

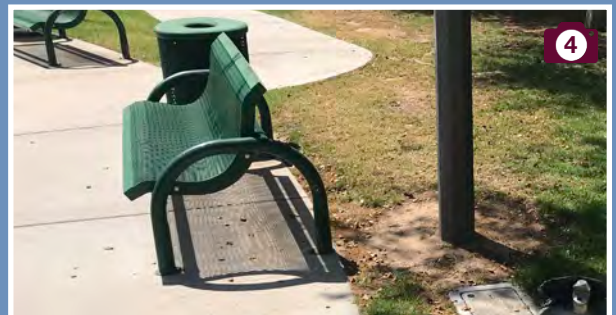
Sidewalk and Concrete Plaza Areas

The concrete sidewalk is in good condition.

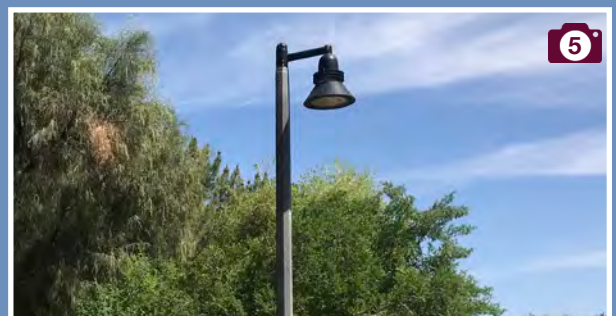
Site Lighting

The site lighting is high-pressure sodium fixtures. The fixtures and poles are in good condition. LED fixture replacement can be deferred until the current fixtures reach their lifecycle.

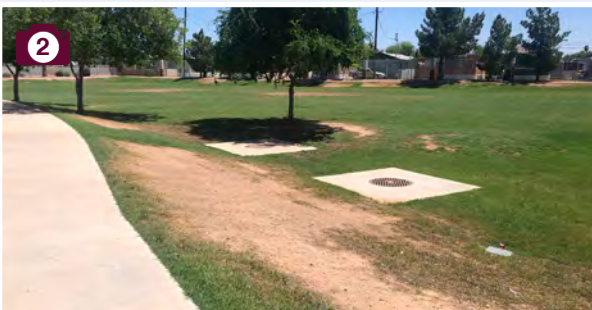
Overall Drainage

The park does not receive and offsite storm water runoff from the adjacent street frontage. The site self retains onsite drainage to the surrounding turf areas. Turf areas provide drainage for the onsite improvements including parking area and building. The drywells within turf area drawdown runoff.

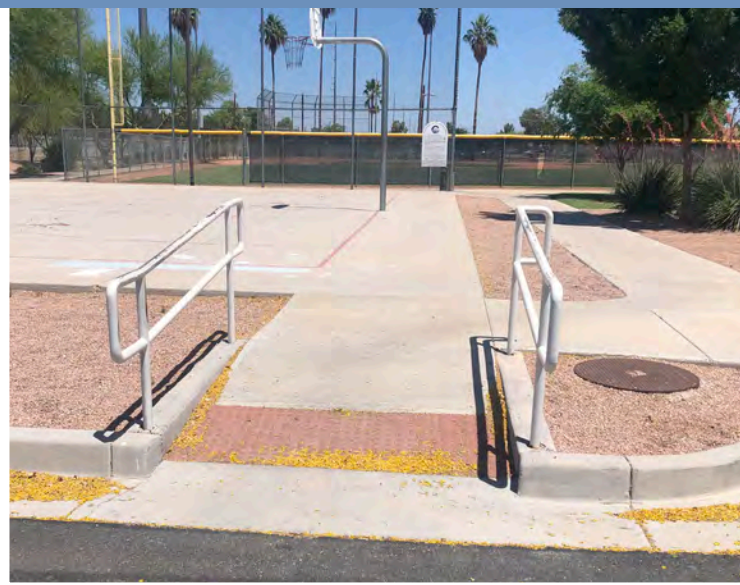
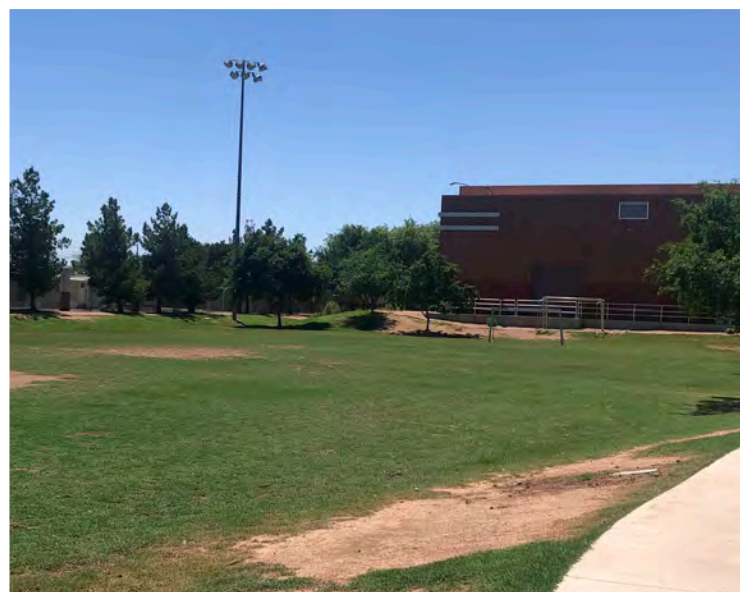
Turf Areas

The northeast turf area has worn areas along the sidewalk and adjacent steep, sideslopes. The condition of slopes is due to lack of irrigation maintenance, not activity. Overall, the turf areas show compaction throughout and has worn areas in the middle. An aeration and soil agronomy test to evaluate soil condition and recommendations for amendments is suggested.

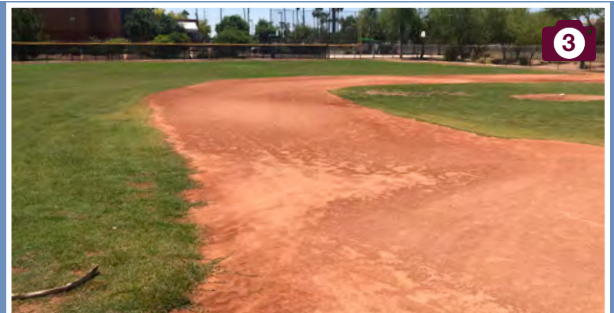
Baseball Field

The baseball field turf is in good condition in the outfield, while the infield has worn areas. The sports lighting is metal halide. The field was part of the Arizona Diamondbacks grant program and built to their specifications. It is recommended that removing the turf infield for skinned infield or converting to artificial turf would help with maintenance.

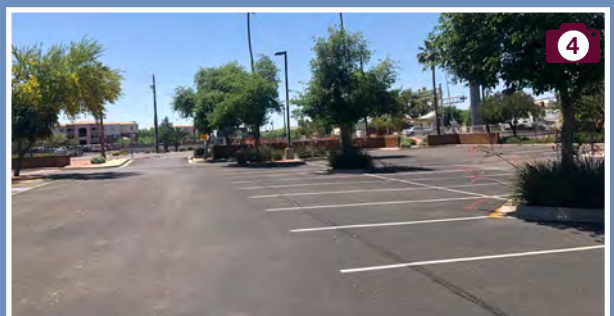
Parking Lot

The parking area for the Boys and Girls Club is in good condition and appears to have been crack sealed and seal coated within the last couple of years. Staff should continue to seal coat and crack seal the parking areas every two to three years to maintain the asphalt.

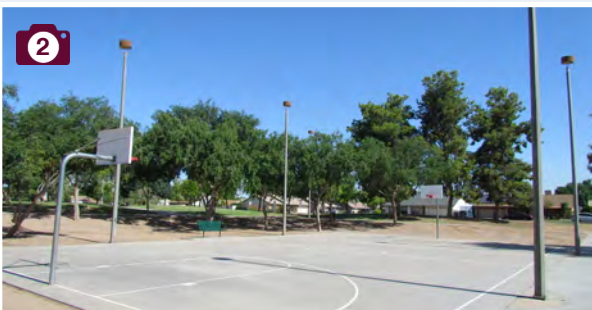
Site Lighting

The park pathway lighting is high-pressure sodium, LED fixture replacement for the pathway lighting is recommended.

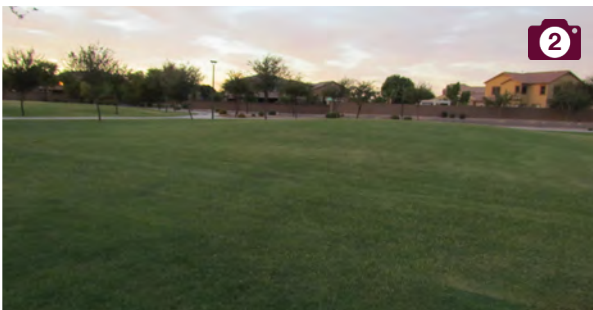
Overall Drainage

The park has two large turf areas on the east and west sides of the park. The south east area provides retention storage for offsite storm water runoff from Nash Way. The east turf area provides on site retention in the southwest area.

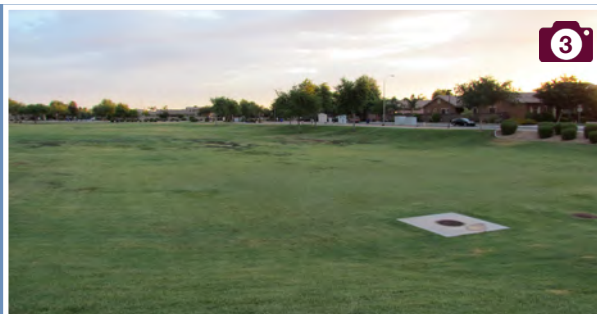
West Turf Area

The west turf area is in good condition. There are some worn areas throughout. An aeration and soil agronomy test to evaluate soil conditioning is recommended. The worn condition of slopes is due to lack of irrigation maintenance, not activity.

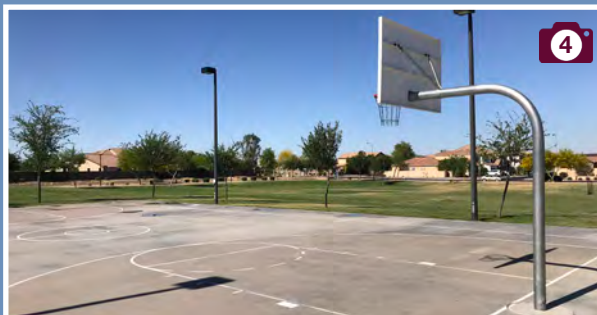
Basketball Court

The concrete post-tension court is in good condition and court lighting has LED fixtures.

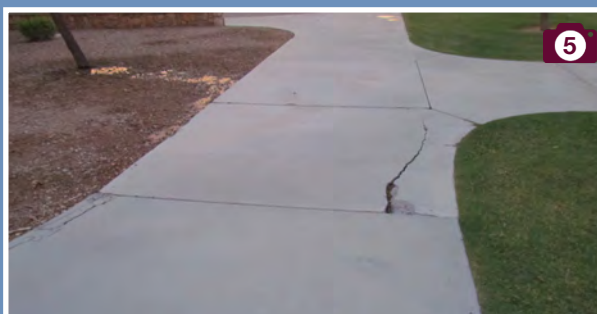
Sidewalk

The concrete sidewalk has some cracking throughout.

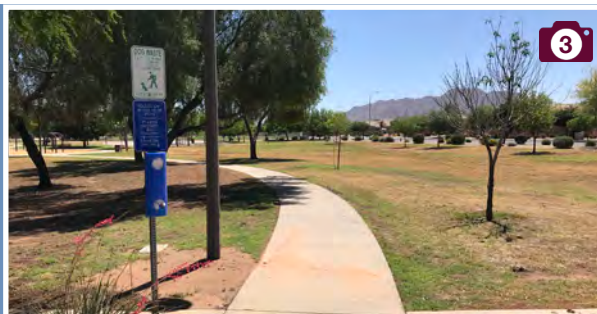
Sidewalk and Concrete Plaza Areas

The concrete sidewalk is in good condition, but there are some cracked panels throughout the pathways and plaza areas.

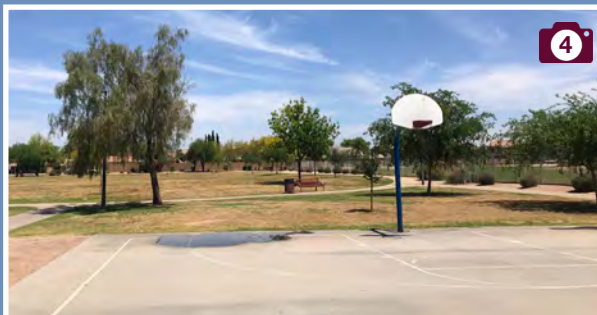
Basketball Court

The post-tension basketball court is in good condition with sawcut scoring throughout, relatively minor hairline cracking, and some surface wear. The light fixtures are high-pressure sodium. LED fixture replacement is recommended for court lighting.

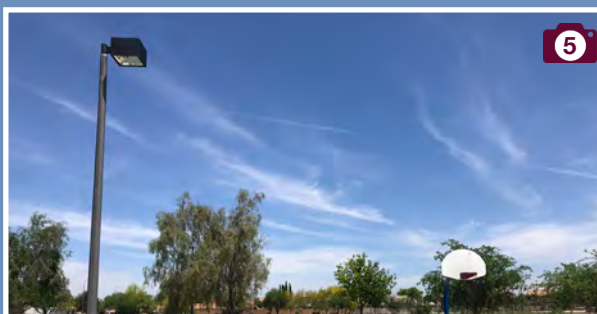
Site Lighting

The high-pressure sodium site lighting fixtures and poles are in good condition. The replacement of fixtures with LED is not recommended until the current fixtures reach lifecycle age.

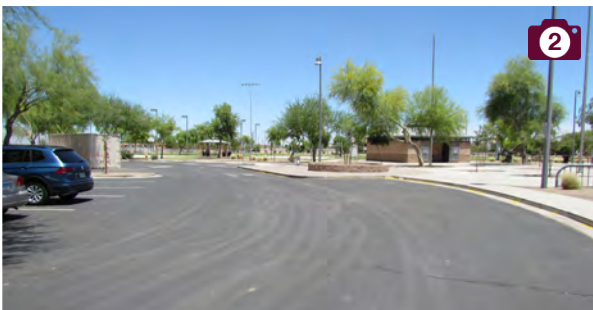
Overall Drainage

The park has a series of retention basins along the Dobson Road frontage. These basins provide storage for offsite storm drainage runoff, as well as onsite storage. The west basin is a large turf area with perimeter decomposed granite. There is a storm drain connector pipe at the park entrance road.

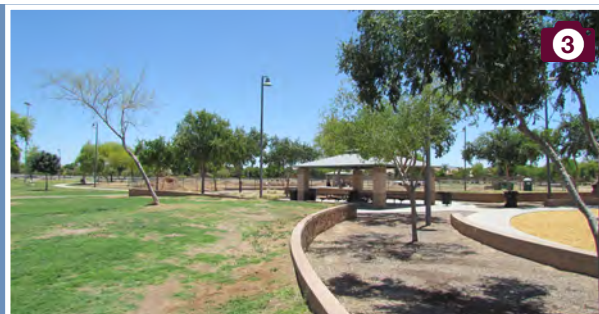
Middle Turf Area

The turf area around the plaza/playground is in below-average condition. There are large worn areas. The condition of slopes is due to lack of irrigation maintenance not activity. An aeration and soil agronomy test are recommended to evaluate soil condition and amendments.

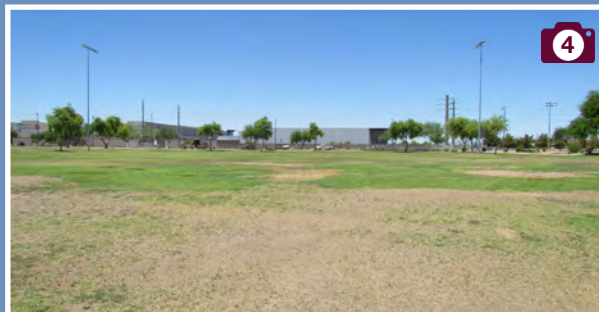
West Multi-Purpose Field

The turf area is in below-average condition with several worn areas from use. The condition of slopes is due to lack of irrigation maintenance not activity. Recommend that aeration and soil agronomy test be undertaken to evaluate soil condition and possible amendments.

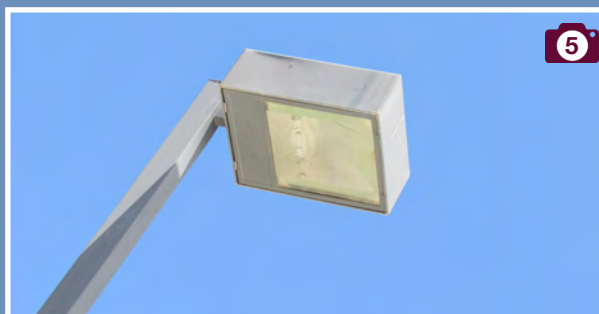
Site Lighting

The pedestrian and parking area lights are high-pressure sodium fixtures. LED fixture replacement along pathways is recommended.

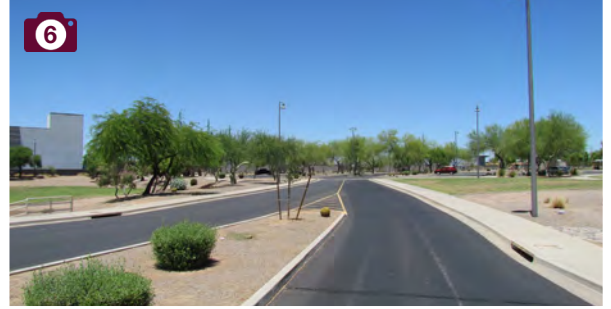
Park Entrance Roadway

The park entry drive is in great condition and was recently seal coated.

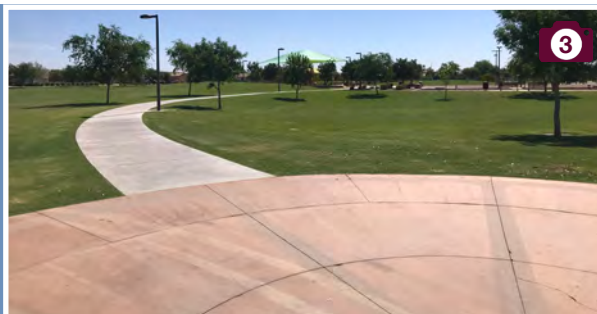
Sidewalk and Concrete Plaza Areas

The concrete sidewalk is in good condition. There are some cracked panels throughout the pathways and plaza areas.

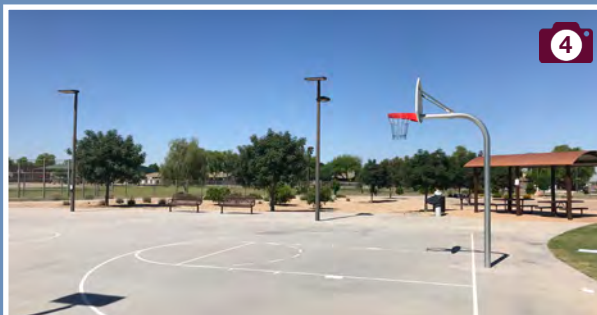
Basketball Court

The concrete basketball court is in new condition and the light fixtures are LED.

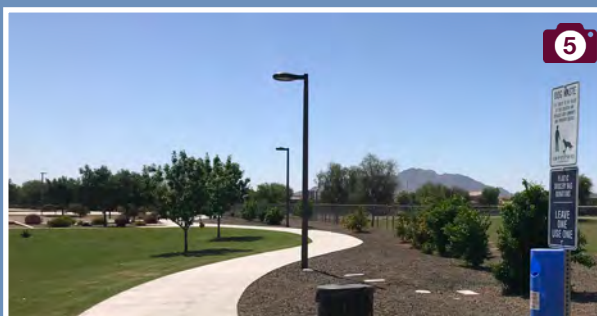
Site Lighting

The site lighting fixtures are high-pressure sodium. The fixtures and poles are in good condition. The replacement of fixtures with LED can wait until the current fixtures reach lifecycle age.

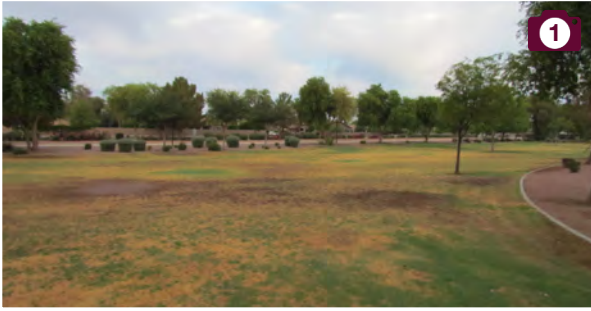
North Turf Area

The north turf area is in below-average condition and there are several worn areas. The condition of slopes is due to lack of irrigation maintenance not activity. The area appears to be very compacted throughout. An aeration and soil agronomy test to evaluate soil conditioning is recommended.

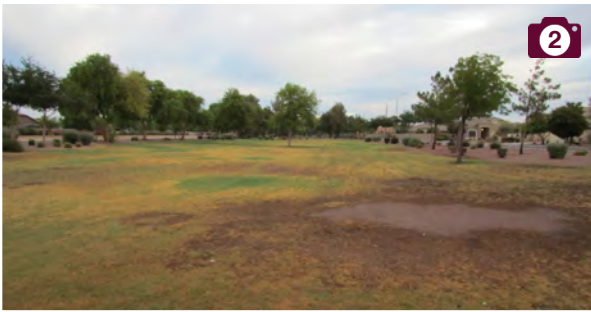
South Turf Area

The south turf area is in below-average condition and there are several worn areas. The condition of slopes is due to lack of irrigation maintenance not activity. The area overall, appears to be very compacted throughout. An aeration and soil agronomy test to evaluate soil conditioning is recommended.

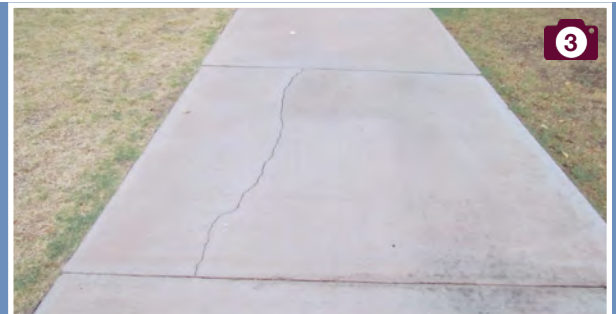
Sidewalk

The concrete sidewalk has some cracking throughout.

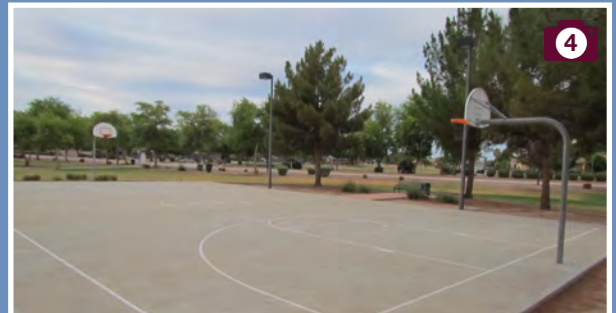
Basketball Court

The concrete post-tension court is in good condition and lighting has high-pressure sodium fixtures. LED fixture replacement for court lighting is recommended.

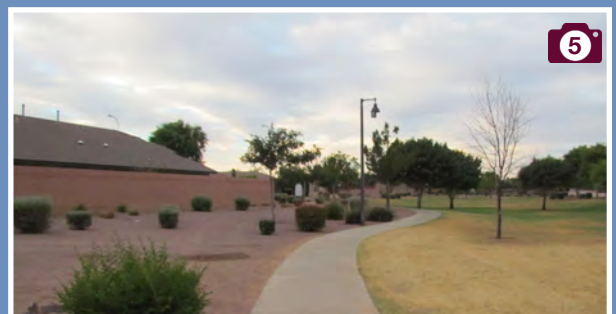
Site Lighting

The pedestrian pathways utilize LED lighting.

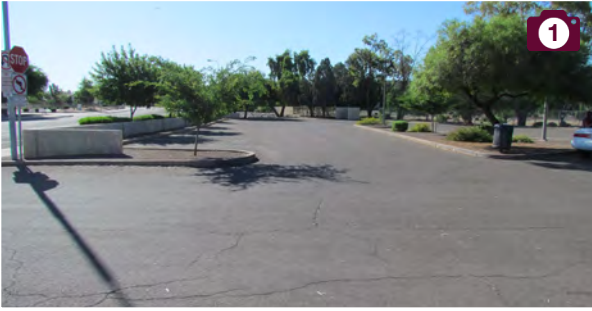
East Parking Area

The asphalt-concrete pavement cracks range from a 1/2" to 1" in width. A seal coat of all surface cracks every three years is recommended. The existing pavement and subbase can age another 10 years with recommended crack seal/seal coat due to positive drainage conveyance. The parking lot utilizes one driveway for ingress/egress.

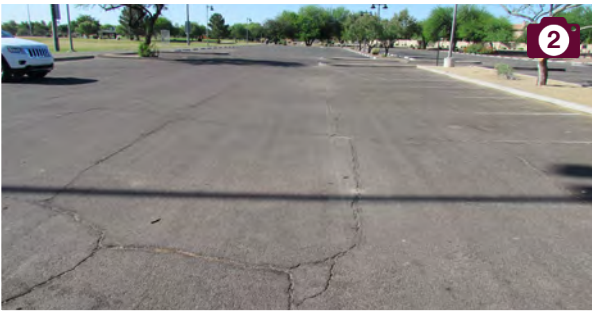
West Parking Area

The asphalt-concrete pavement cracks range from 1/2" to 1" in width. A seal coat of all surface cracks every three years is recommended. The existing pavement and subbase can age another 10 years with recommended crack seal/seal coat due to positive drainage conveyance. The parking lot utilizes one driveway for ingress/egress.

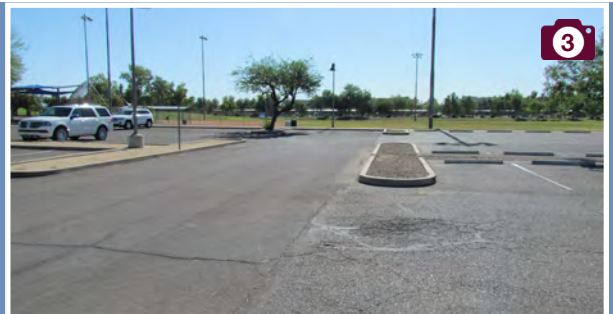
Middle Parking Area

The parking lot sheet flows drainage to the adjacent decomposed granite retention basins to the west. Some erosion exposure at the drainage outlet points, but it is relatively minor. The southern half of this parking area is collectively the worst pavement observed among all the parking areas. Minimal slopes within this section of the parking area shows evidence of ponding within the lot, which has resulted in more visible AC pavement cracking.

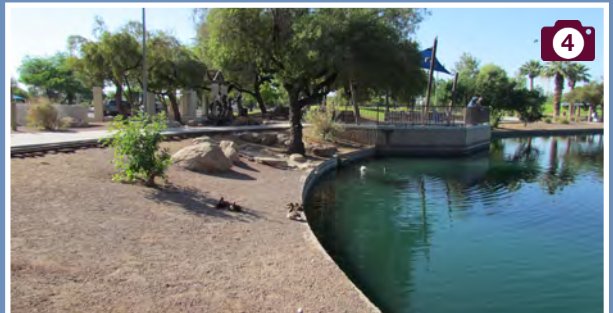
Lake Slope

The interior lake slope from the sidewalk to lake edge show established slopes with minimal rilling and erosion. The only area of rilling and erosion for the lake area is the northwest cove as these bank slopes are the highest among the entire lake perimeter. A slope reduction or larger riprap treatment to maintain bank slope is recommended.

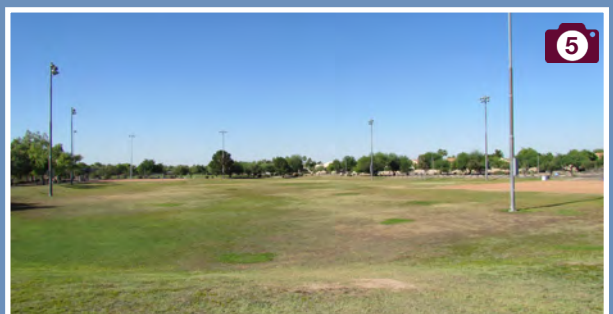
Multi-purpose/Baseball Field Areas

The turf area shows several wear areas and is in significantly poorer condition than the other turf areas throughout the park. The condition is due to lack of irrigation maintenance not activity. This area does not utilize flood irrigation. A sprinkler irrigation evaluation is recommended to determine if flood irrigation could be expanded to provide intermediate irrigation option. An aeration and soil agronomy test to evaluate soil conditioning is recommended.

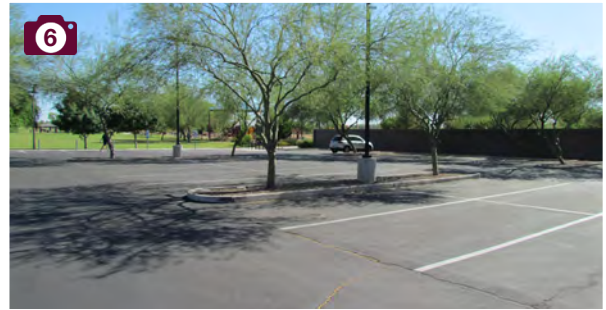
South Parking Area

The asphalt-concrete pavement cracks range from 1/2" to 1" in width. The parking lot appears to have been crack sealed and seal coated within the last two years. A seal coat of all surface cracks every three years is recommended. The existing pavement and subbase can age another 10 years with recommended crack seal/seal coat due to positive drainage conveyance.

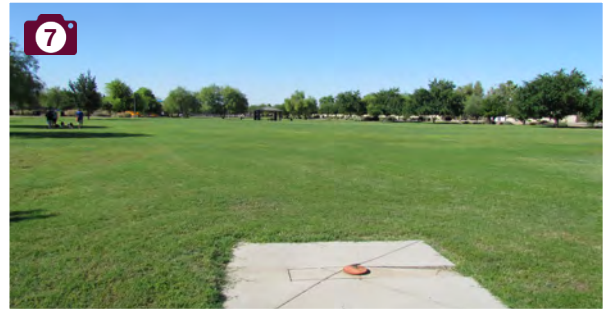
Middle Open Turf Area

Turf area is in moderate condition. The two large turf areas both utilize flood irrigation, as well as conventional sprinklers. These turf areas are in significantly better condition than the multi-purpose turf area to the north. A turf reduction around ramada areas, which slope up due to the use of the flood irrigation, is recommended. Additionally, a header curb with decomposed granite is recommended as these areas have lack of irrigation coverage, and are worn dirt areas.

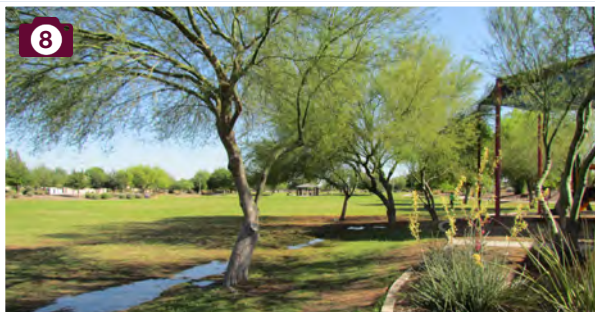
Southern Open Turf Area

The turf area is in good condition. The two large turf areas both utilize flood irrigation, as well as conventional sprinklers. These turf areas are in significantly better condition than the multi-purpose turf area to the north. A turf reduction is recommended around ramada areas, which slope up due to the use of the flood irrigation. Also recommended is a header curb at DG areas, as they have lack of irrigation coverage and are worn dirt areas.

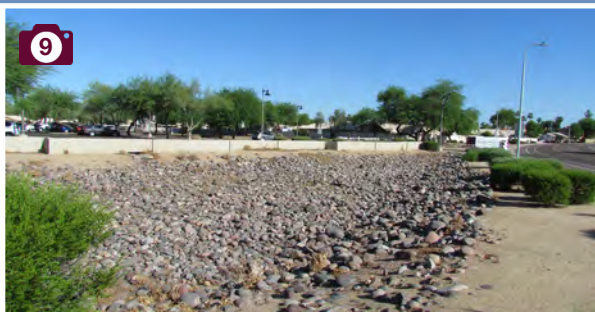
North Parking Area

The north parking area is well drained. This parking area utilizes three localized drainage basins located along the frontage of the parking area. The North basin provides drainage storage from the northern parking area, as well as the half street from the parks maintenance road. None of the existing basins have drywells and it could not be determined if the basins drain within 36 hours of a storm event per the Maricopa County regulations during the site visit.

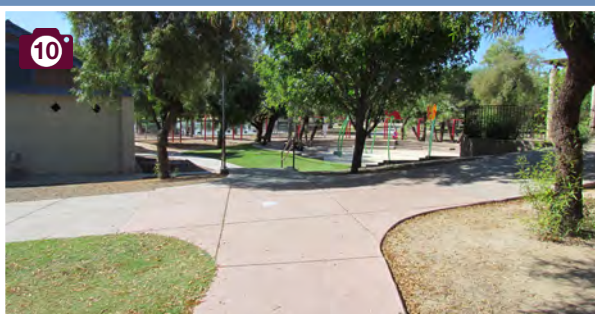
Sidewalk around Playground Area

A sidewalk panel replacement is recommended due to several cracked sidewalk panels around the playground area.
